# Bridge No. BC 1255

Central Avenue over  
Harford Run

Routine Inspection

**City of Baltimore Contract #1105**

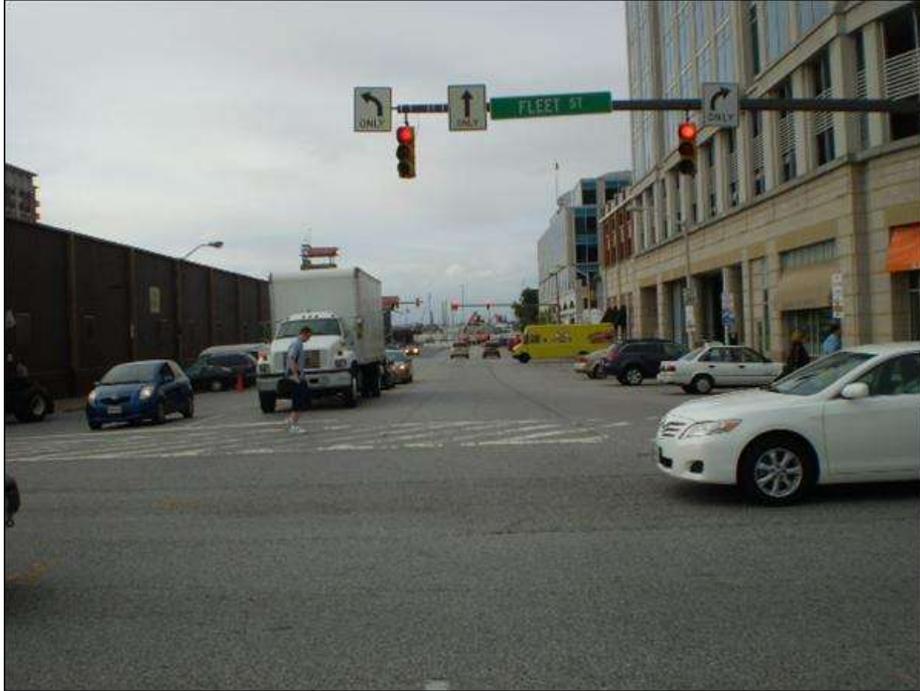
1. North Approach Looking South

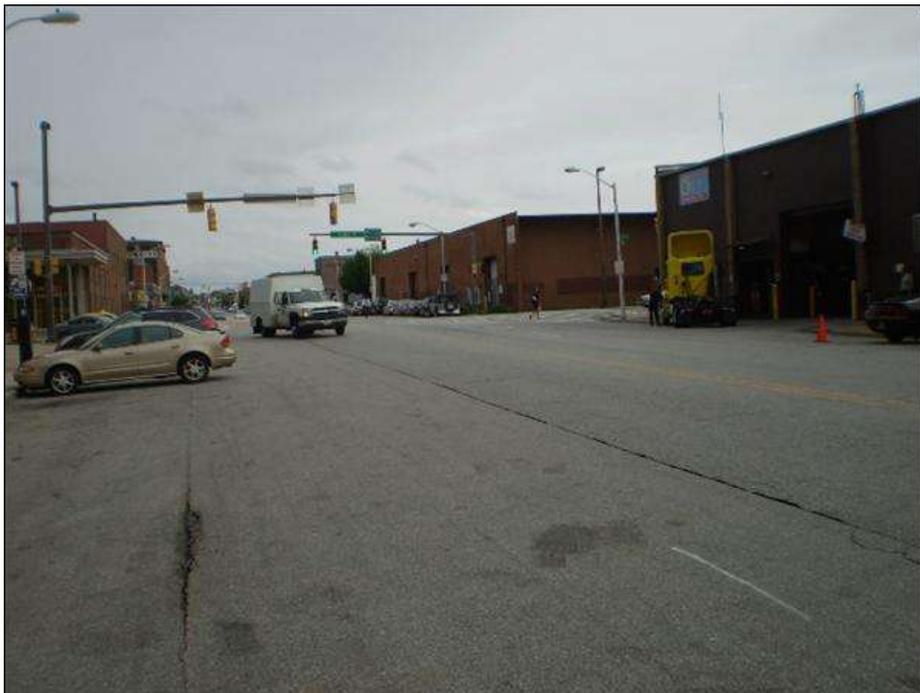
2. North Approach Looking North

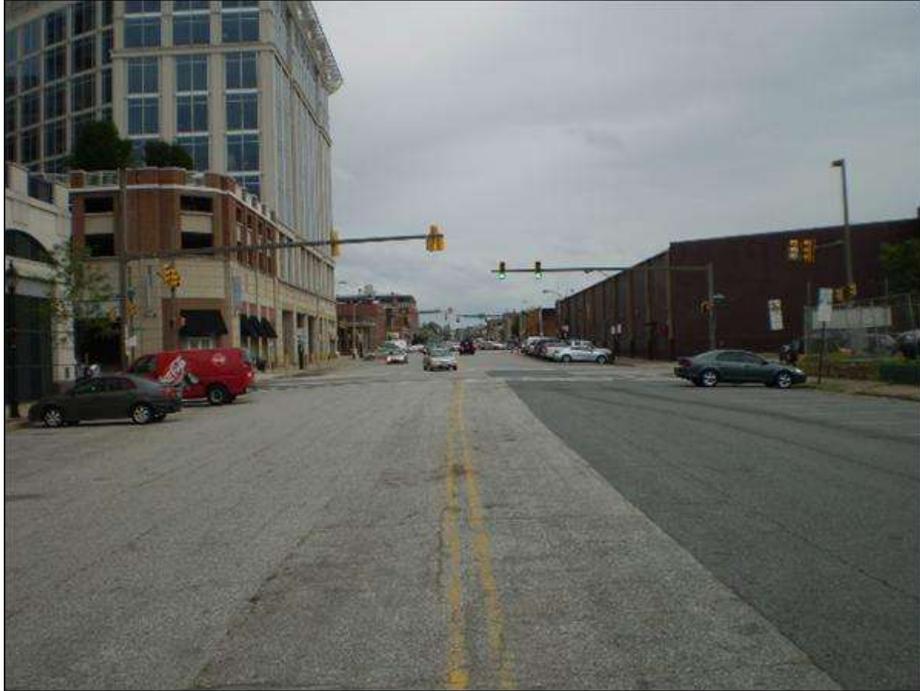
3. South Approach Looking North

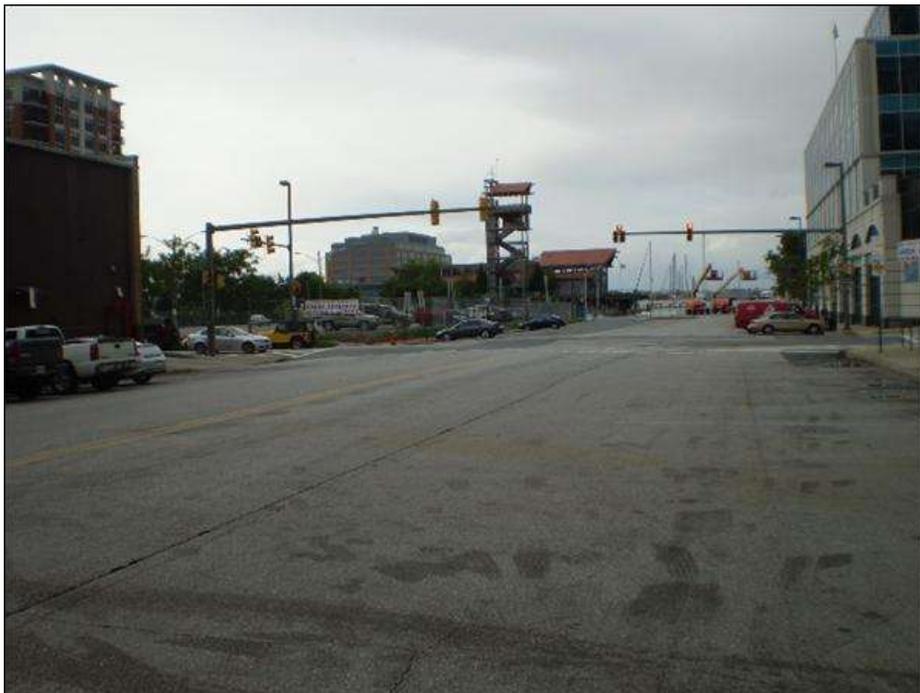
4. South Approach Looking South

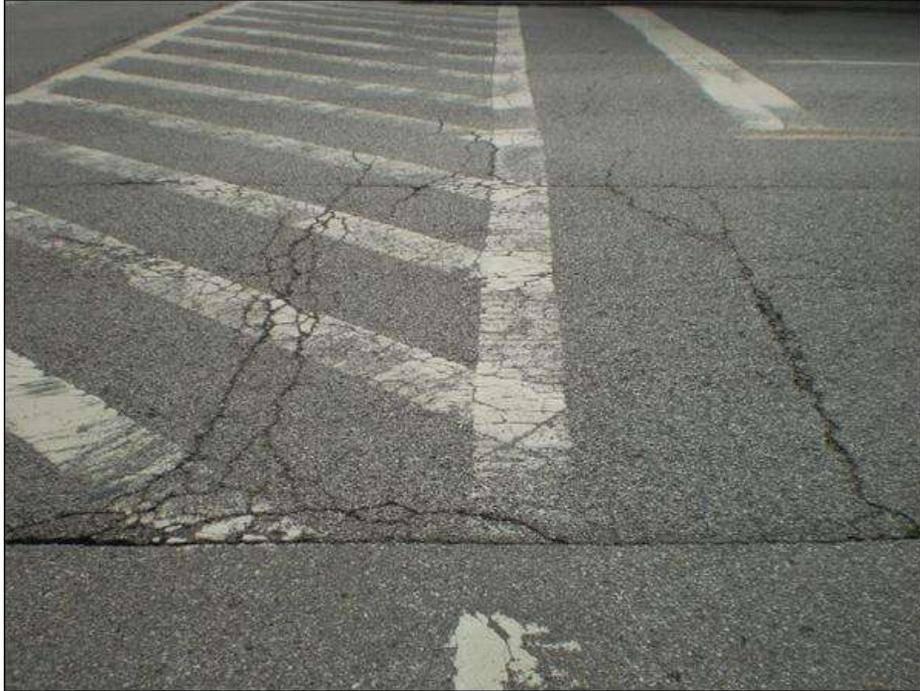
1. The wearing surface on the approaches and over the culvert is in satisfactory condition.
2. There are 1/8" to 1/2" wide cracks in the pavement construction joint along both the east and west edges of the culvert.
3. There are random hairline to 1/8" wide transverse and longitudinal cracks in the bituminous wearing surface over the culvert. The transverse cracks are typically 5'-0" long with a few up to full width.
4. There is a 6'-0" x 6'-0" area of pavement that has heaved up to 3/8" near the north end (see Photograph No. 5).

5. Heaved Pavement Near the North End Over the Culvert

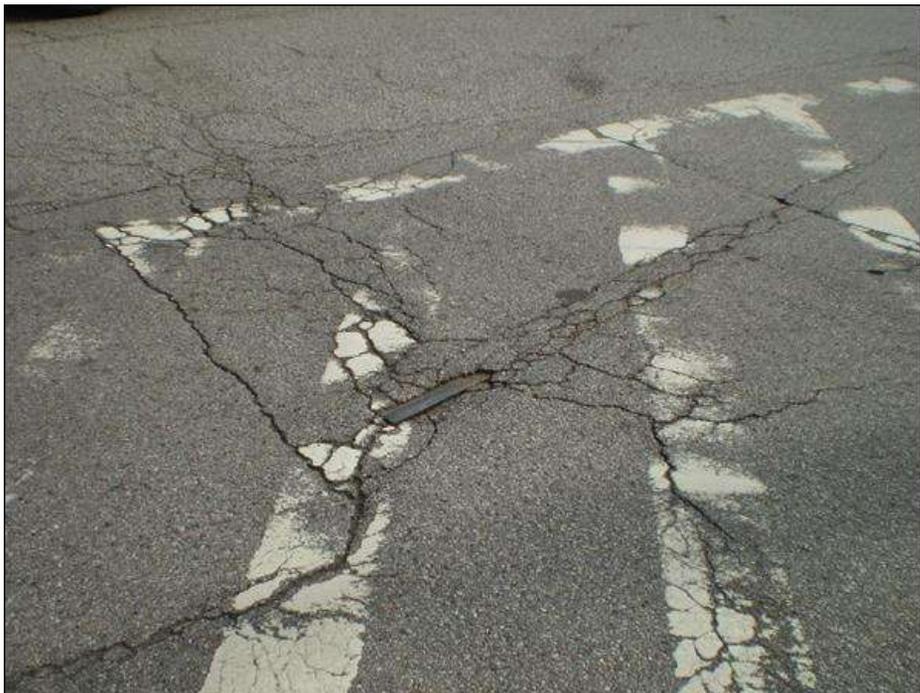
5. There is a 1'-0" long piece of exposed train car rail in the pavement at the northwest corner with map cracking in a 10' x 6' area (see Photograph No. 6).
6. There is multi-directional cracking up to 1/8" wide in the South Approach Roadway (see Photograph No. 7).

1. A piece of train car rail is exposed with map cracking in the pavement at the northwest corner.
2. There is a failing repair in the west wall.

6. Exposed Train Car Rail in Pavement at Northwest Corner

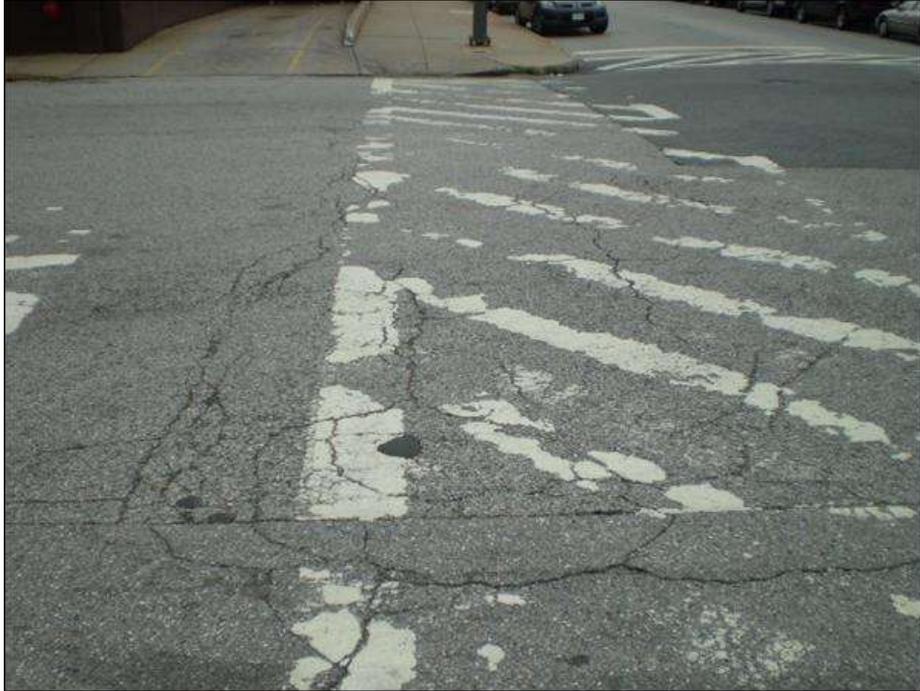
7. Multi-Directional Cracking in the South Approach Roadway

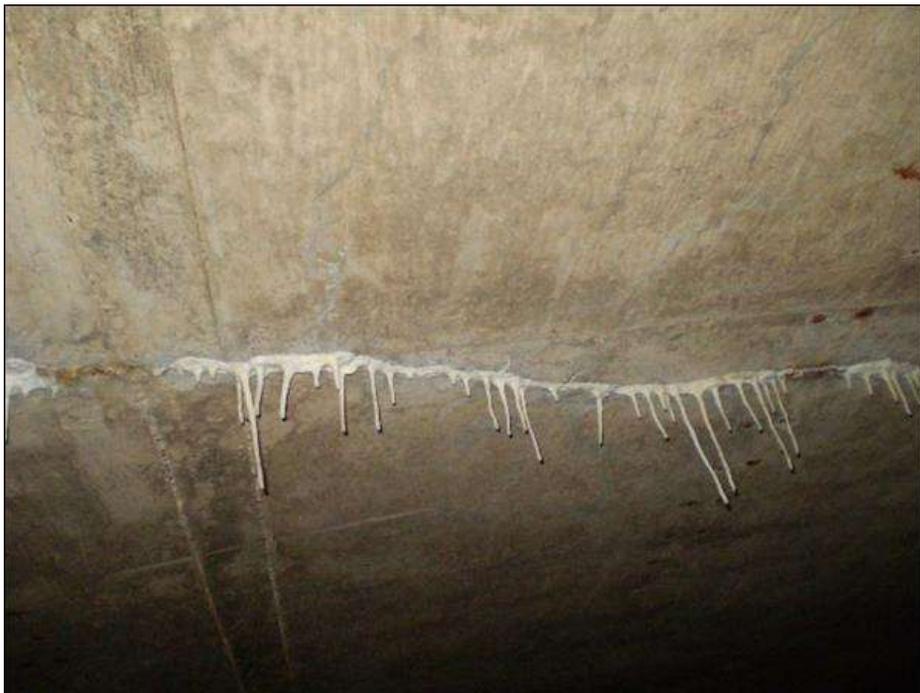
1. The culvert is in satisfactory condition.
2. The construction joints typically are cracked with water leakage, rust staining and efflorescence.
3. There are sixteen (16) full width hairline transverse cracks with moderate efflorescence and rust staining in the top slab (see Photograph No. 8). The majority of these cracks extend through the full height of the culvert walls.

8. Typical Transverse Crack with Efflorescence and Rust Staining in the Top Slab

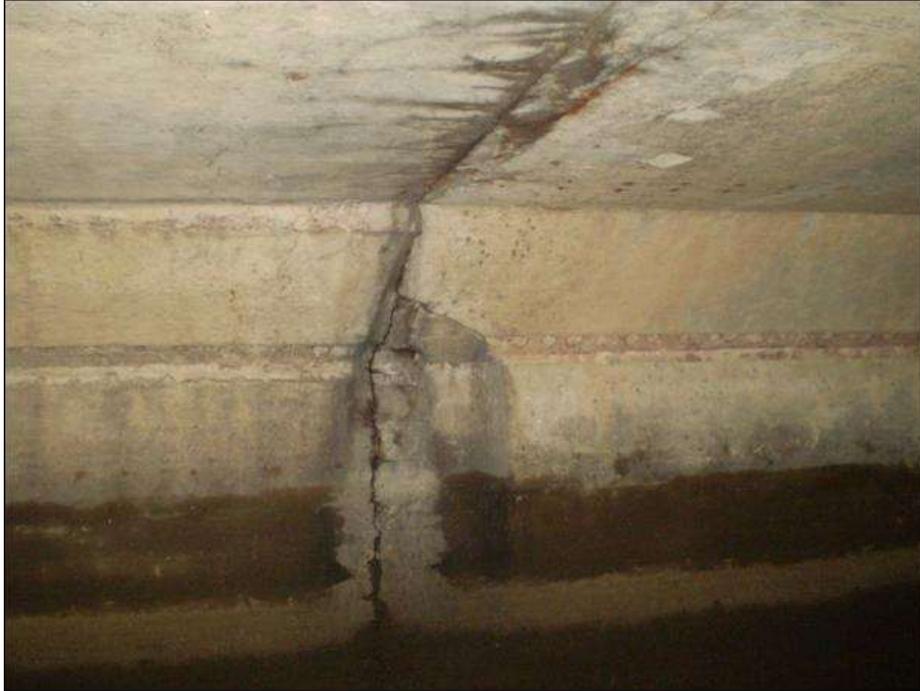
6. There are random hairline vertical cracks in the culvert walls.
7. There is random hairline map cracking in the east wall with light efflorescence.
8. There is a failing repair in the west wall at a construction joint at mid-length of the culvert (see Photograph No. 9).

9. Failing Repair in the West Wall at Midlength of the Culvert

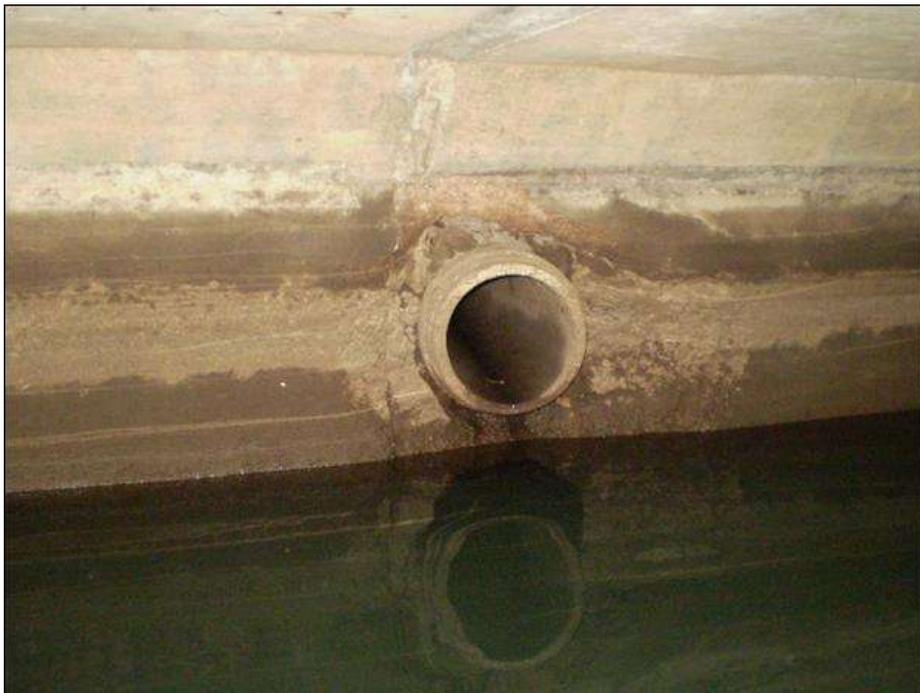
9. There is an inlet pipe opening in the west wall of the culvert. There are spalls surrounding the entire circumference of the pipe (see Photograph No. 10).

10. Pipe with Adjacent Spalling in the West Wall

Item	Quantity	Units	Unit Cost	Total Cost
<b><i>Immediate</i></b>				
None				\$0.00
<b>Subtotal (Immediate)</b>				<b>\$0.00</b>
<b><i>Short Term</i></b>				
None				\$0.00
<b>Subtotal (Short Term)</b>				<b>\$0.00</b>
<b><i>Long Term</i></b>				
1. Repair spalls in the top slab at Joints 7 and 10 and in the west wall of the culvert around the storm drain.	80	SF	\$60	\$4,800.00
<b>Subtotal (Long Term)</b>				<b>\$4,800.00</b>
<b>Total Maintenance Cost</b>				<b>\$4,800.00</b>
