Bridge No. BC 1555

Central Avenue over
Harford Run

Routine Inspection

2009

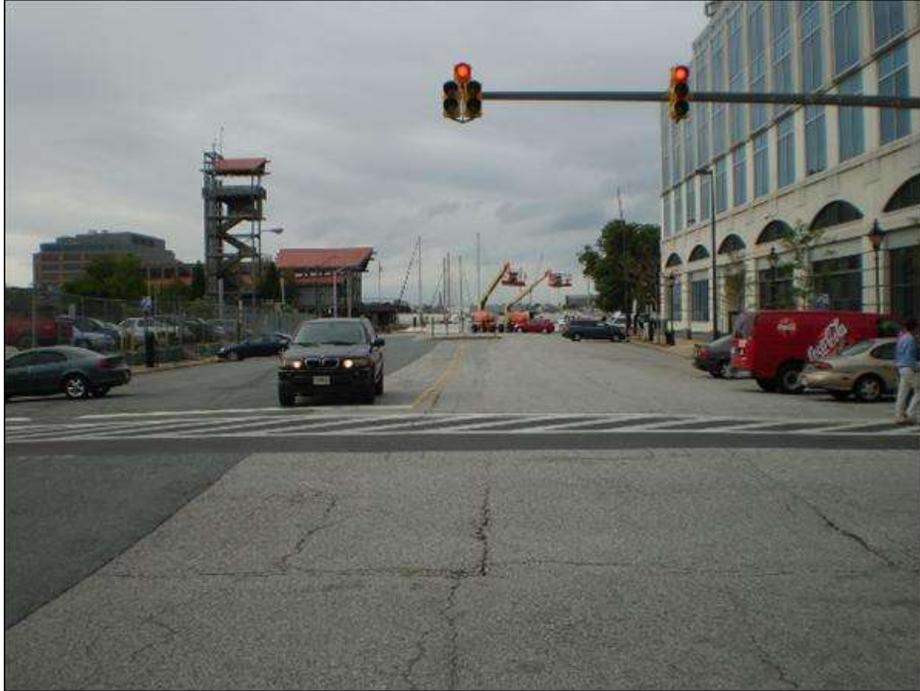
1. North Approach Looking South

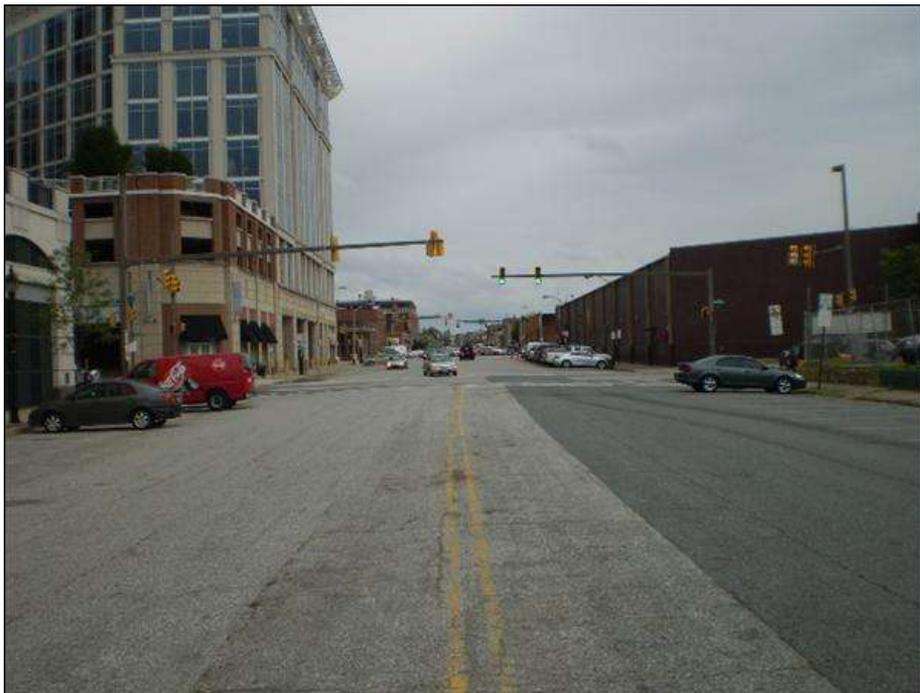
2. North Approach Looking North

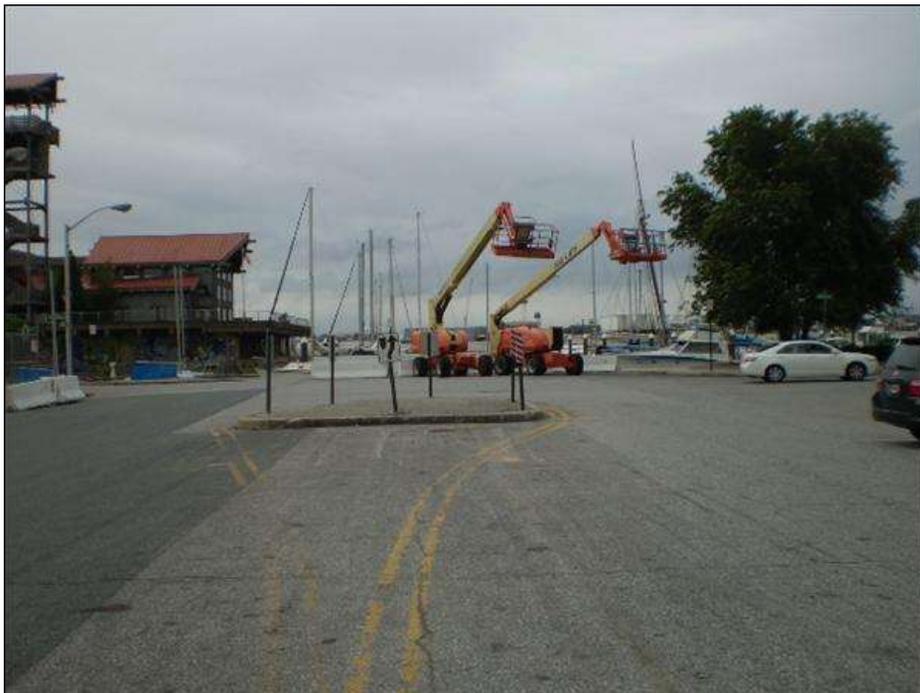
4. South Approach Looking South

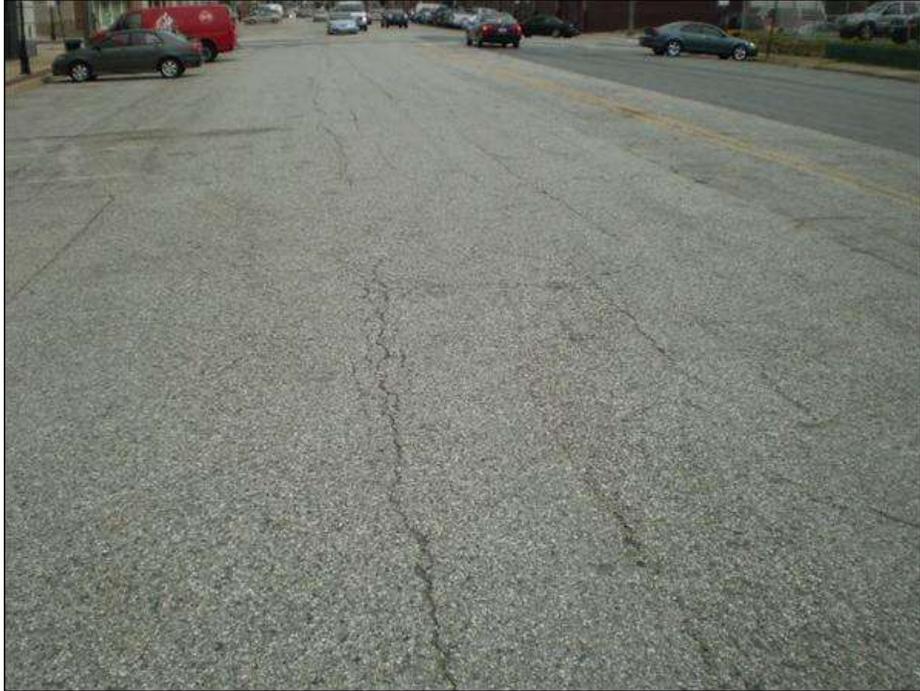
1. There is an 1/8" to 1/2" wide crack in the pavement construction joint along the west edge of the culvert (see Photograph No. 5).
2. There are random hairline to 1/4" wide transverse and longitudinal cracks in the bituminous wearing surface over the culvert. Several of the transverse cracks are full width.

5. Typical Longitudinal Cracking in Wearing Surface at West Side of Culvert

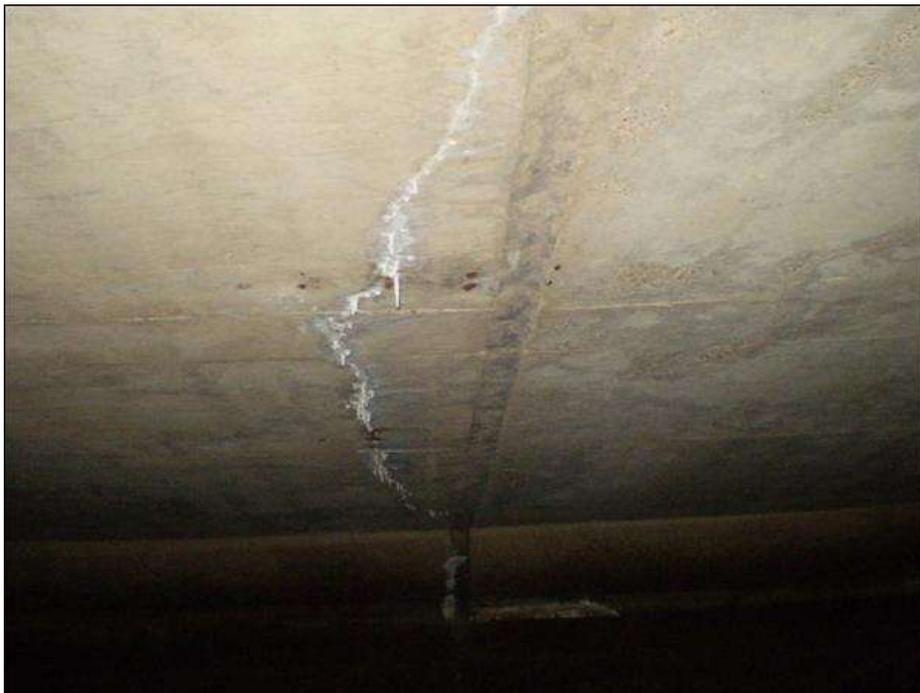
1. There are sixteen (16) full width hairline transverse cracks with moderate efflorescence and minor rust staining in the top slab. Several of these cracks extend through the haunches and culvert walls.
2. The construction joints typically are cracked with water leakage, rust staining and

efflorescence (see Photograph No. 6).

6. Typical Cracking at Transverse Joint in Top Slab

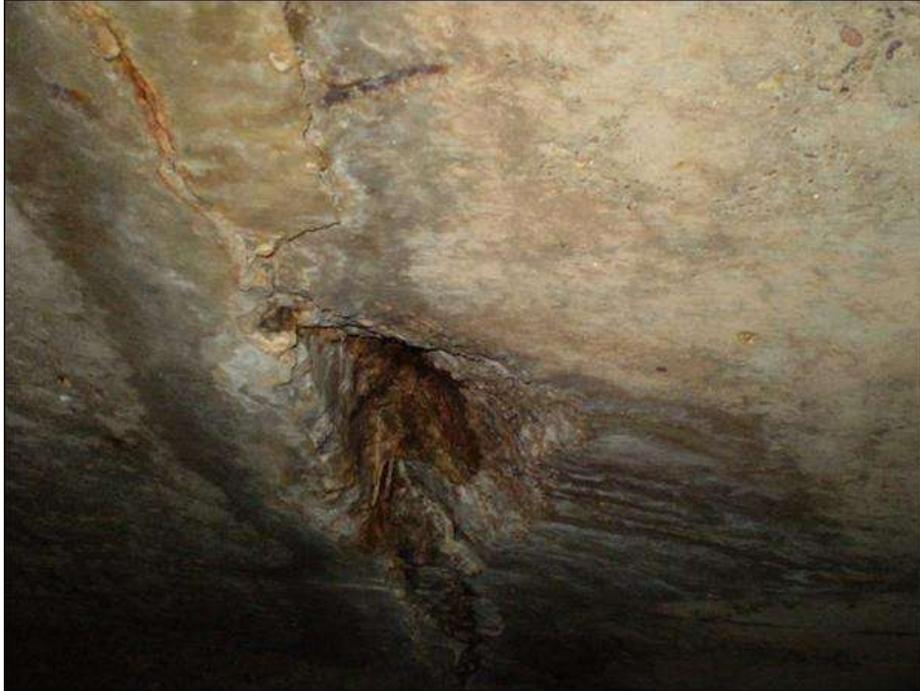
7. There is a 1'-4" square by 3" deep spall with exposed reinforcement in the top slab approximately 20' from the south end of the culvert (see Photograph No. 7).

7. Spall in Top Slab Approximately 20' from South End of Culvert

Item	Quantity	Units	Unit Cost	Total Cost
Immediate				
None				\$0.00
Subtotal (Immediate)				\$0.00
Short Term				
None				\$0.00
Subtotal (Short Term)				\$0.00
Long Term				
1. Clean the exposed reinforcement steel and repair the spalls in the top slab and the west wall of the culvert around the storm drains.	70	SF	\$60	\$4,200.00
2. Clean out the partially blocked drain pipe in the west wall.	1	LS	\$250.00	\$250.00
Subtotal (Long Term)				\$4,450.00
Total Maintenance Cost				\$4,450.00

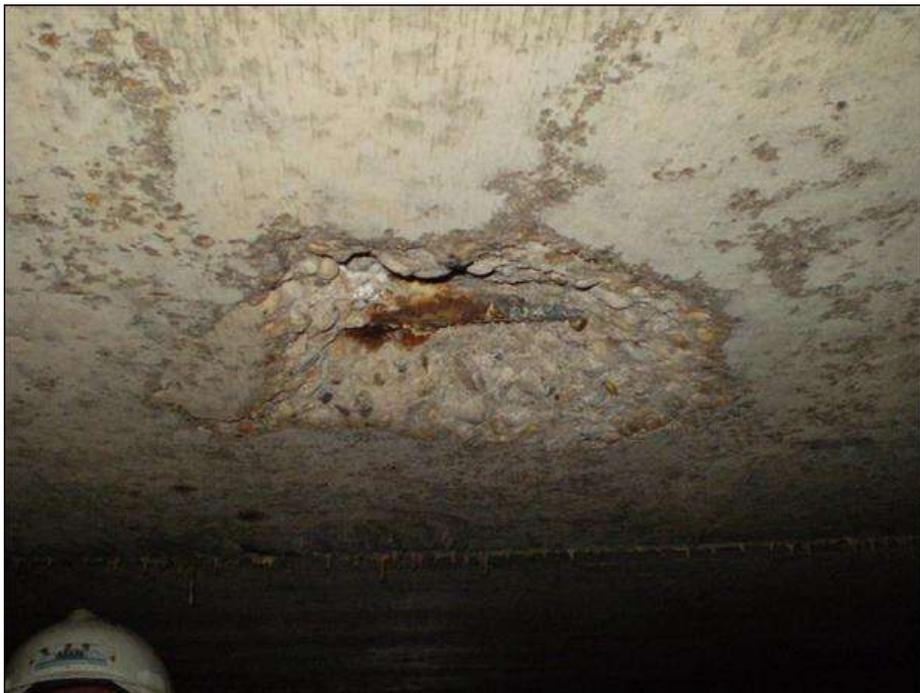
10. There is a 1'-4" wide x 7" long x 4" deep spall with exposed reinforcement in the culvert wall approximately 30' from the south end of the culvert (see Photograph 8).

1. The spall approximately 30' from the south end of the culvert has exposed reinforcement.

8. Spall in Top Slab Approximately 30' from South End of Culvert

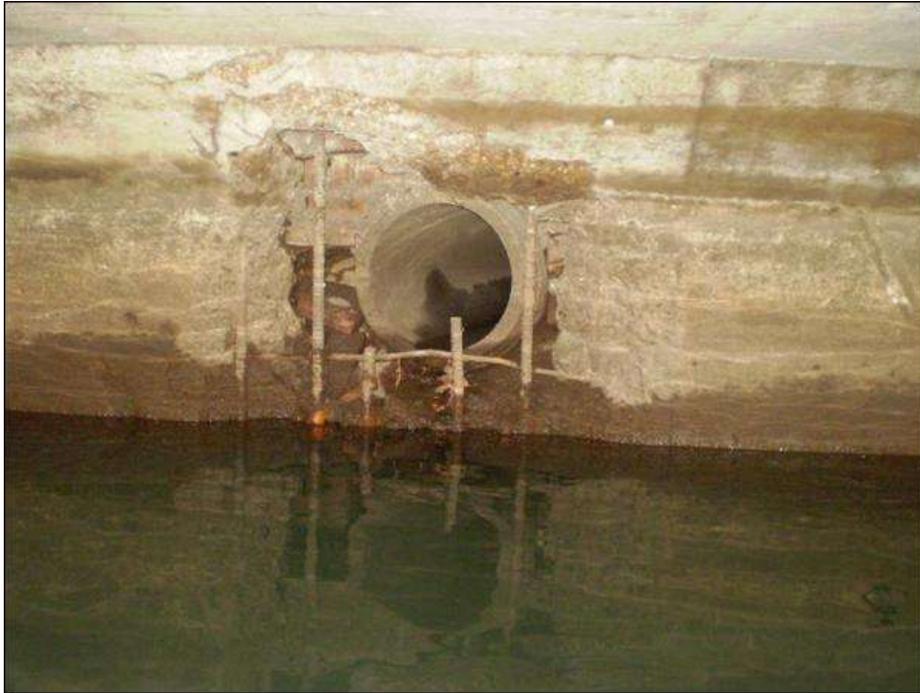
11. There are two storm water pipe outlets in the west wall of the culvert. There are spalls surrounding the entire circumference of both pipes with exposed and corroded reinforcement (see Photograph Nos. 9 & 10). Flow in the northern most pipe in the west wall is approximately 50% blocked due to debris build-up in the pipe.

9. Spalling at the North Pipe Opening in the West Wall

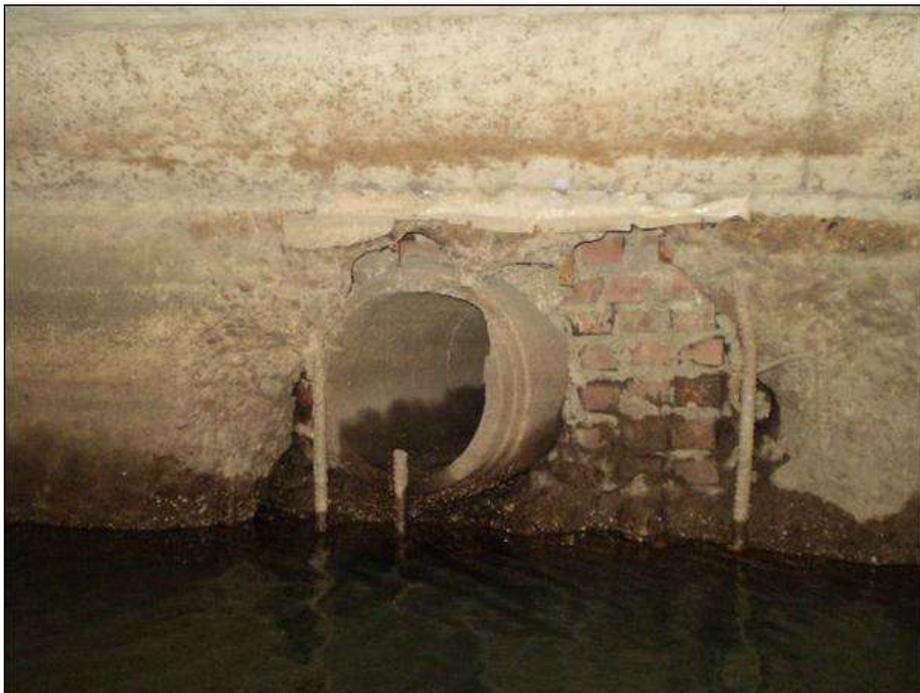
10. Spalling at the South Pipe Opening in the West Wall
