Bridge No. BC 8019

Aliceanna Street at Central Avenue over
Harford Run

Routine Inspection

2009

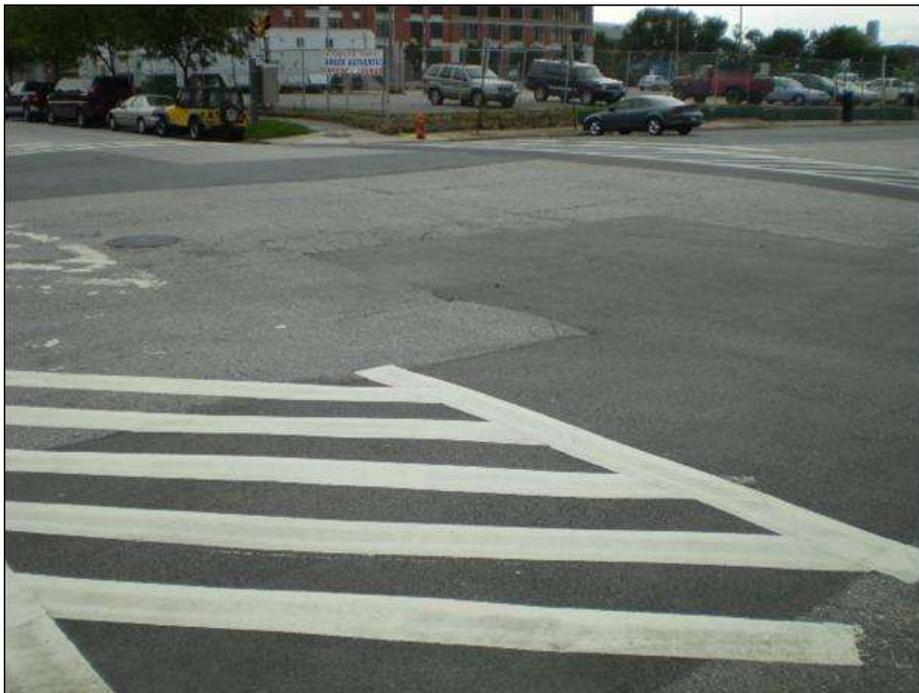
1. The deck is in fair condition with minor unevenness at the pavement joints and numerous pavement patches throughout (see Photograph 7).
2. There is a 1'-0" square x 6" deep spall in the soffit near the East Abutment Backwall between Beams 4 and 5 exposing a brick wall.

7. Patches in the Bituminous Wearing Surface of the Deck

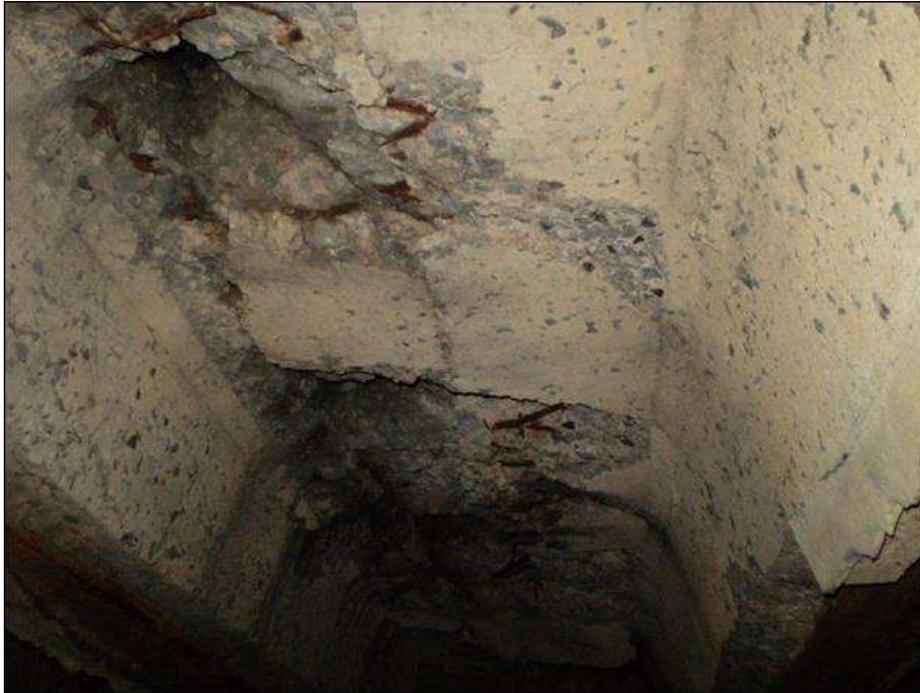
4. There is an 8'-0" wide x 1'-8" long x up to 6" deep area of spalling with exposed wire reinforcing in the soffit between Beams 6 and 7 near the West Abutment. It appears as if three 2" diameter deck cores were taken at 2'-0" spacing between the beams causing the deck soffit to spall. There is asphalt visible in the 2" diameter core holes (see Photograph 8).

8. Soffit Spalls at Core Holes between Beams 6 and 7 near the West Abutment

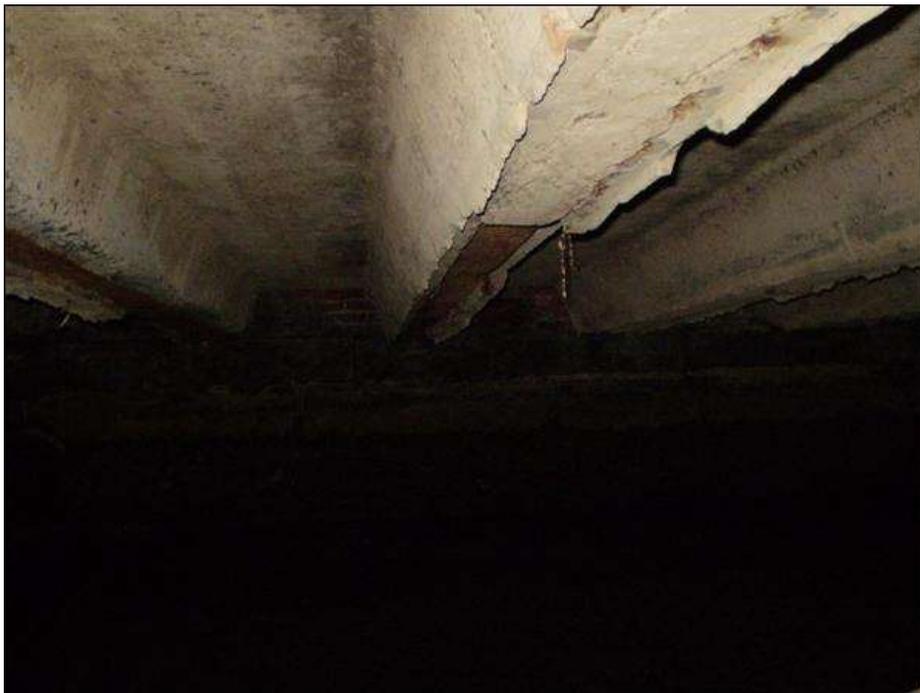
2. Approximately 30% of the bottom flanges of the steel beams are exposed and exhibit minor to moderate surface rust with minor section loss (see Photograph 9).

3. The steel beam concrete encasements are delaminated and typically exhibit cracking along the bottom flange corners of approximately 80% of the total beam lengths.

9. Typical Exposed Bottom Flange of the Concrete Beams

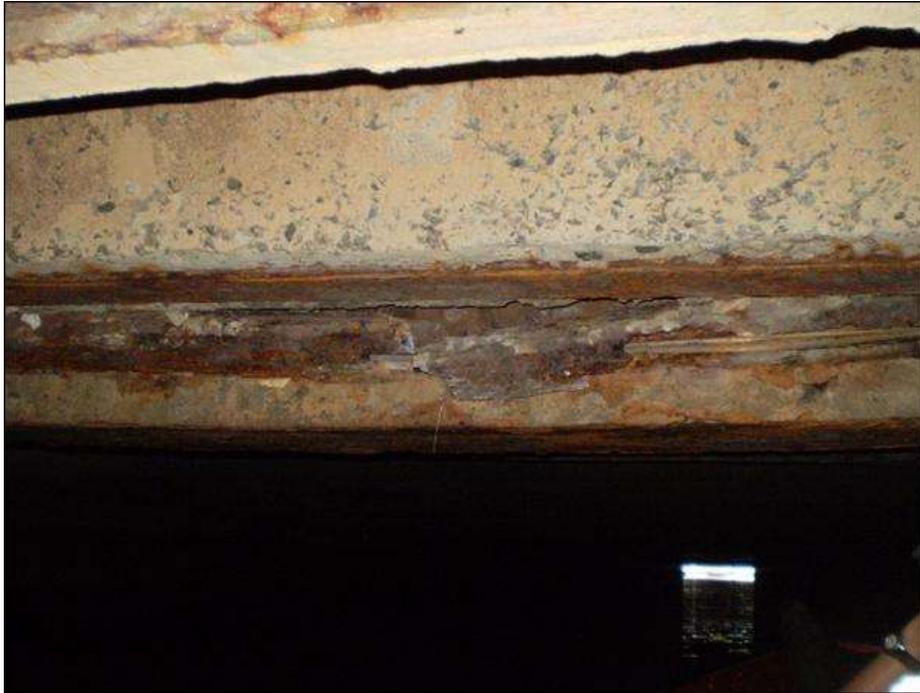
5. There is a terra cotta utility duct supported by a steel channel which is sagging below the beams as much as 8" at the south side of the bridge (see Photograph 10).

10. Sagging Steel Channel Supporting a Terra Cotta Utility

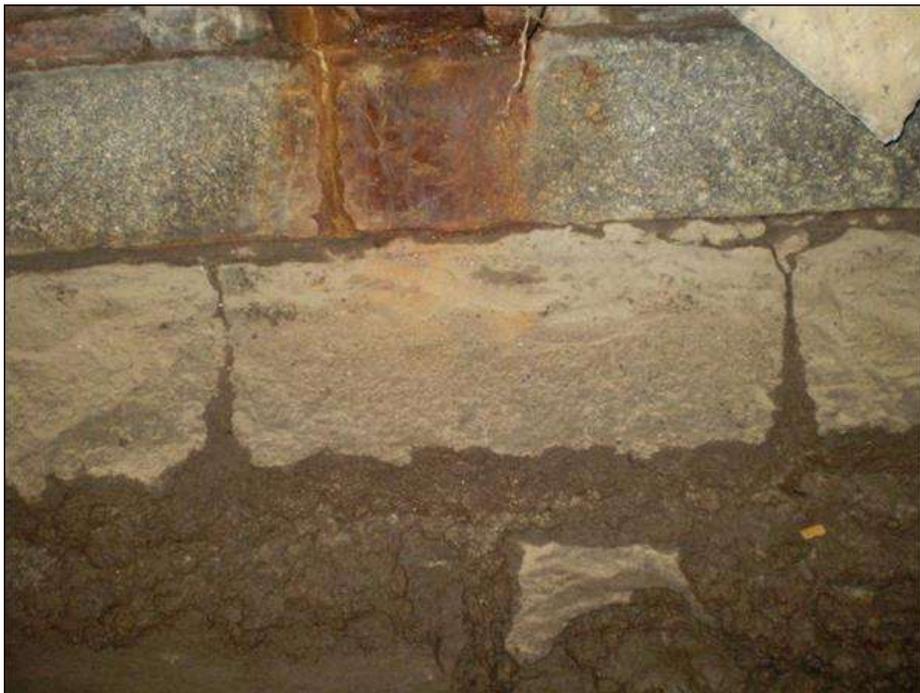
1. The stone masonry abutments are in satisfactory condition. Approximately 50% of the mortar is missing above the waterline (see Photograph 11).

11. Typical Mortar Joints in Stone Masonry Abutment

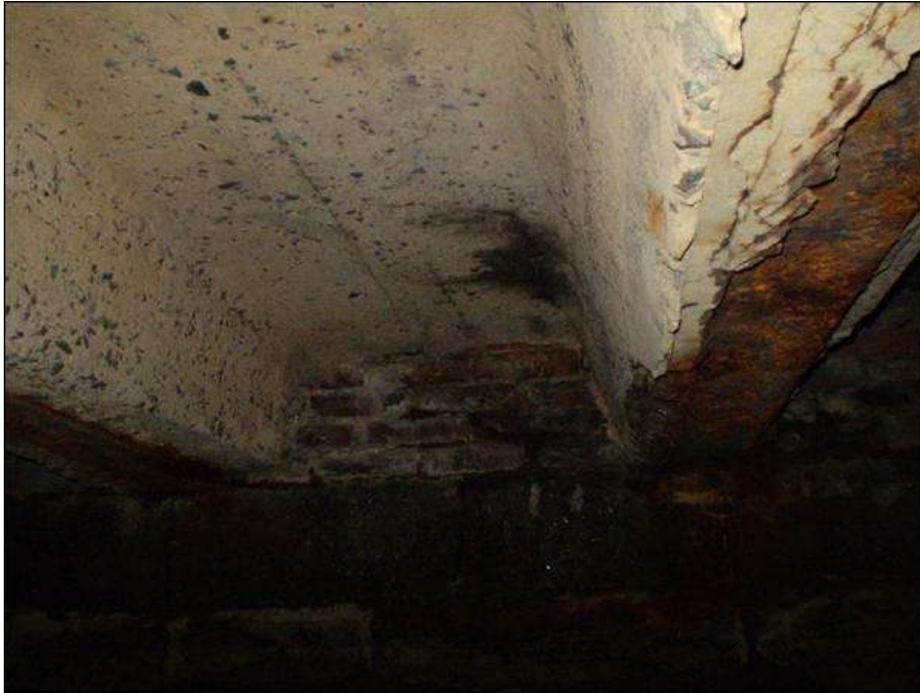
2. The brick backwalls are in good condition (see Photograph 12).

12. Typical Brick Abutment Backwall
