CHAPTER 4: ANALYSIS OF THE EXISTING TRANSPORTATION NETWORK

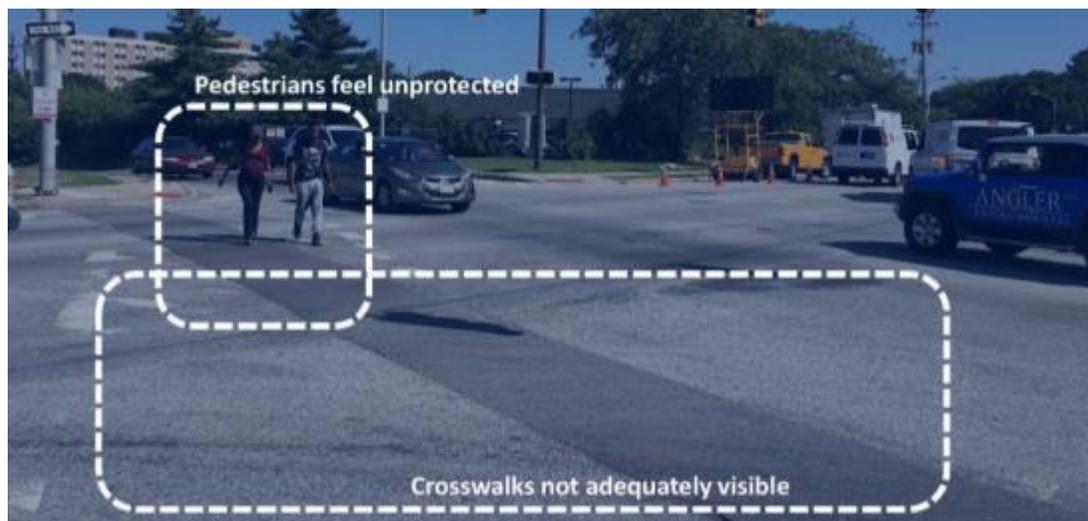
FIGURE 4-2: PEDESTRIAN VULNERABILITY AT STREET CROSSINGS

At many locations along the corridor, pedestrians can feel exposed and unprotected. This contributes to an intimidating atmosphere for many people connecting to transit, walking or bicycling.

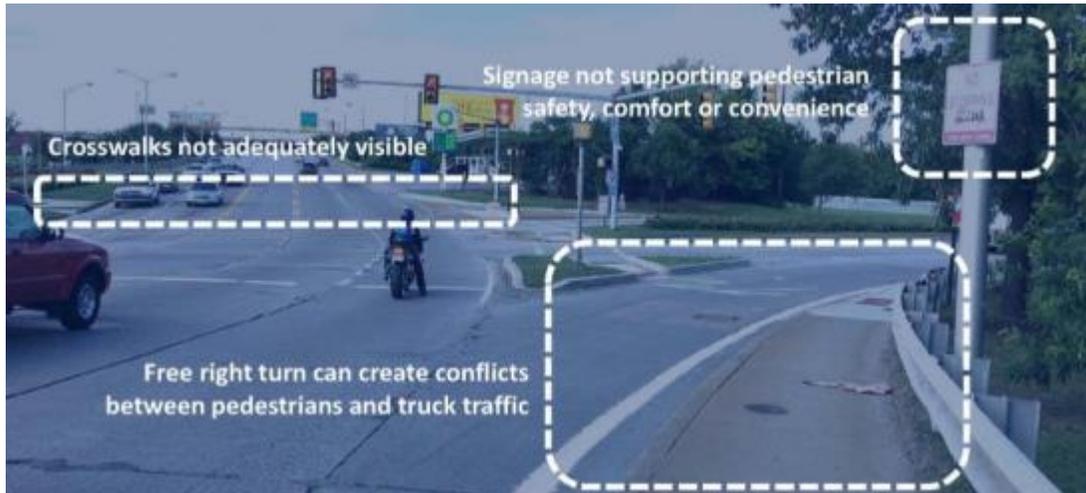
FIGURE 4-3: EXAMPLE OF PEDESTRIAN/VEHICULAR CONFLICT AREA

In addition, many conditions exist that encourage unnecessarily fast turning movements and travel speeds at pedestrian crossing points. This limits connectivity and increases chances of accidents.

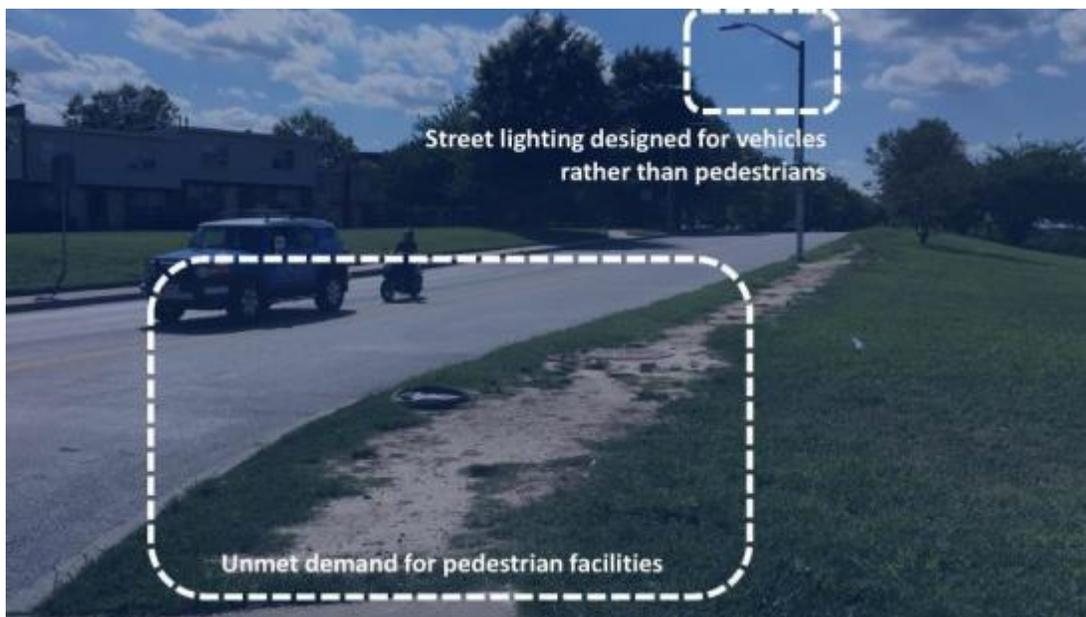
FIGURE 4-4: MISSING PEDESTRIAN NETWORK LINK AND VEHICULAR LIGHTING

In some cases the lack of desired pedestrian facilities such as sidewalks and the vehicular orientation of lighting can make pedestrians feel unwelcome.

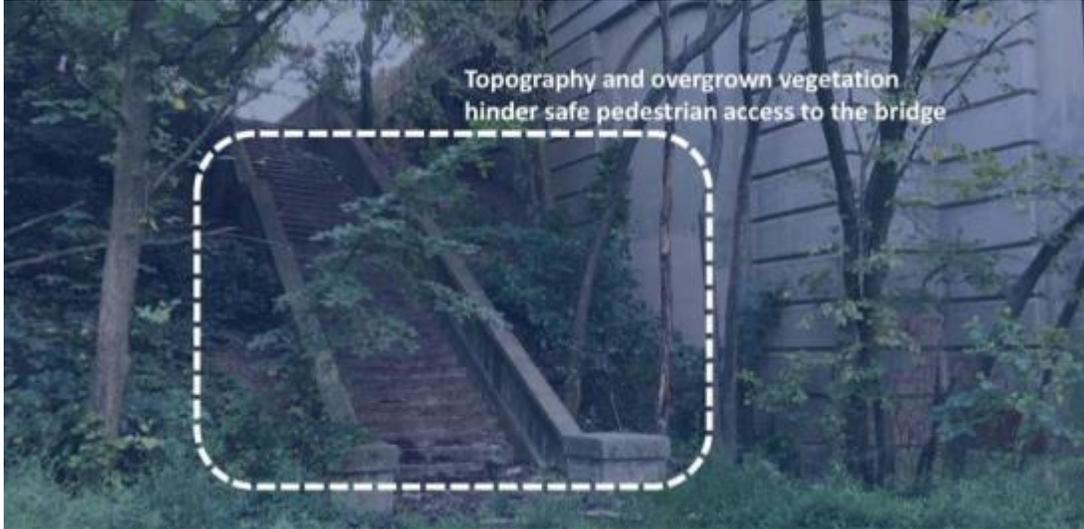
FIGURE 4-5: TOPOGRAPHIC CHALLENGES AND INADEQUACY OF EXISTING BRIDGE CONNECTIONS

Topographic challenges exist as well as limited safe connections between the waterfront/Gwynns Falls Trail and the Vietnam Veterans Memorial Bridge.

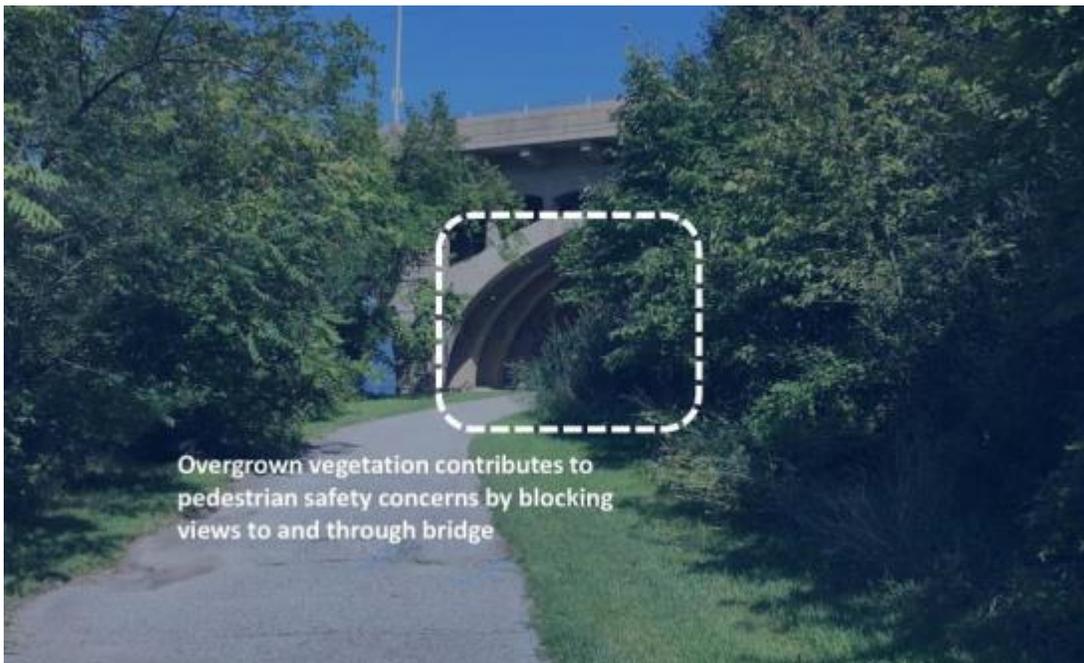
FIGURE 4-6: LACK OF VISIBILITY AT SOUTHERN BRIDGE LANDING

In some locations, site lines along regional pathways can be improved to promote visibility and reduce safety concerns.

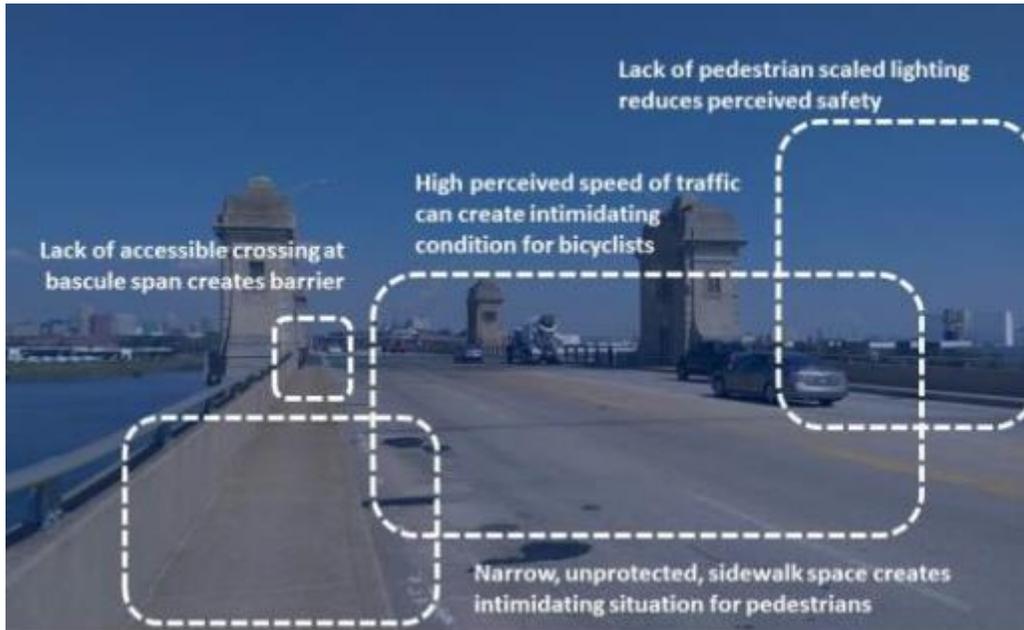
FIGURE 4-7: MULTIMODAL CHALLENGES ON THE BRIDGE DECK

Many conditions exist on the bridge itself that limit the potential for safe multimodal connectivity.

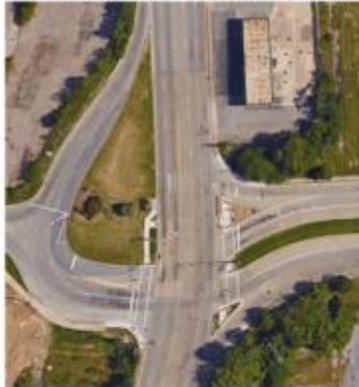
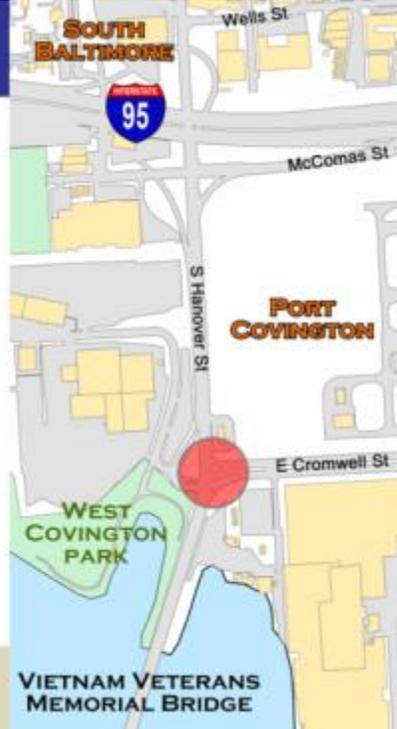
FIGURE 4-9: MULTIMODAL BARRIERS NORTH OF THE DRAWBRIDGE SPAN (2)

Hanover Street at Cromwell Street intersection geometric configuration is challenging for all users, especially pedestrians and cyclists

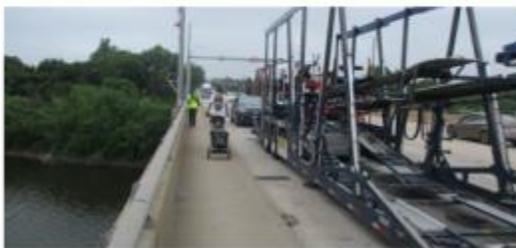
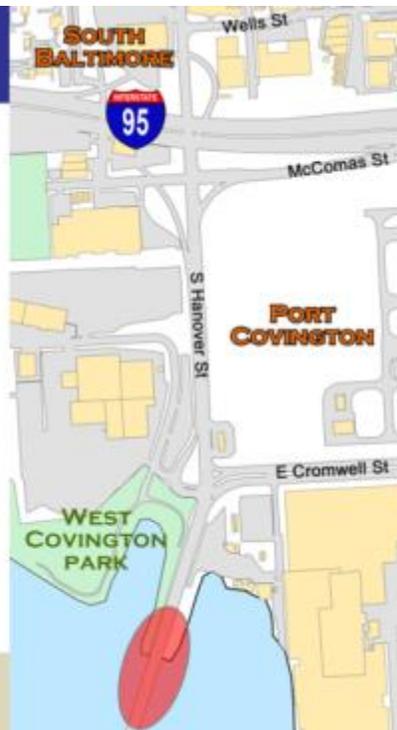
FIGURE 4-10: MULTIMODAL BARRIERS NORTH OF THE DRAWBRIDGE SPAN (3)

- No bicycle facilities on bridge
- Narrow sidewalk on bridge without buffer
- Minimum 24" buffer recommended (NACTO Design Guide)

Sidewalk ramps on bridge not ADA compliant

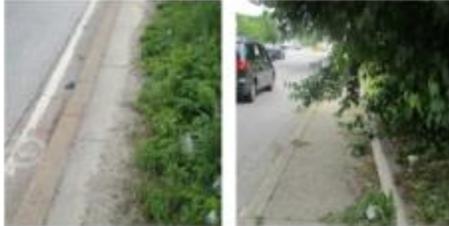
Overgrown vegetation on sidewalk reduces width along corridor; 60" width recommended for ADA compliance

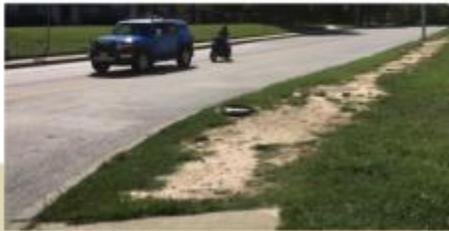
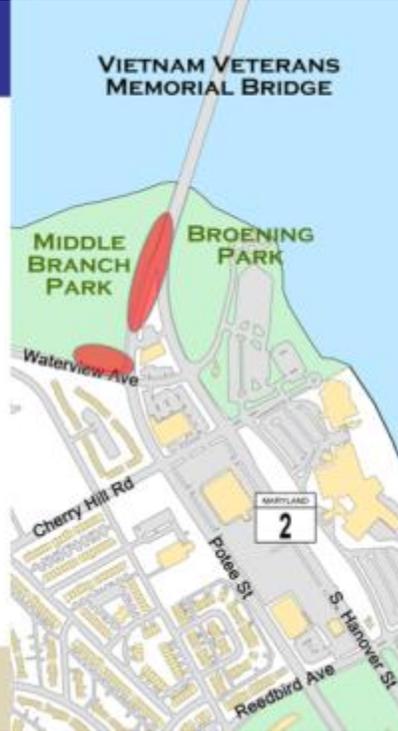
FIGURE 4-13: MULTIMODAL BARRIERS SOUTH OF THE DRAWBRIDGE SPAN (3)

Missing sidewalk / pedestrian connections to bus stops

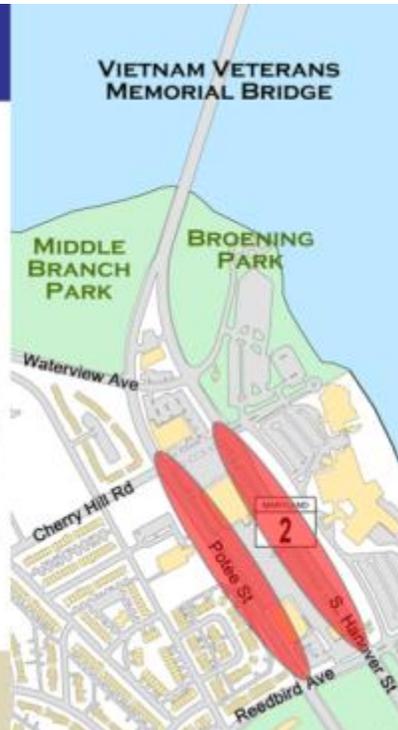
FIGURE 4-14: MULTIMODAL BARRIERS SOUTH OF THE DRAWBRIDGE SPAN (4)

Faded crosswalks

- Sidewalk obstructions decrease width
- 36" min. width for ADA compliance

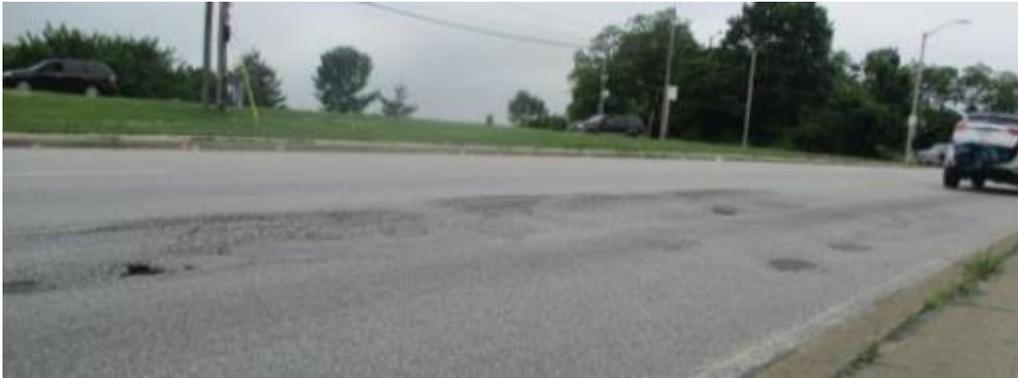
PHOTO 4-6: TYPICAL HANOVER STREET PAVEMENT RUTTING

As documented throughout this report, poor pavement conditions exist in the corridor. Significant truck traffic in the area causes pavement rutting, as shown in **Photo 4-6**, which leads to increased maintenance costs and potential safety concerns.

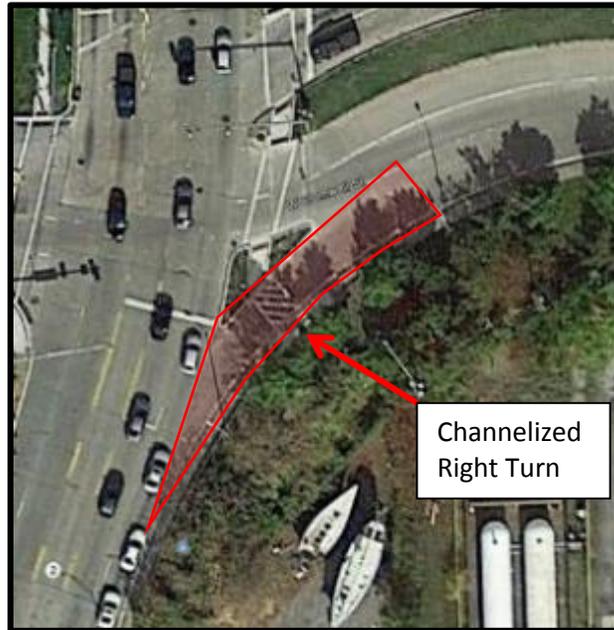
FIGURE 4-21: CHANNELIZED RIGHT TURN EXAMPLE (HANOVER STREET AT CROMWELL STREET)

Unsignalized, channelized right-turns, shown in **Figure 4-21**, present a challenge for pedestrians trying to cross at intersections. Channelized right-turning lanes are separated from the rest of the intersection by painted lines or raised barriers, usually in the shape of a triangular island. With longer turning radii, vehicles are not required to slow down as much as they would at traditional intersections. The Federal Highway Administration has stated “a change in curb radius from 15’ to 50’ will increase the crossing distance from 62’ to 100’ and increase pedestrian crossing time by 16-25 seconds.” Pedestrians are also not provided a protected phase where vehicles are required to stop. Two of these instances exist in the study corridor on the northbound approach of Hanover Street at McComas Street and Hanover Street at Cromwell Street. In both instances, the northbound right turns are channelized and unsignalized. A marked crosswalk is located at Cromwell Street, but not at McComas Street.

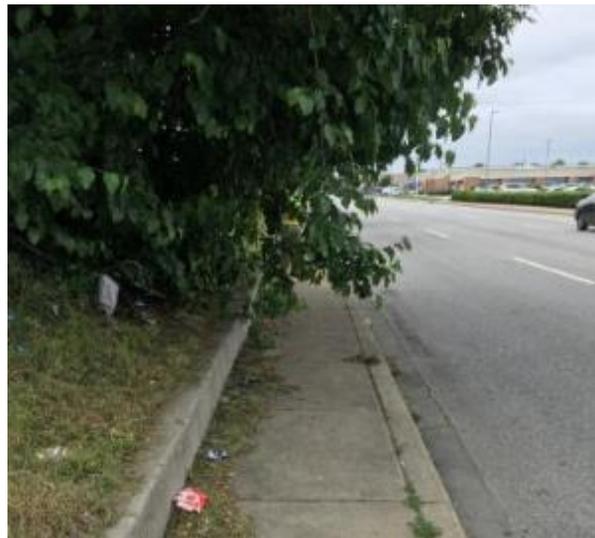
PHOTO 4-7: OBSTACLES BLOCKING SIDEWALK

There are also numerous locations throughout the study area where the sidewalk has been encroached on by grass, trees, debris, etc. These obstacles can make it difficult to use the sidewalks causing pedestrians to walk in the road. **Photo 4-7** shows an example obstacle on Potee Street north of Reedbird Avenue.

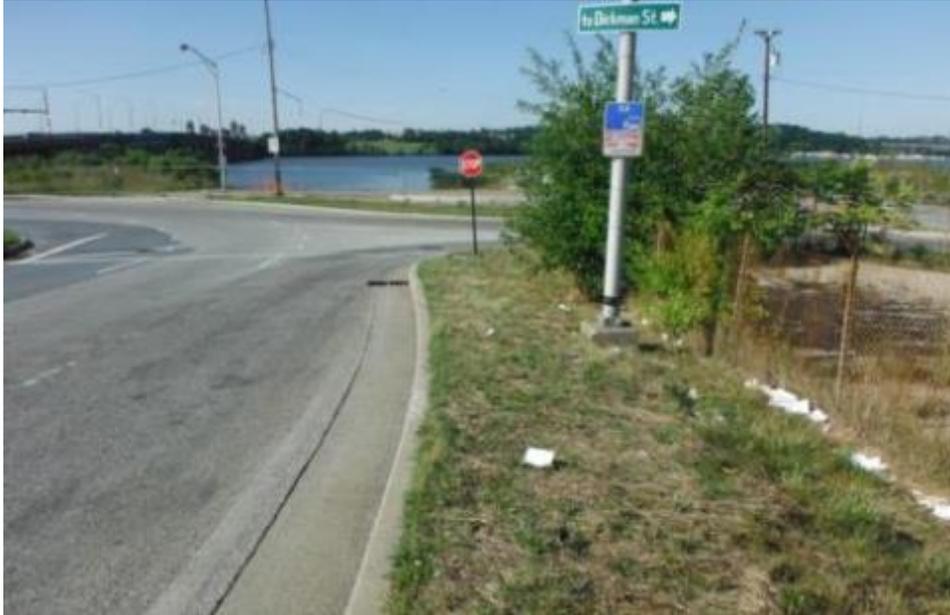
PHOTO 4-11: DICKMAN STREET/CROMWELL STREET (NO PEDESTRIAN ACCESS)

Although most of the bus stops evaluated were connected with sidewalks, not all sidewalks were in good condition or had adequate width for pedestrians to travel to the bus stops safely and comfortably. In several places, the sidewalks were obstructed by light poles or were discontinued. Two stops in the study area were on grass without any sidewalk access.

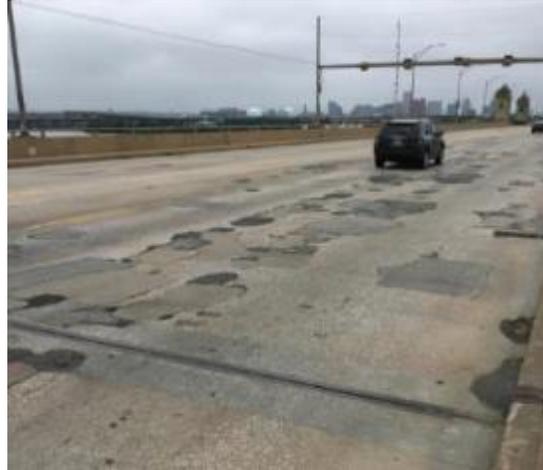
PHOTO 4-13: POOR DECK CONDITION ON VIETNAM VETERANS MEMORIAL BRIDGE

- The reversible lane signal lighting and pavement markings do not utilize newer, higher visibility technologies/materials available.
- Poor pavement conditions and potholes, particularly on the Vietnam Veterans Memorial Bridge, can cause unexpected driver behavior (i.e. drivers swerving out of their lane). **Photo 4-13** shows the deck condition on the bridge.

- The age and condition of the Vietnam Veterans Memorial Bridge necessitates ongoing maintenance particularly for the deck and bascule span. This frequently causes lane closures which impact the study corridor.
