HANOVER STREET CORRIDOR STUDY

includes the Vietnam Veterans Memorial Bridge

Public Information Meeting

Tuesday, January 31, 2017

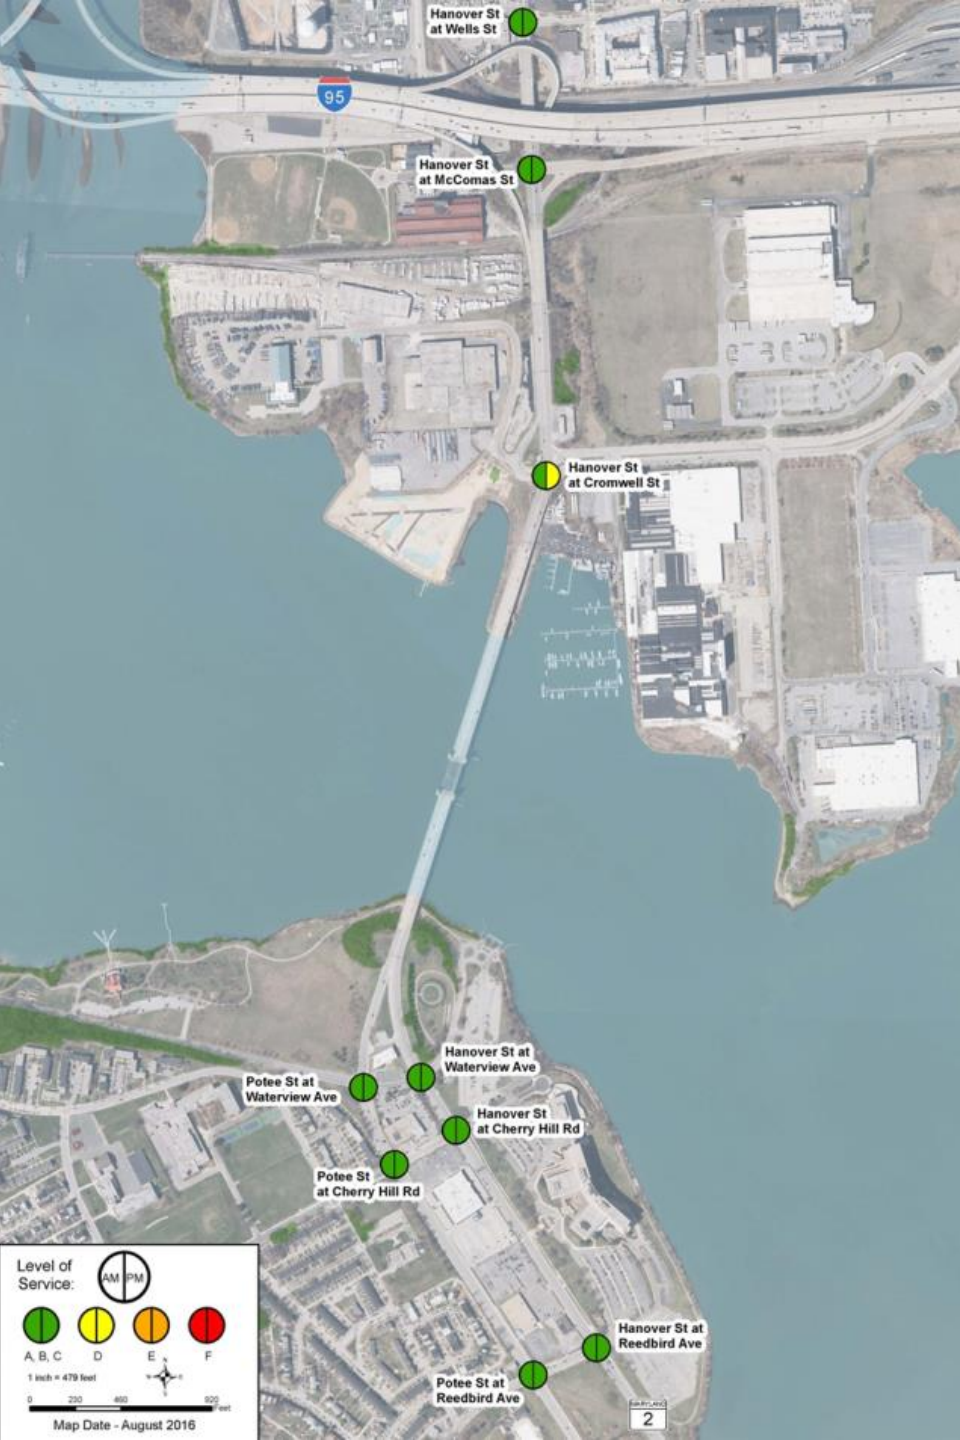
- All intersections within the project study area limits operate with an acceptable LOS during the AM and PM peak hours
- Reversible lane required during PM peak hour at intersection of Hanover Street at Cromwell Street
- Traffic volumes will grow significantly with Port Covington development

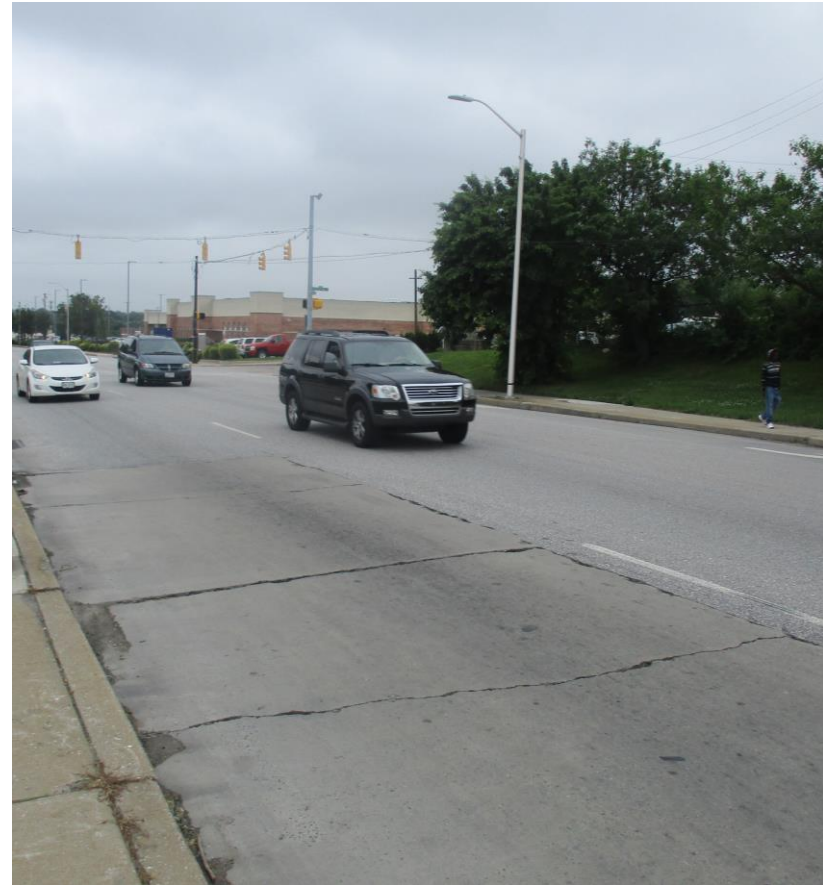
Existing Roadway Facilities

- Corridor designed for vehicular travel
- 12-foot travel lanes
- Vehicular overhead lighting
- Drainage
 - Existing roadways served by closed storm drain system – curb, gutter, and pipe system
 - Outfalls discharge to the Middle Branch of the Patapsco River
- Stormwater management
 - No existing SWM – existing roads constructed prior to water quality regulations
 - Existing median areas may be useful for future bioretention type facilities

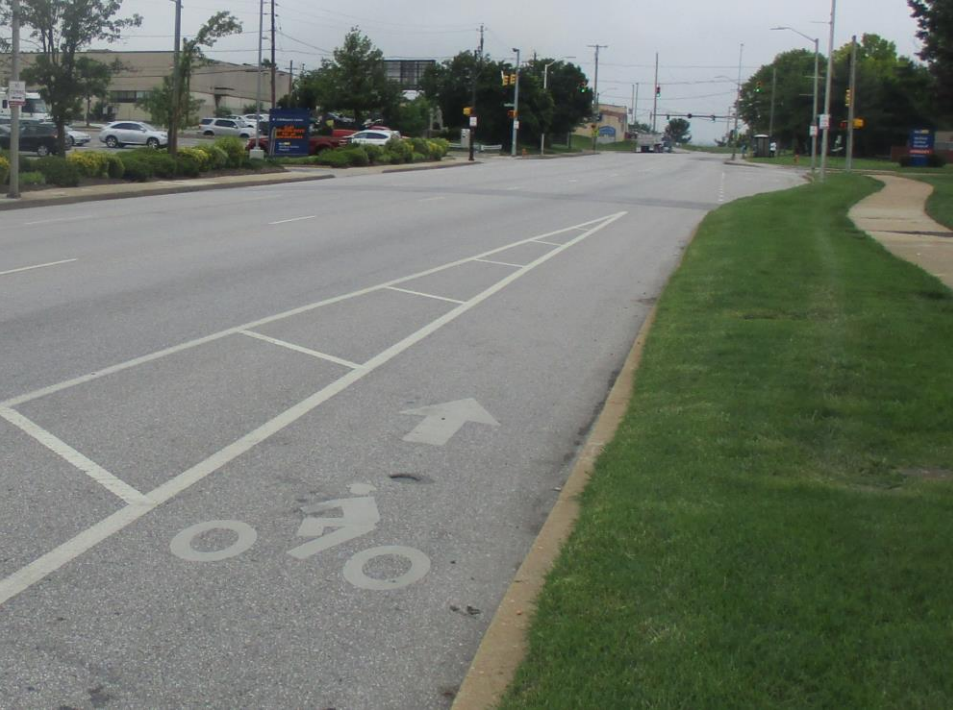
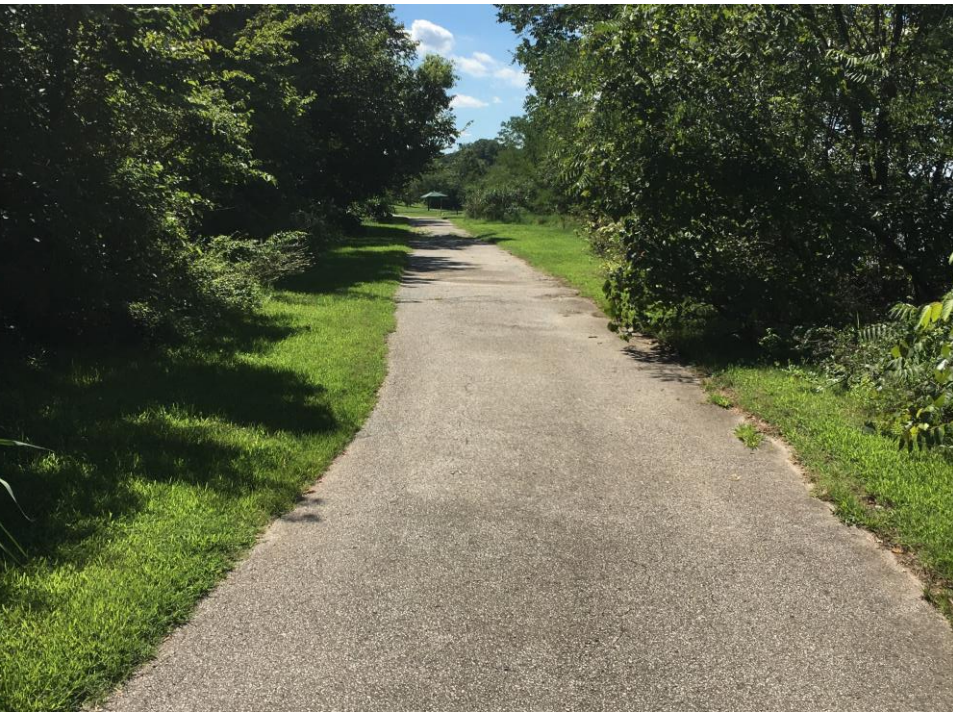
Existing Bicycle Facilities

- Designated bike lanes
 - Northbound Hanover Street from Reedbird Avenue to Cherry Hill Road
 - Eastbound and westbound on Cherry Hill Road from Hanover Street to points west
- Off-road
 - Gywnns Falls Trail

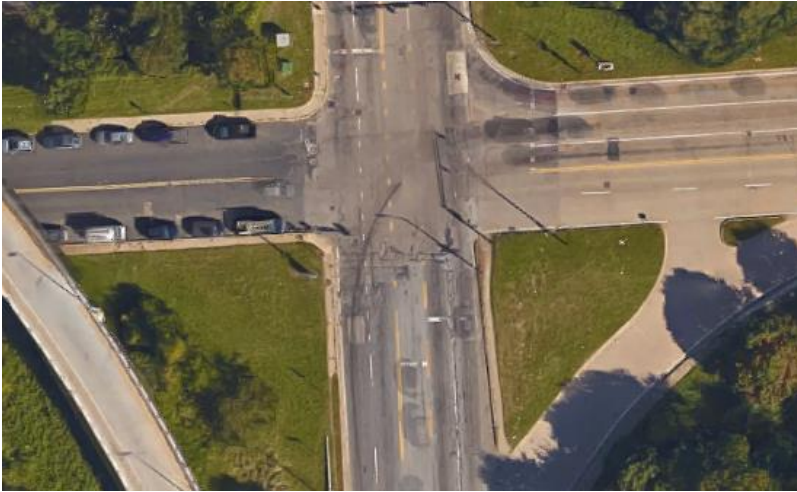
- Unmarked pedestrian crossings
- Clearly marked crosswalks with 10' outer edge width recommended for ADA compliance

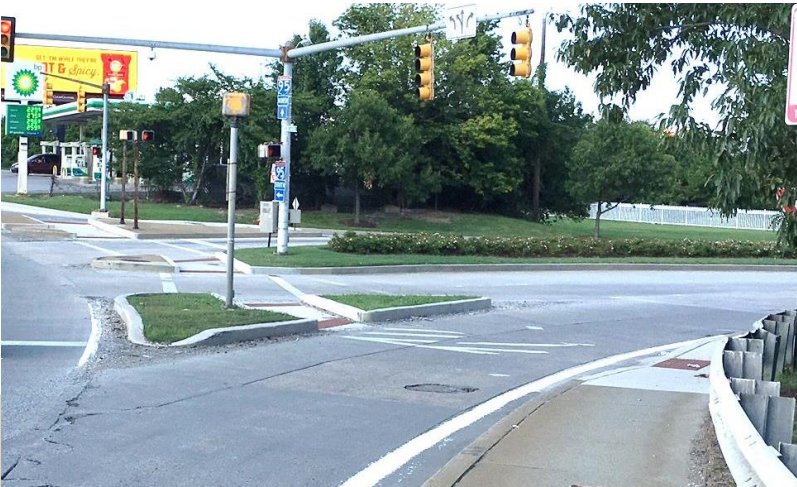
Pedestrian / vehicle conflicts at free right turns

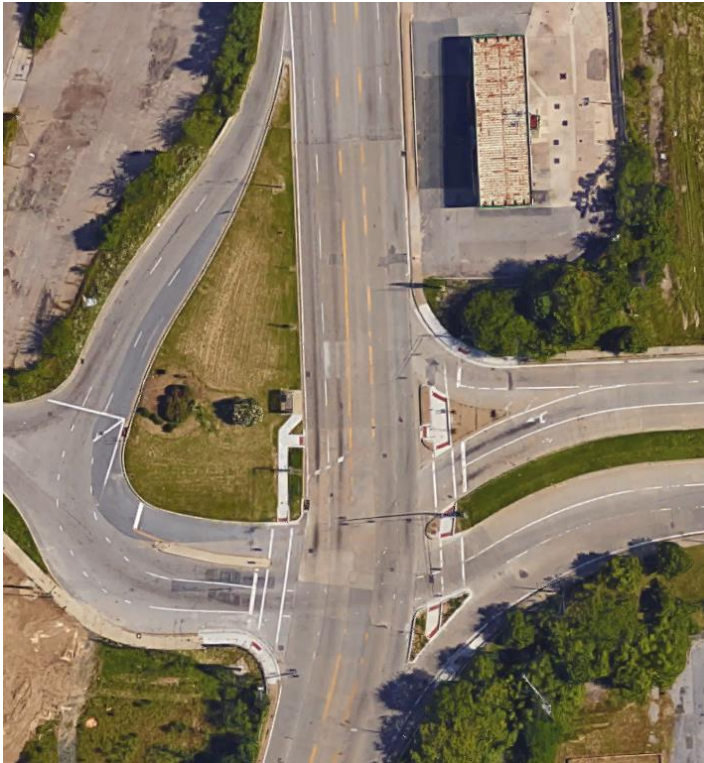
Hanover Street at Cromwell Street intersection
geometric configuration is challenging for all users,
especially pedestrians and cyclists

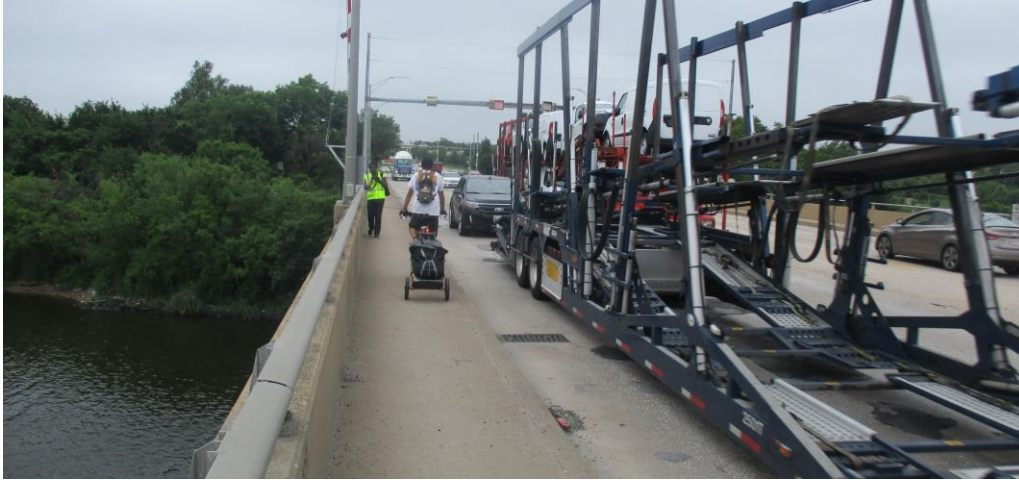
- No bicycle facilities on bridge
- Narrow sidewalk on bridge without buffer
- Minimum 24" buffer recommended (NACTO Design Guide)

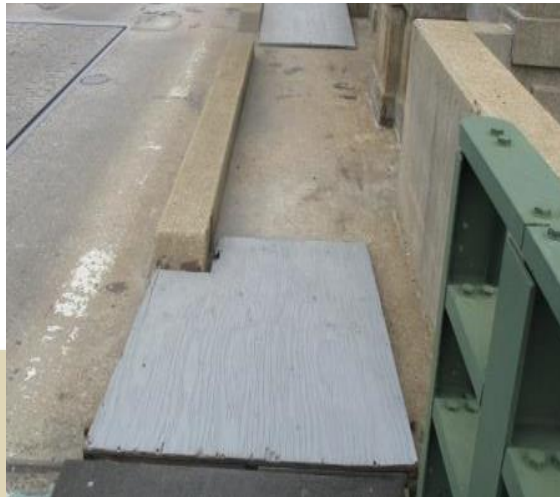
Sidewalk ramps on bridge
not ADA compliant

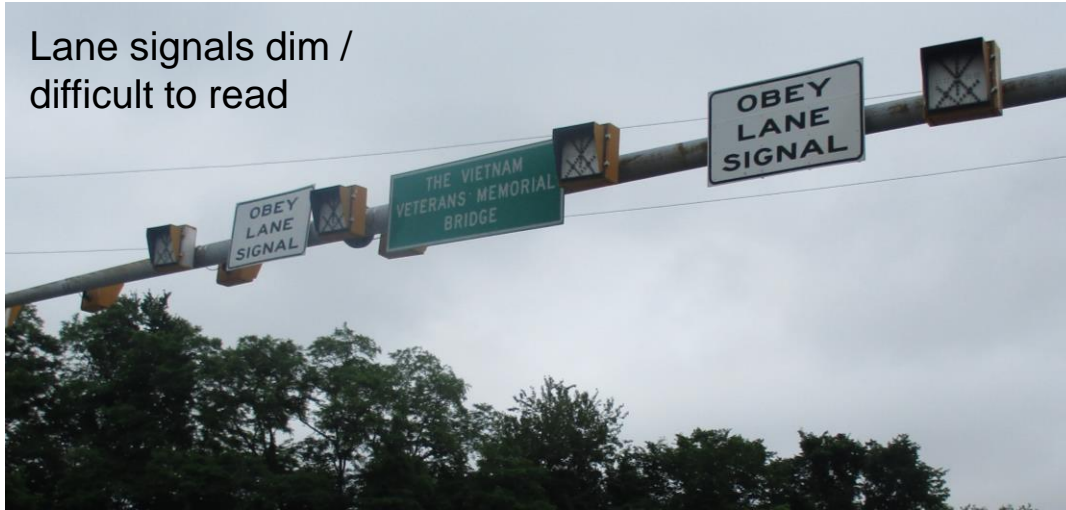
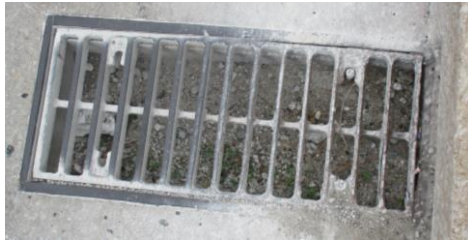
Lane signals dim /
difficult to read

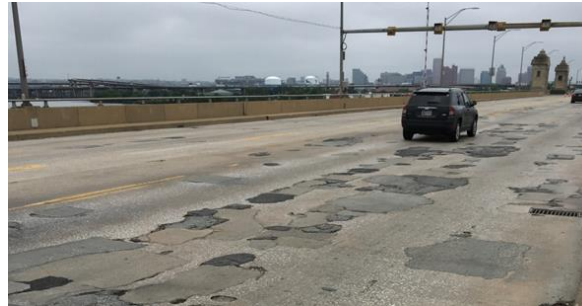
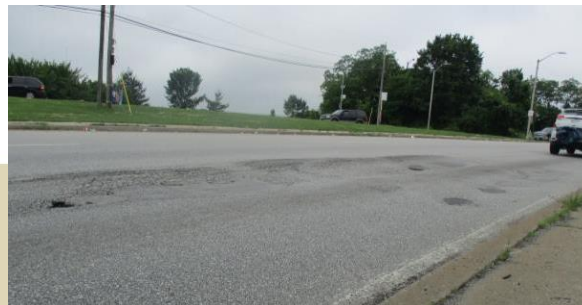
Blocked inlets (flooding
and safety concerns)

Poor bridge deck and
pavement conditions

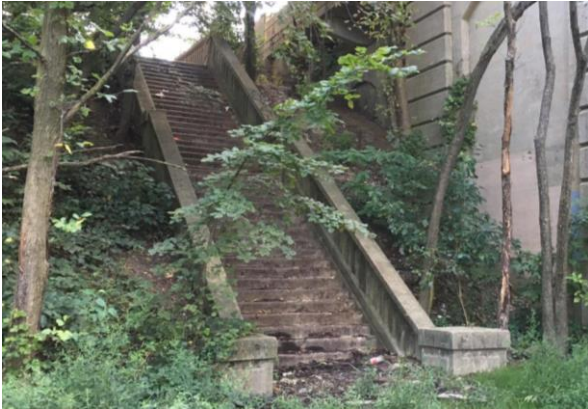
Overgrown vegetation and limited pedestrian access from bridge to Gwynns Falls Trail and no suitable, accessible bicycle connectivity

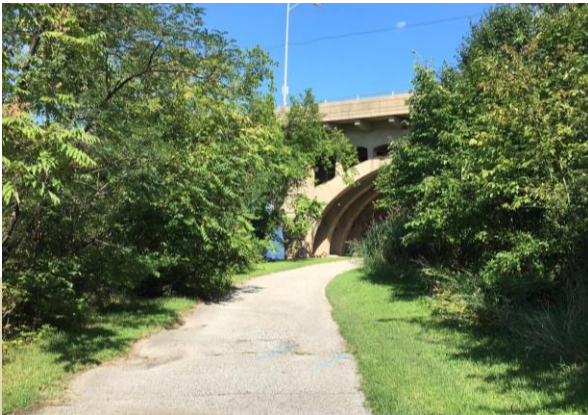
Overgrown vegetation on Gwynns Falls Trail blocks views and contributes to pedestrian safety concerns

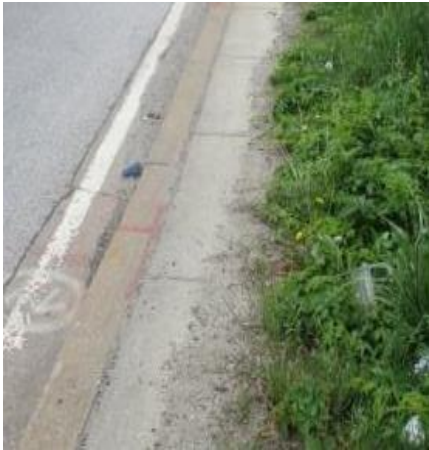
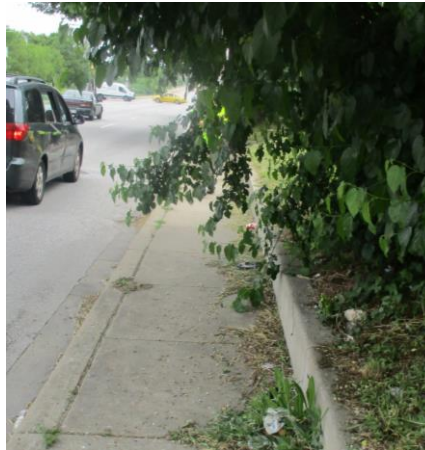
Overgrown vegetation on sidewalk reduces width along corridor; 60" width recommended for ADA compliance

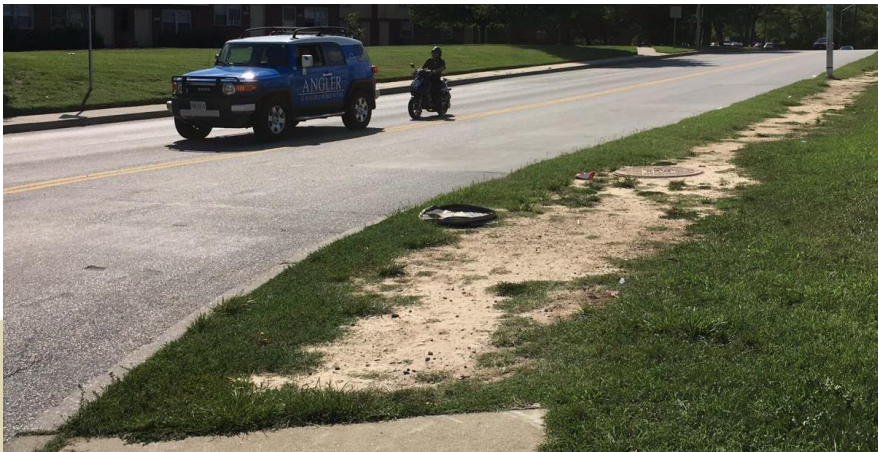
Missing sidewalk / pedestrian connections to bus stops

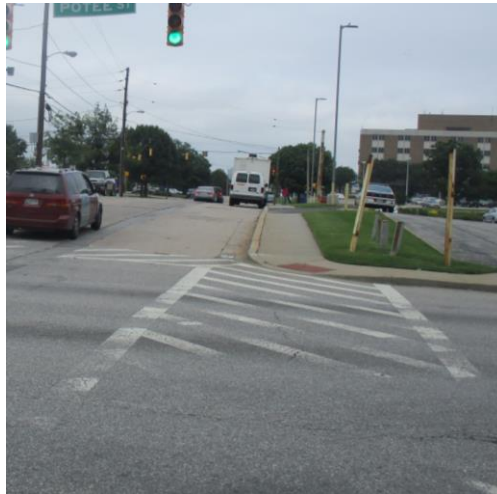
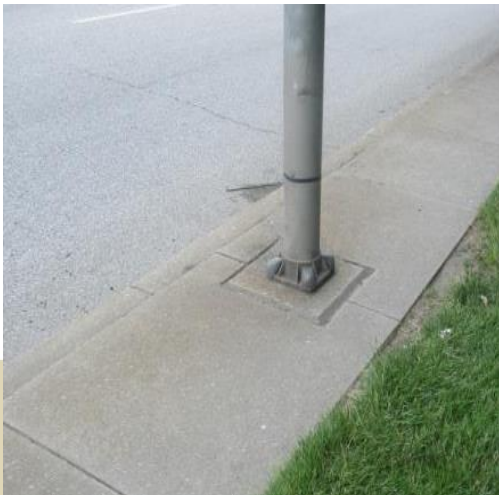
Lack of low level lighting for pedestrians along corridor

- Sidewalk obstructions decrease width
- 36" min. width for ADA compliance

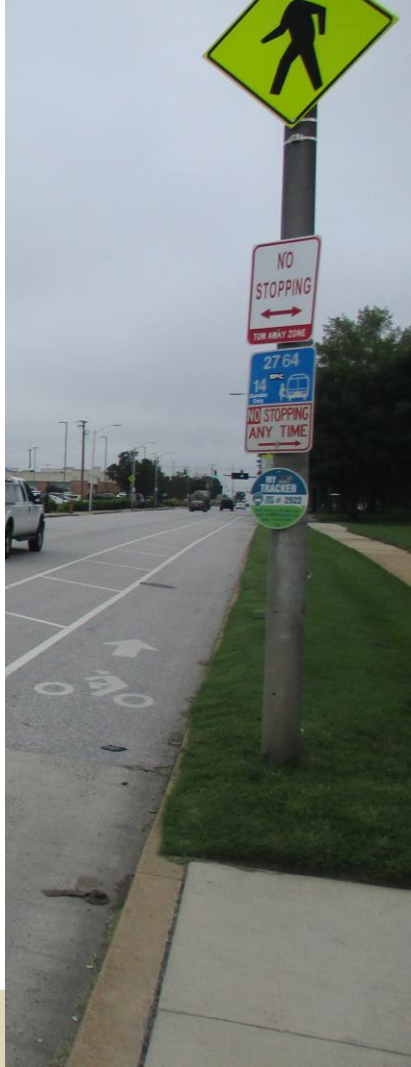
- Bus shelters and benches not present at all stops along the corridor
- Shelters are recommended for stops with average daily ridership of 100 or more
- Seven bus stops have average daily ridership greater than 100, but only three of those stops have shelters

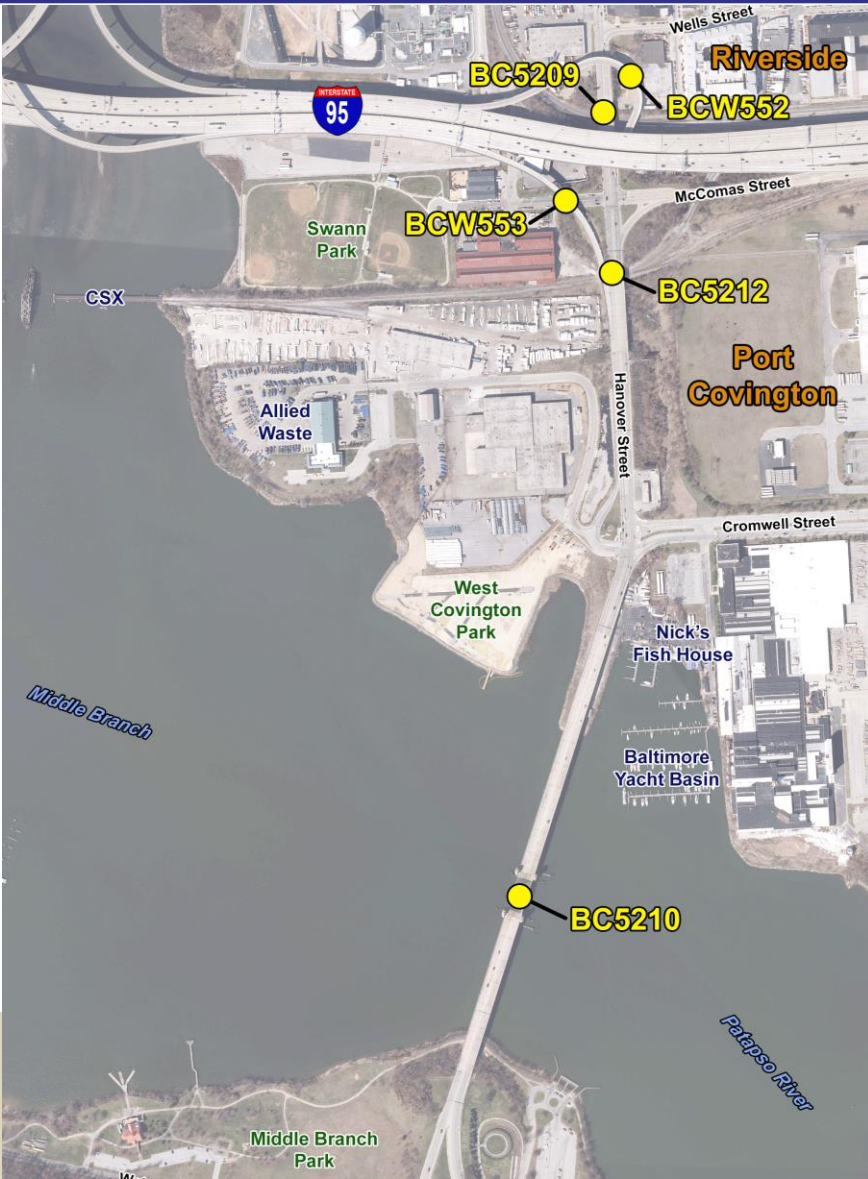
Hanover Street Corridor Structures and Bridges

Minor Maintenance

- Hanover St NB ramp to I-95 SB (BCW552) *
- I-95 NB ramp to SB Hanover St (BCW553) *

Major Rehabilitation/Replacement

- Hanover St over CSX Railroad (BC5209) *
- Hanover St over CSX Railroad (BC5212) *
- Hanover St over Middle Branch – Vietnam Veterans Memorial Bridge (BC5210)

* *Overlaps with Port Covington development*

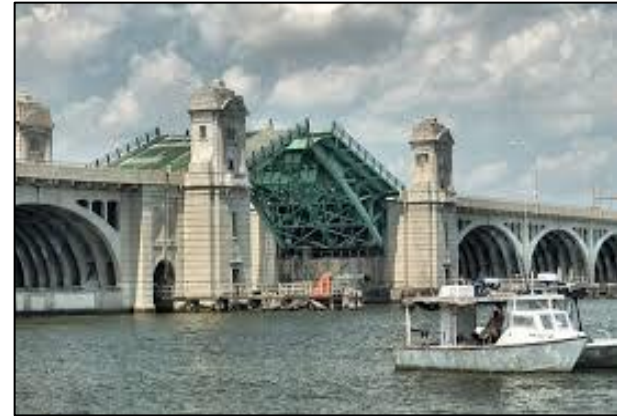
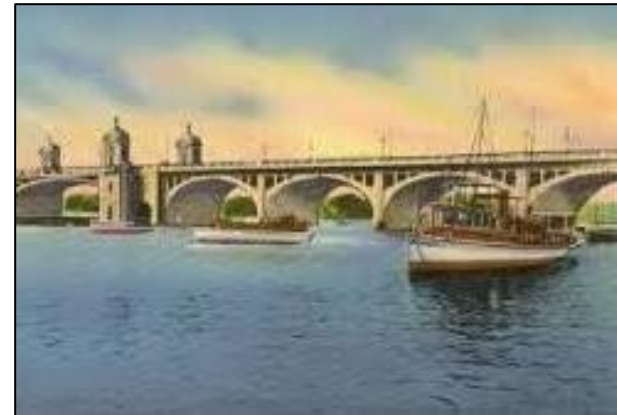
Vietnam Veterans Memorial Bridge (BC5210)

- Built in 1916 – the major component of this corridor
- Most iconic structure in the inventory of the Baltimore City Department of Transportation
- Age and **two** unique structural configurations make it significant on a **national scale**
 - Rall Mechanical Operating System – Movable Span
 - Concrete Encased Steel Trusses – Arched Approaches

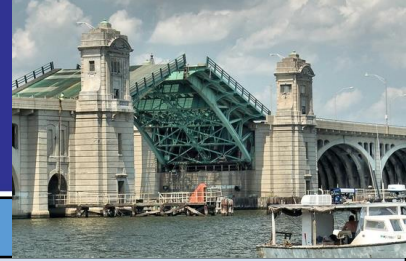
Vietnam Veterans Memorial Bridge

Movable Span			
Element	Description	Potential Repair	Additional Study
Bridge Lighting	None present	N/A	Architectural Evaluation of Period Lighting Standards
Traffic Barriers	Open Steel Barrier	Replacement	Barrier Studies to consider supplemental pedestrian protection and period elements
Deck and Sidewalk	Open Steel Grid	Replacement	N/A
Steel Superstructure	Riveted Steel Truss / Girder	<ul style="list-style-type: none"> Clean and Paint Steel General Retrofits 	<ul style="list-style-type: none"> Evaluate fatigue life Detailed Inspection Metallurgical Study of Structural Steel
Operator's Houses	Masonry and Concrete	Rehabilitation of exterior and interior elements	Architectural and Hazardous Materials Evaluations
Electrical and Mechanical Operating Systems	Rail Mechanical Operating System	General Reconstruction	Detailed Inspection
Bascule Piers	Reinforced Concrete and Masonry	Rehabilitation	<ul style="list-style-type: none"> Detailed Inspection Underwater Inspection Detailed Structural / Hydraulic Analyses

Concrete Pile Foundations	Reinforced Concrete	Unknown at this time	<ul style="list-style-type: none"> In situ Investigation of Existing Piles Detailed Structural Analysis
Waterway Fenders and Dolphins	Timber	Unknown at this time	Analyze piers in accordance with AASHTO Vessel Collision Criteria

Assessments based upon guidelines established by the current AASHTO publications – *Manual for Bridge Element Inspection* and *Movable Bridge Inspection, Evaluation, and Maintenance Manual*.

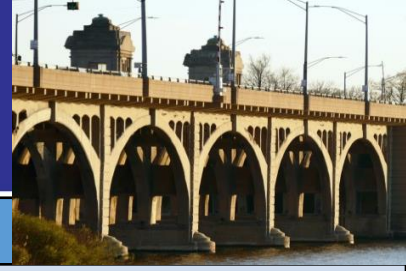
Vietnam Veterans Memorial Bridge

Arched North and South Main Approach Spans			
Element	Description	Potential Repair	Additional Study
Bridge Lighting	Standard Roadway	Replace/Augment with "Pedestrian Friendly" Period Lighting Standards	Architectural Evaluation of Period Lighting Standards
Traffic Barriers	Concrete w/ Steel Rail	Replacement	Barrier Studies to consider supplemental pedestrian protection and period elements
Deck and Sidewalk	Reinforced Concrete	Replacement	N/A
Floor System	Reinforced Concrete w/ Steel Encased Members	Replacement	Detailed Inspection
Concrete/Steel "Arched" Superstructure	Composite Steel Truss with Concrete	General Rehabilitation	<ul style="list-style-type: none"> Detailed Inspection Non-linear Structural Analysis - Member Capacities In-situ metallurgical Study of Steel Members Evaluate Riveted Connections
Piers	Reinforced Concrete	General Rehabilitation	<ul style="list-style-type: none"> Detailed Inspection Underwater Inspection Detailed Structural / Hydraulic Analyses

Concrete Pile Foundations	Reinforced Concrete	Unknown at this time	<ul style="list-style-type: none"> In situ Investigation of Existing Piles Detailed Structural Analysis

Assessments based upon guidelines established by the current AASHTO publication – *Manual for Bridge Element Inspection*

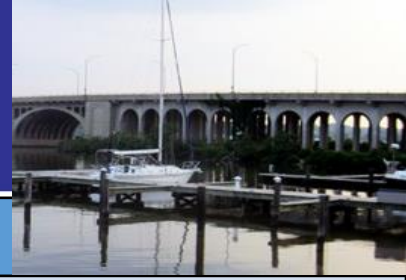
Arcade North Approach Spans

Element	Description	Potential Repair	Additional Study
Bridge Lighting	Standard Roadway	Replace/Augment with “Pedestrian Friendly” Period Lighting Standards	Architectural Evaluation of Period Lighting Standards
Traffic Barriers	Concrete w/ Steel Rail	Replacement	Barrier Studies to consider supplemental pedestrian protection and period elements
Deck and Sidewalk	Reinforced Concrete	Replacement	N/A
Concrete Arcades	Reinforced Concrete	General Rehabilitation	<ul style="list-style-type: none">• Detailed Inspection• Detailed Structural Analysis
Timber Pile Foundations	Georgia Long-leaf Pine	Unknown at this time	<ul style="list-style-type: none">• In situ Investigation of Existing Piles• Detailed Structural / Hydraulic Analyses

Assessments based upon guidelines established by the current AASHTO publications – *Manual for Bridge Element Inspection*

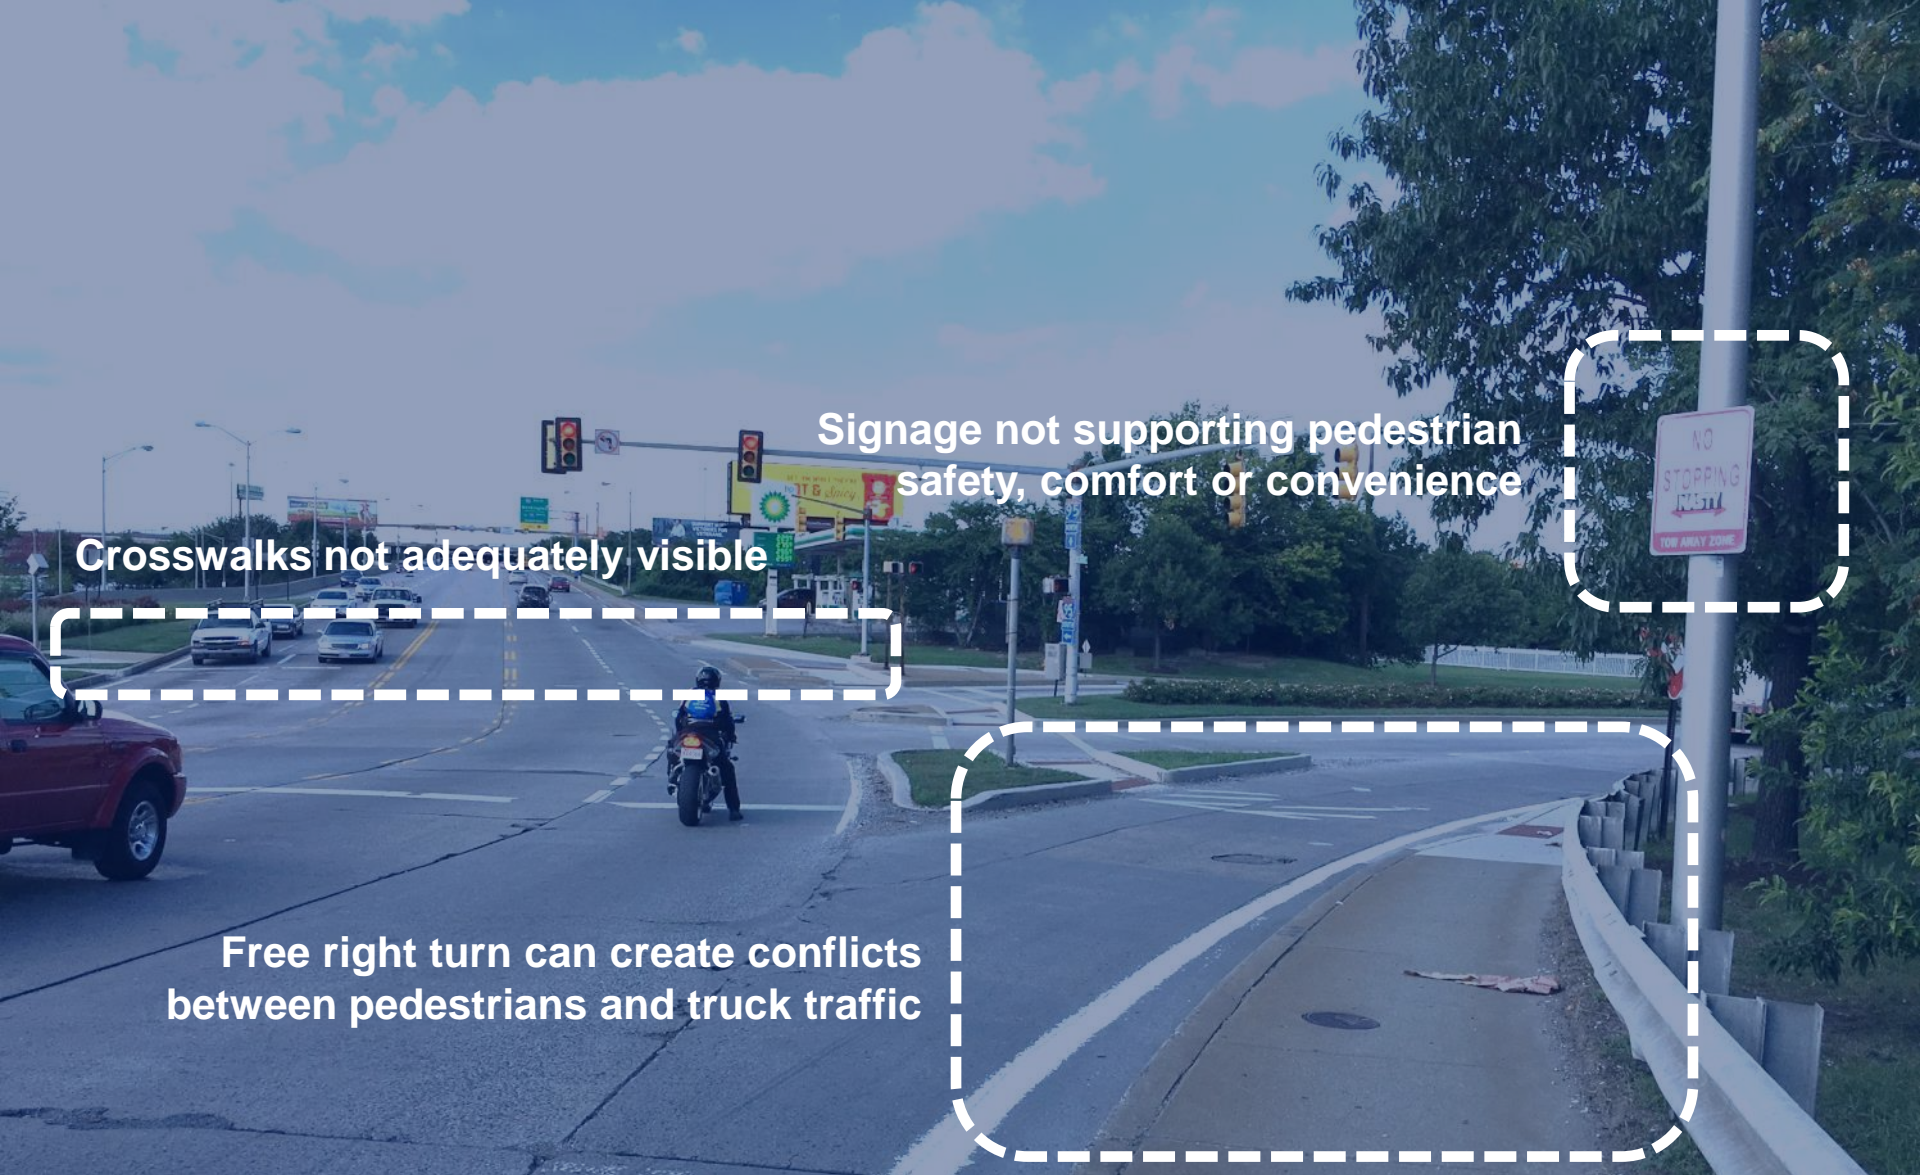
Signage not supporting pedestrian safety, comfort or convenience

Crosswalks not adequately visible

Free right turn can create conflicts between pedestrians and truck traffic

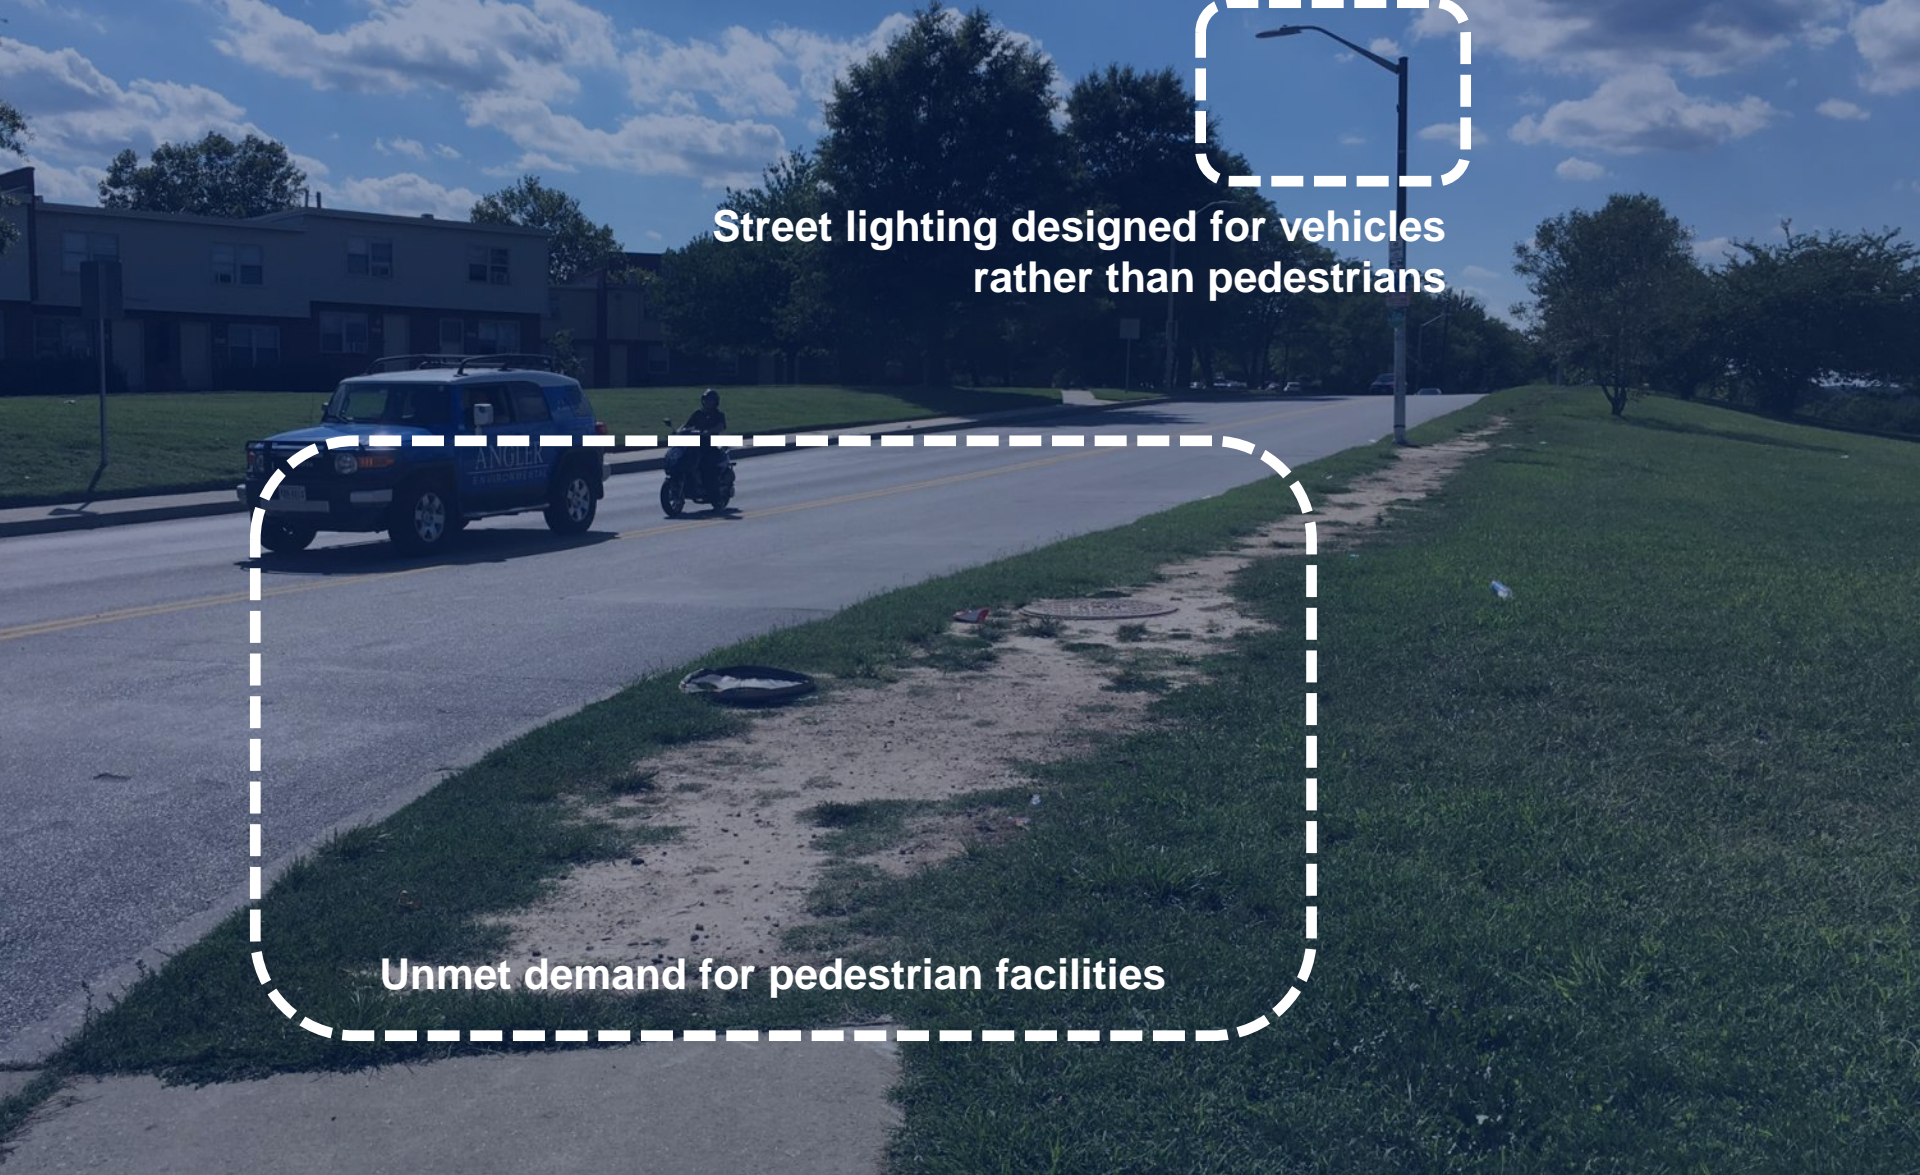
Street lighting designed for vehicles
rather than pedestrians

Unmet demand for pedestrian facilities

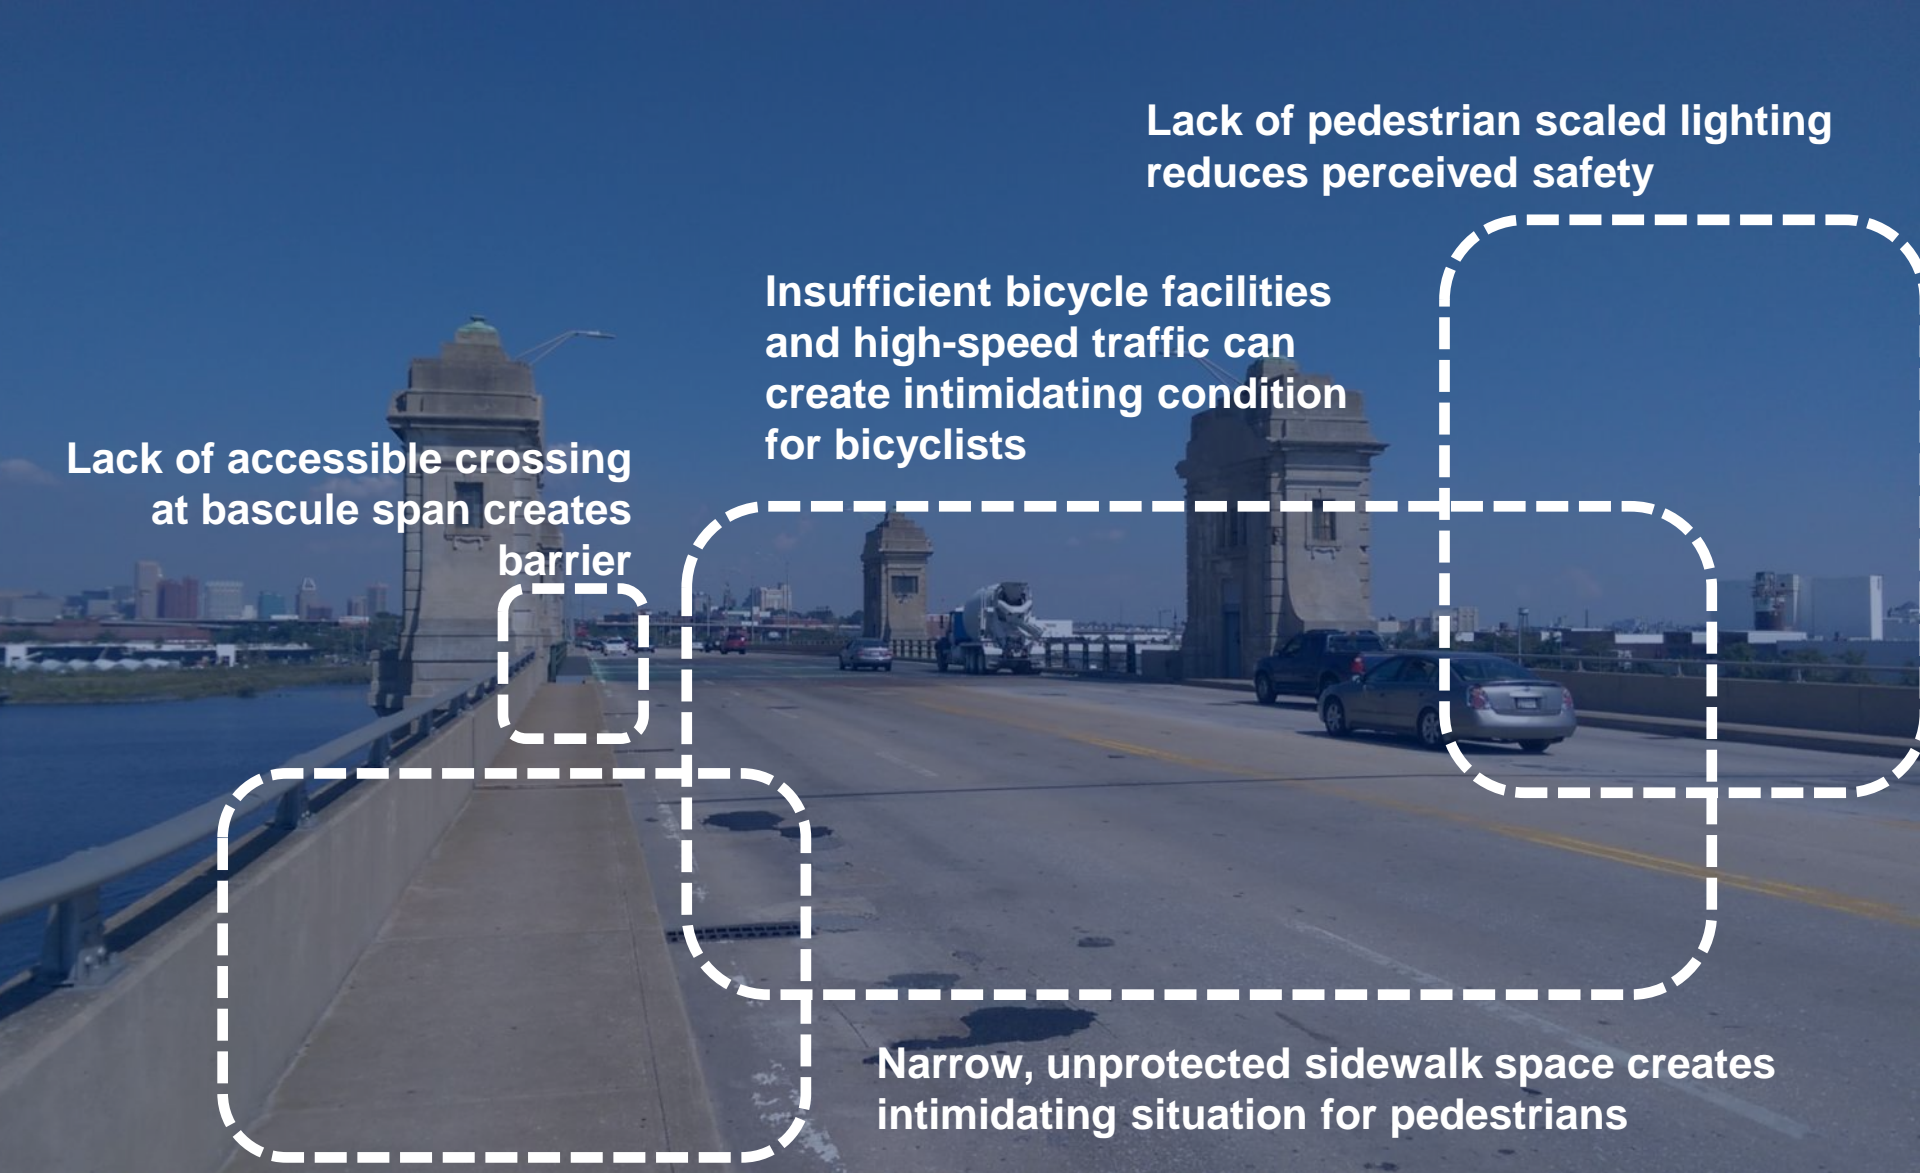
Lack of pedestrian scaled lighting reduces perceived safety

Insufficient bicycle facilities and high-speed traffic can create intimidating condition for bicyclists

Lack of accessible crossing at bascule span creates barrier

Narrow, unprotected sidewalk space creates intimidating situation for pedestrians
