INNER HARBOR EAST – HIGH TEMPERATURE
HOT WATER MAIN RELOCATION – TEST PIT PLAN
SCALE: 1" = 10'-0"

PROJECT TITLE: INNER HARBOR EAST HIGH TEMP HOT WATER RELOCATION

MESSAGE: Test Hole Reports and Invert Sheets

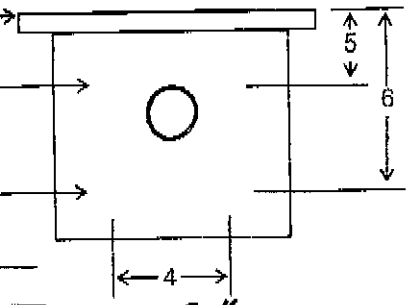
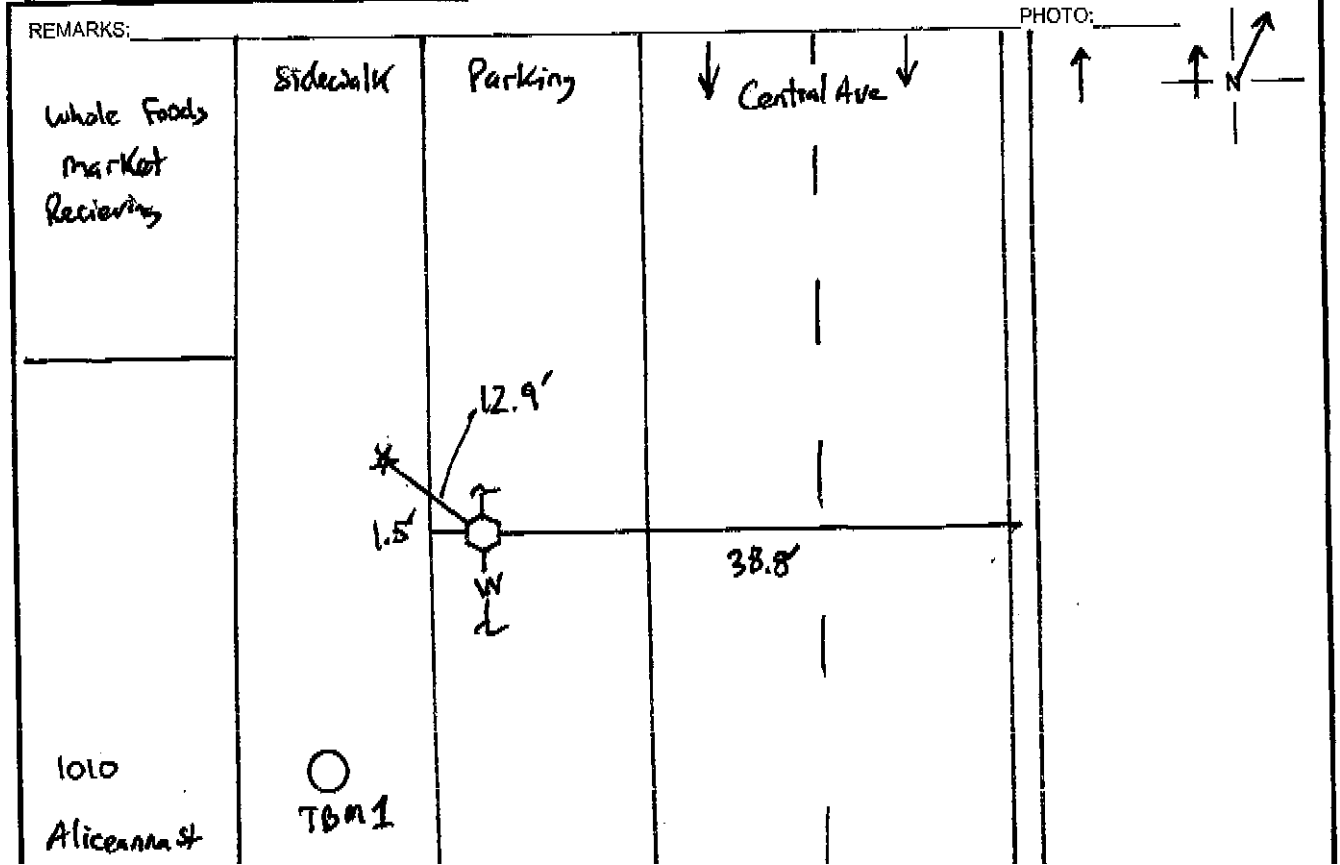
SoftDig® Project #: 113210 Test Hole #: 2 Client: Veolia Energy Date: [illegible]
One-Call Permit #: 114 211 94 SUE Analyst: R. Molnar Truck #: 5110
City / County/State: Baltimore / Baltimore County / MD Road: Central Ave
General Location: near Intersection Aliceanna St / Central Avenue

Actual Size, Color, Material, Type of Utility: 10" Black metal Water Pipe
Utility Owner: Unknown Designation Color: Blue
Observed Utility Condition: Good ✓ Poor ___ Other: ___
Test Hole marked by: PK Nail ___ Hub ✓ Other: ___
Portion of Utility Exposed: Top ✓ Half ___ Side ___ Full ___

1. Reference Mark Elevation: 99.36'
2. Utility Top Elevation: 95.55'
3. Utility Bottom Elevation (if applicable): —
4. Width (if applicable): ___
5. Utility Top Depth from Reference: 3.81'
6. Utility Bottom Depth from Reference (if applicable): ___

Surface Covering Type: Asphalt ✓ Concrete ___ Soil ___ Surface Covering Depth: 21"
Generalized Soil Profile: Select Fill ___ Rock ___ Sand ✓ Clay ___ Other: Sand around Pipe
1.) Bench Mark Elev.: 100.00' (Assumed) Description: Water meter Manhole North Rim
2.) Bench Mark Elev.: — Description: —
Excavated Location Station: — Offset —

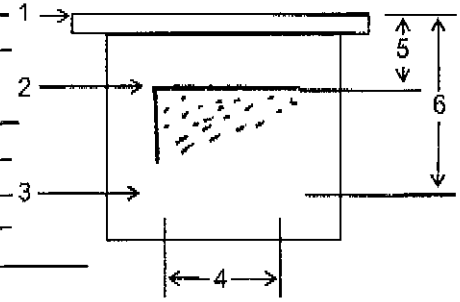
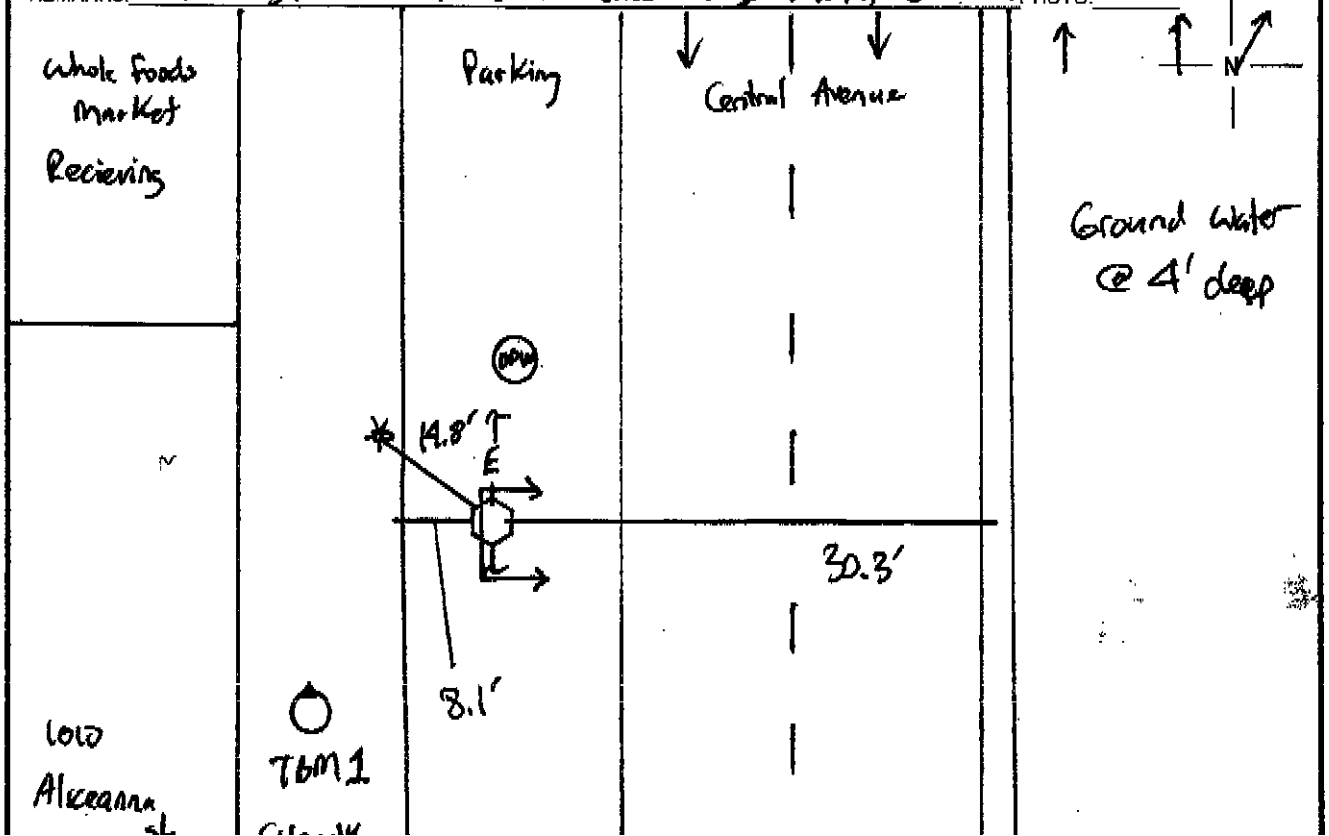
SoftDig® Project #: 113210 Test Hole #: 3 Client: Veolia Energy Date: 8/19/2011
One-Call Permit #: 114 211 94 SUE Analyst: R. Molnar Truck #: 5110
City / County/State: Baltimore / Baltimore County / MD Road: Central Ave
General Location: near Intersection Aliceanna / Central

Actual Size, Color, Material, Type of Utility: Concret Duct Bank Electric
Utility Owner: Unknown Designation Color: Red
Observed Utility Condition: Good ✓ Poor ___ Other: ___
Test Hole marked by: PK Nail ✓ Hub ___ Other: ___
Portion of Utility Exposed: Top ✓ Half ___ Side ___ Full ___

1. Reference Mark Elevation: 99.38'
2. Utility Top Elevation: 95.26'
3. Utility Bottom Elevation (if applicable): —
4. Width (if applicable): 2'
5. Utility Top Depth from Reference: 4.12'
6. Utility Bottom Depth from Reference (if applicable): —

Surface Covering Type: Asphalt ✓ Concrete ___ Soil ___ Surface Covering Depth: 16"
Generalized Soil Profile: Select Fill ___ Rock ___ Sand ✓ Clay ___ Other: Water at level of Duct Bank
1.) Bench Mark Elev.: 100.00' (Assumed) Description: Water Meter Manhole North Rim
2.) Bench Mark Elev.: — Description: —
Excavated Location Station: — Offset —

REMARKS: Could not get bottom in this hole due to large amount of water PHOTO: ___

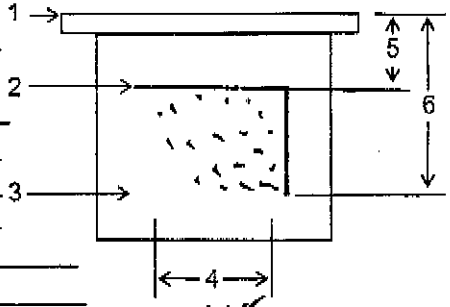
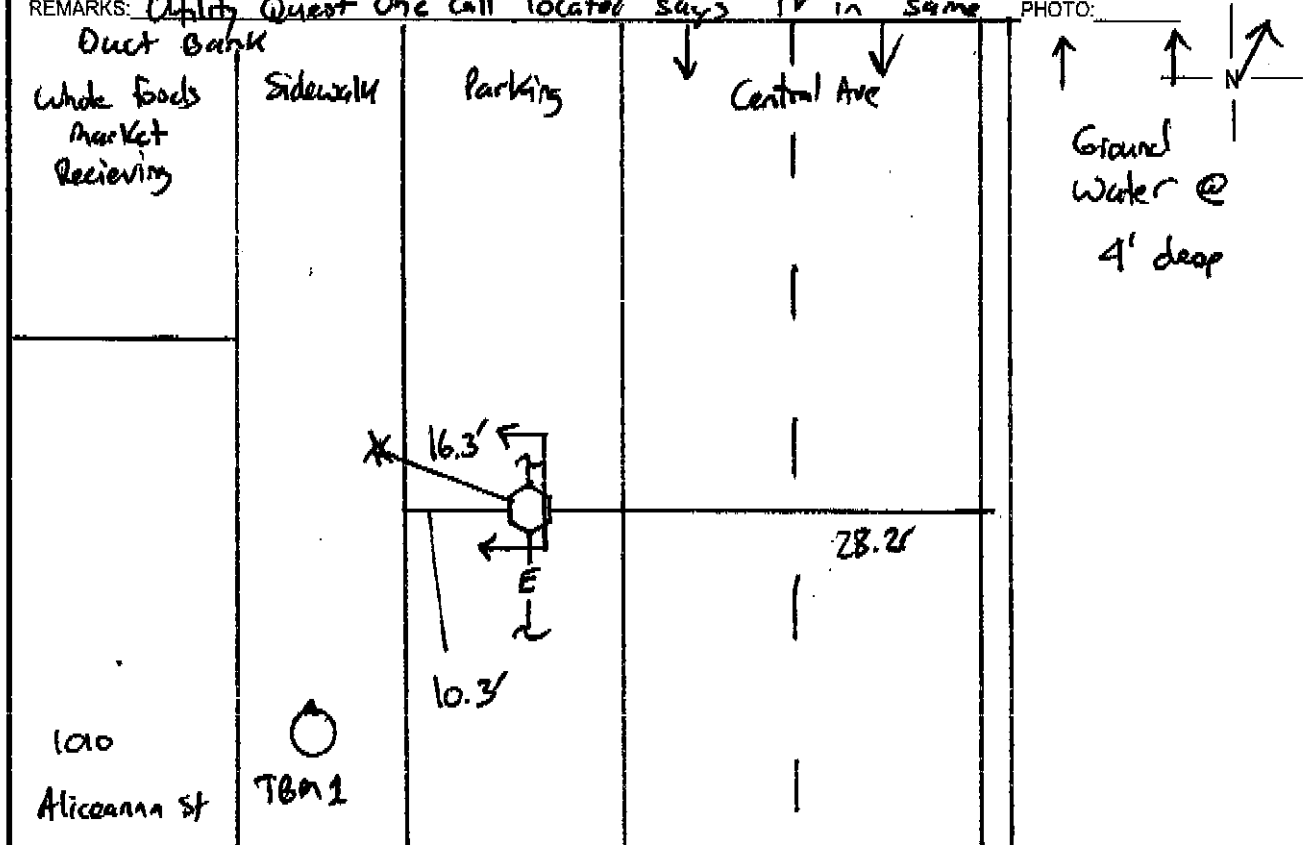
SoftDig® Project #: 113210 Test Hole #: 34 Client: Veolia Energy Date: 8/19/2011
One-Call Permit #: 114 211 94 SUE Analyst: R. Molnar Truck #: S110
City / County/State: Baltimore / Baltimore County / MD Road: Central Ave
General Location: Near Intersection Aliceanna St / Central Ave

Actual Size, Color, Material, Type of Utility: Concrete Duct Bank Electric
Utility Owner: Unknown Designation Color: Red
Observed Utility Condition: Good ✓ Poor ___ Other: ___
Test Hole marked by: PK Nail ✓ Hub ___ Other: ___
Portion of Utility Exposed: Top ✓ Half ___ Side ___ Full ___

1. Reference Mark Elevation: 99.42'
2. Utility Top Elevation: 95.31'
3. Utility Bottom Elevation (if applicable): 92.26'
4. Width (if applicable): 2'
5. Utility Top Depth from Reference: 4.11'
6. Utility Bottom Depth from Reference (if applicable): 7.16'

Surface Covering Type: Asphalt ✓ Concrete ___ Soil ___ Surface Covering Depth: 16"
Generalized Soil Profile: Select Fill ___ Rock ___ Sand ___ Clay ✓ Other: Water at level of Duct Bank
1.) Bench Mark Elev.: 100.00' (Assumed) Description: Water meter manhole North Rim
2.) Bench Mark Elev.: — Description: —
Excavated Location Station: — Offset —

REMARKS: Utility Quest One call located says TV in same Duct Bank PHOTO: ___

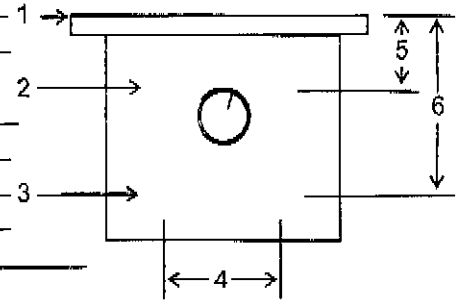
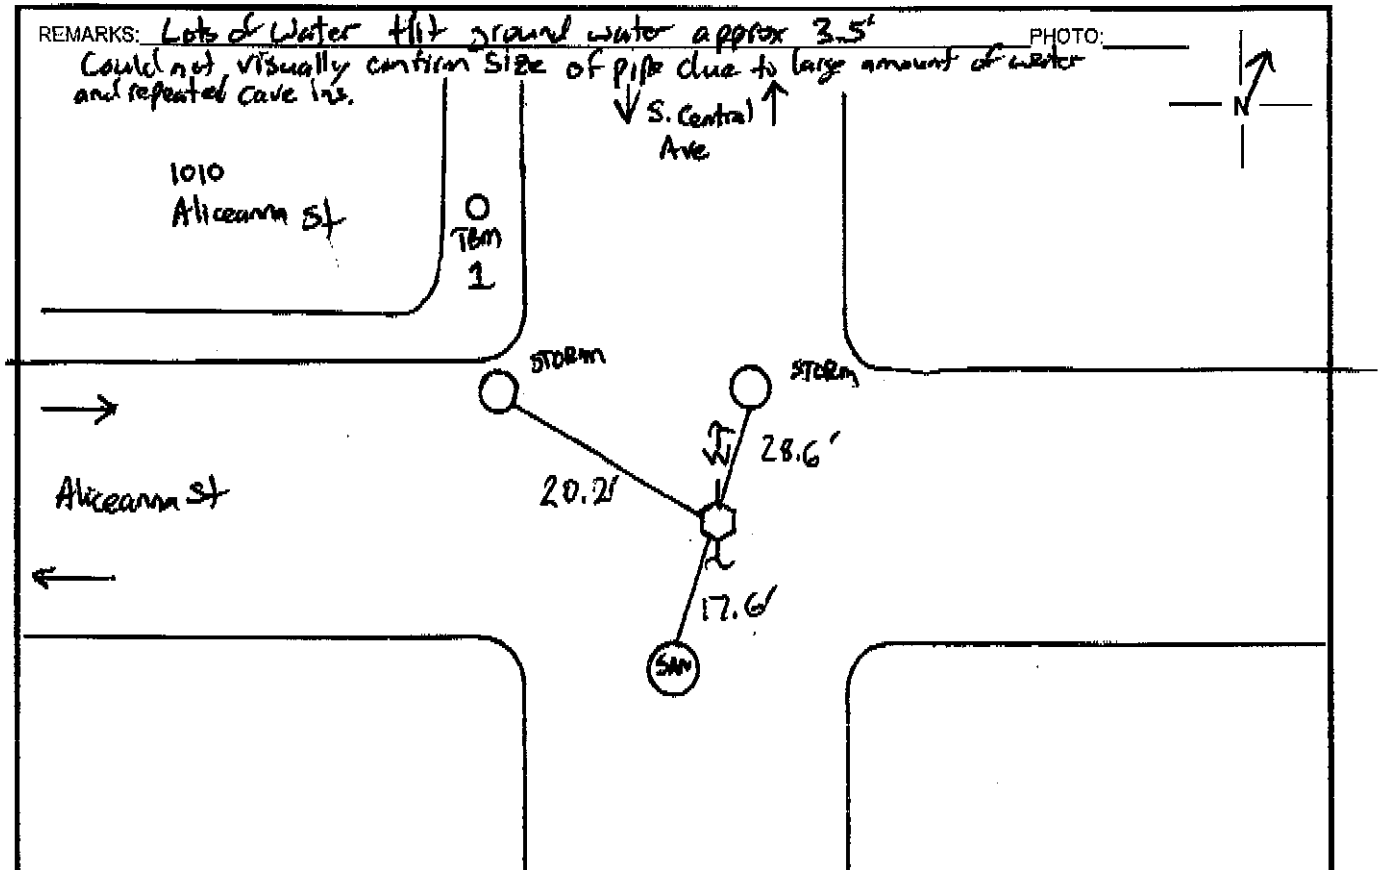
SoftDig® Project #: 113210 Test Hole #: 5 Client: Veolia Energy Date: 8/22/2011
One-Call Permit #: 114 211 94 SUE Analyst: R. Molnar Truck #: 5110
City / County/State: Baltimore / Baltimore County / MD Road: S. Central Ave
General Location: Aliceanna St / S. Central Avenue

Actual Size, Color, Material, Type of Utility: 10" Black Metal Water Pipe
Utility Owner: Unknown Designation Color: Blue
Observed Utility Condition: Good ✓ Poor ___ Other: ___
Test Hole marked by: PK Nail ✓ Hub ___ Other: ___
Portion of Utility Exposed: Top ✓ Half ___ Side ___ Full ___

1. Reference Mark Elevation: 99.11'
2. Utility Top Elevation: 94.65'
3. Utility Bottom Elevation (if applicable): —
4. Width (if applicable): —
5. Utility Top Depth from Reference: 4.46'
6. Utility Bottom Depth from Reference (if applicable): —

Surface Covering Type: Asphalt ✓ Concrete ___ Soil ___ Surface Covering Depth: 12"
Generalized Soil Profile: Select Fill ___ Rock ✓ Sand ___ Clay ___ Other: Crushed Stone
1.) Bench Mark Elev.: 100.00' (Assumed) Description: Water Meter Manhole North Rim
2.) Bench Mark Elev.: — Description: —
Excavated Location Station: — Offset —

REMARKS: Lots of Water Hit ground water approx 3.5' PHOTO: ___
Could not visually confirm size of pipe due to large amount of water and repeated cave ins.

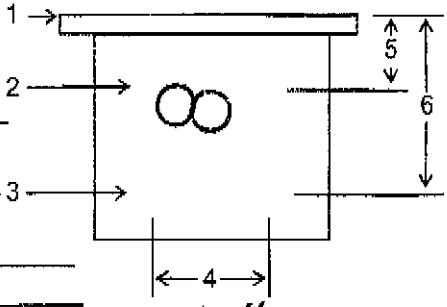
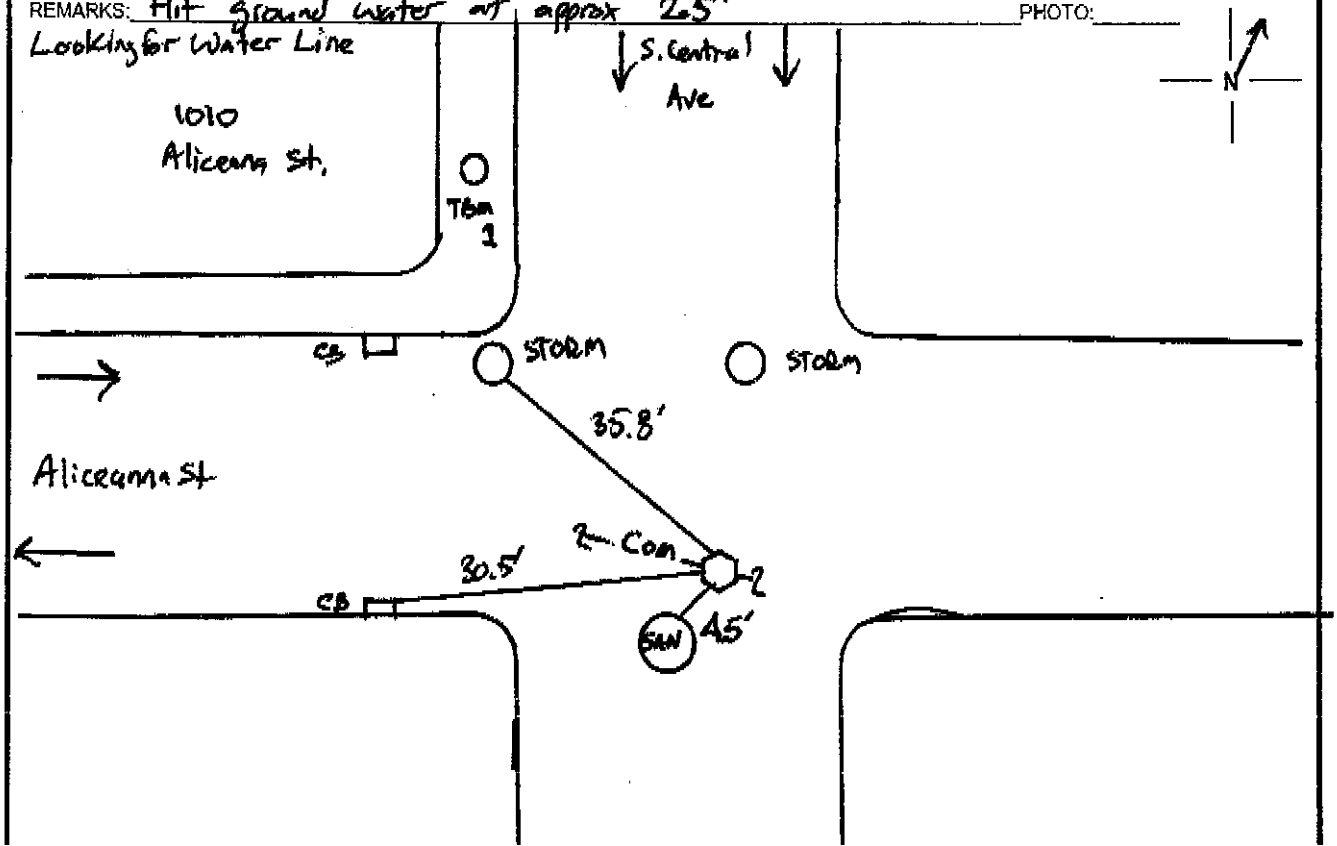
SoftDig® Project #: 113210 Test Hole #: 5A Client: Veolia Energy Date: 8/22/2011
One-Call Permit #: 114 211 94 SUE Analyst: R. Molnar Truck #: 5110
City / County/State: Baltimore / Baltimore County / MD Road: S. Central Ave
General Location: Aliceanna St / S. Central Avenue

Actual Size, Color, Material, Type of Utility: 2 4" Gray Plastic Conduits Communications
Utility Owner: Unknown Designation Color: Orange
Observed Utility Condition: Good ✓ Poor ___ Other: ___
Test Hole marked by: PK Nail ✓ Hub ___ Other: ___
Portion of Utility Exposed: Top ✓ Half ___ Side ___ Full ___

1. Reference Mark Elevation: 99.13'
2. Utility Top Elevation: 95.65'
3. Utility Bottom Elevation (if applicable): —
4. Width (if applicable): —
5. Utility Top Depth from Reference: 3.48'
6. Utility Bottom Depth from Reference (if applicable): —

Surface Covering Type: Asphalt ✓ Concrete ___ Soil ___ Surface Covering Depth: 12"
Generalized Soil Profile: Select Fill ___ Rock ___ Sand ✓ Clay ___ Other: Crushed Stone
1.) Bench Mark Elev.: 100.00' (Assumed) Description: Water Meter Manhole North Rim
2.) Bench Mark Elev.: — Description: —
Excavated Location Station: — Offset —

REMARKS: Hit ground water at approx 2.5' PHOTO: ___
Looking for Water Line

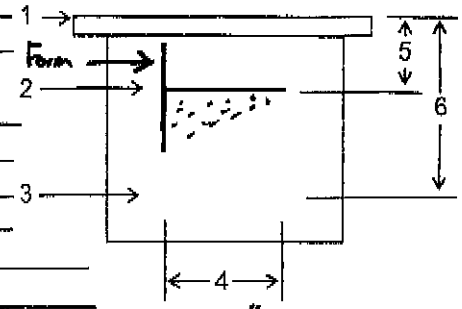
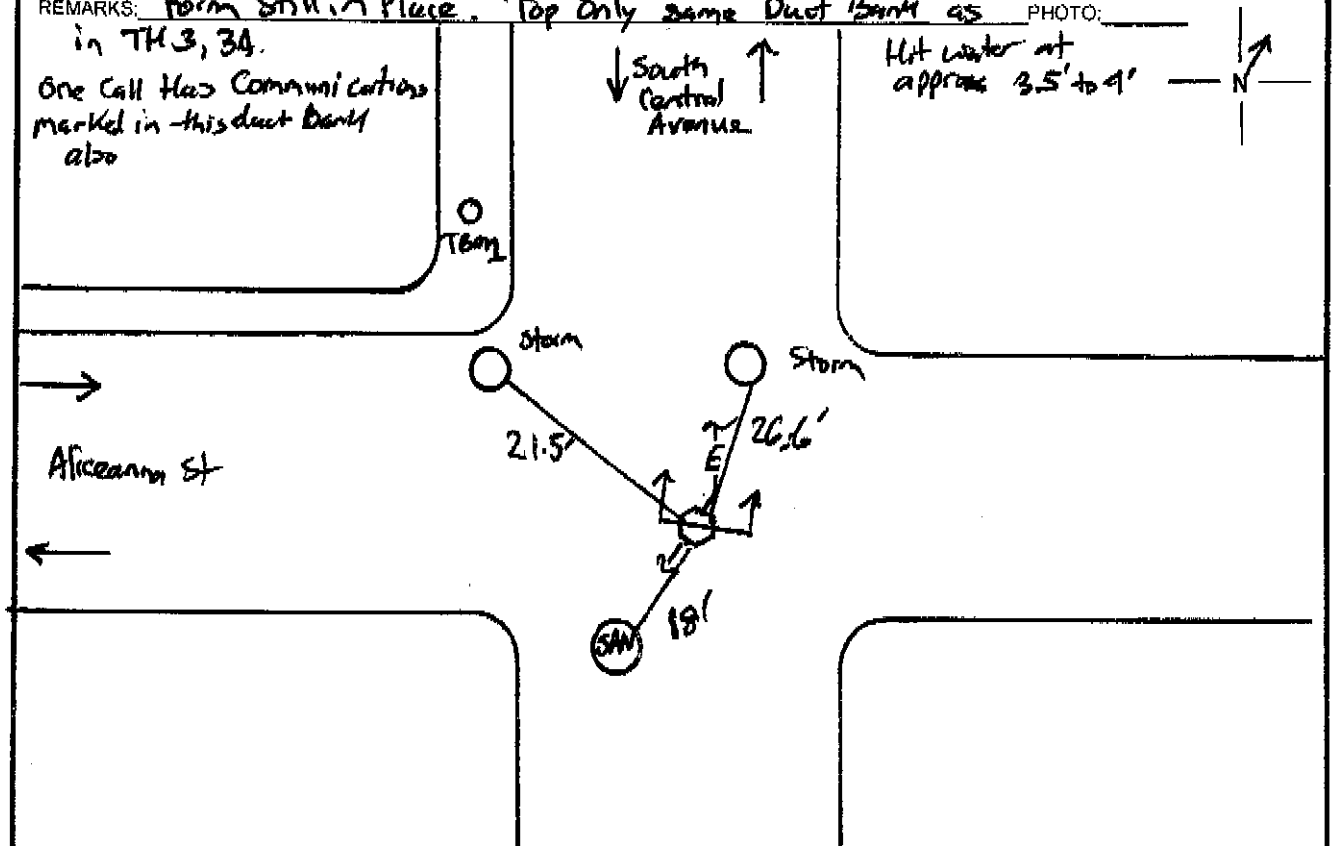
SoftDig® Project #: 113210 Test Hole #: 7 Client: Veolia Energy Date: 8/22/2011
One-Call Permit #: 114 211 94 SUE Analyst: R. Molnar Truck #: 5110
City / County/State: Baltimore / Baltimore County / MD Road: South Central Ave
General Location: Aliceanna St / South Central Ave

Actual Size, Color, Material, Type of Utility: Concrete Duct Bank Electric
Utility Owner: Unknown Designation Color: Red
Observed Utility Condition: Good ✓ Poor ___ Other: ___
Test Hole marked by: PK Nail ✓ Hub ___ Other: ___
Portion of Utility Exposed: Top ✓ Half ___ Side ___ Full ___

1. Reference Mark Elevation: 99.05'
2. Utility Top Elevation: 94.45'
3. Utility Bottom Elevation (if applicable): —
4. Width (if applicable): ___
5. Utility Top Depth from Reference: 4.60'
6. Utility Bottom Depth from Reference (if applicable): —

Surface Covering Type: Asphalt ✓ Concrete ___ Soil ___ Surface Covering Depth: 12"
Generalized Soil Profile: Select Fill ___ Rock ✓ Sand ___ Clay ___ Other: Crushed Stone
1.) Bench Mark Elev.: 100.00' (Assumed) Description: Water Meter Manhole North Rim
2.) Bench Mark Elev.: — Description: —
Excavated Location Station: — Offset —

REMARKS: Form Still in Place. Top Only same Duct Bank as in TH 3, 34. One Call Has Communications marked in this duct Bank also

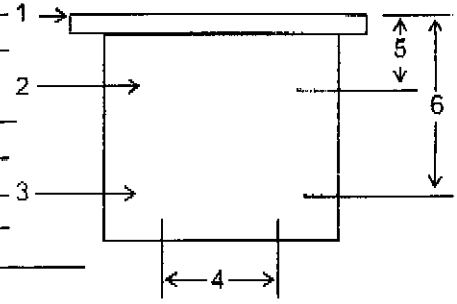
SoftDig® Project #: 115210 Test Hole #: 8 Client: Veolia Energy Date: 8/25/2011
One-Call Permit #: 114 212 239 SUE Analyst: R. Molnar Truck #: —
City / County/State: Baltimore / Baltimore County / MD Road: Aliceanna St
General Location: Aliceanna St near Intersection with S. Central Avenue

Actual Size, Color, Material, Type of Utility: No Hole Dug
Utility Owner: _____ Designation Color: _____
Observed Utility Condition: Good ___ Poor ___ Other: _____
Test Hole marked by: PK Nail ___ Hub ___ Other: _____
Portion of Utility Exposed: Top ___ Half ___ Side ___ Full ___
1. Reference Mark Elevation: _____
2. Utility Top Elevation: _____
3. Utility Bottom Elevation (if applicable): _____
4. Width (if applicable): _____
5. Utility Top Depth from Reference: _____
6. Utility Bottom Depth from Reference (if applicable): _____

REMARKS: One call had no Electric markout where drawing shows TH8. We opened three small DPW manhole clamp around everything got nothing running perpendicular to street at Location for TH8

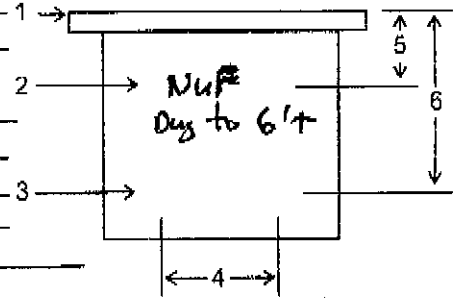
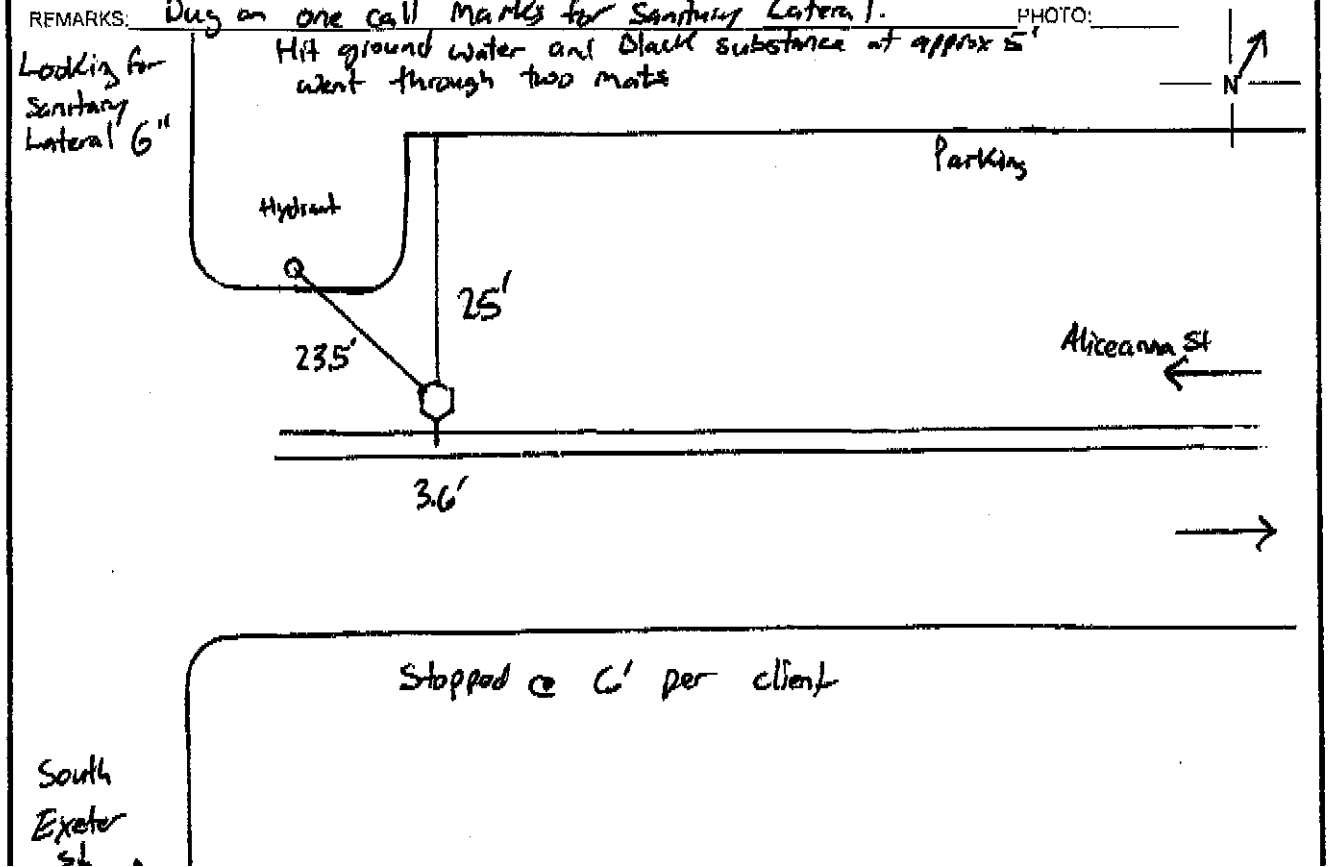
SoftDig® Project #: [illegible] Test Hole #: 10 Client: Veolia Energy Date: [illegible]

Actual Size, Color, Material, Type of Utility: No utility found

REMARKS: Dug on one call marks for Sanitary Lateral. PHOTO: ___

Hit ground water and black substance at approx 5' went through two mats

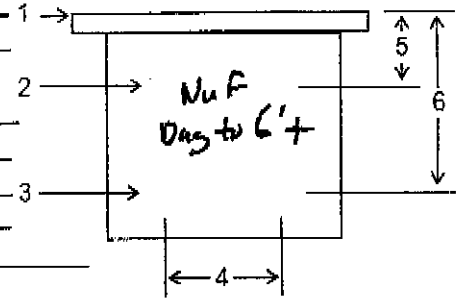
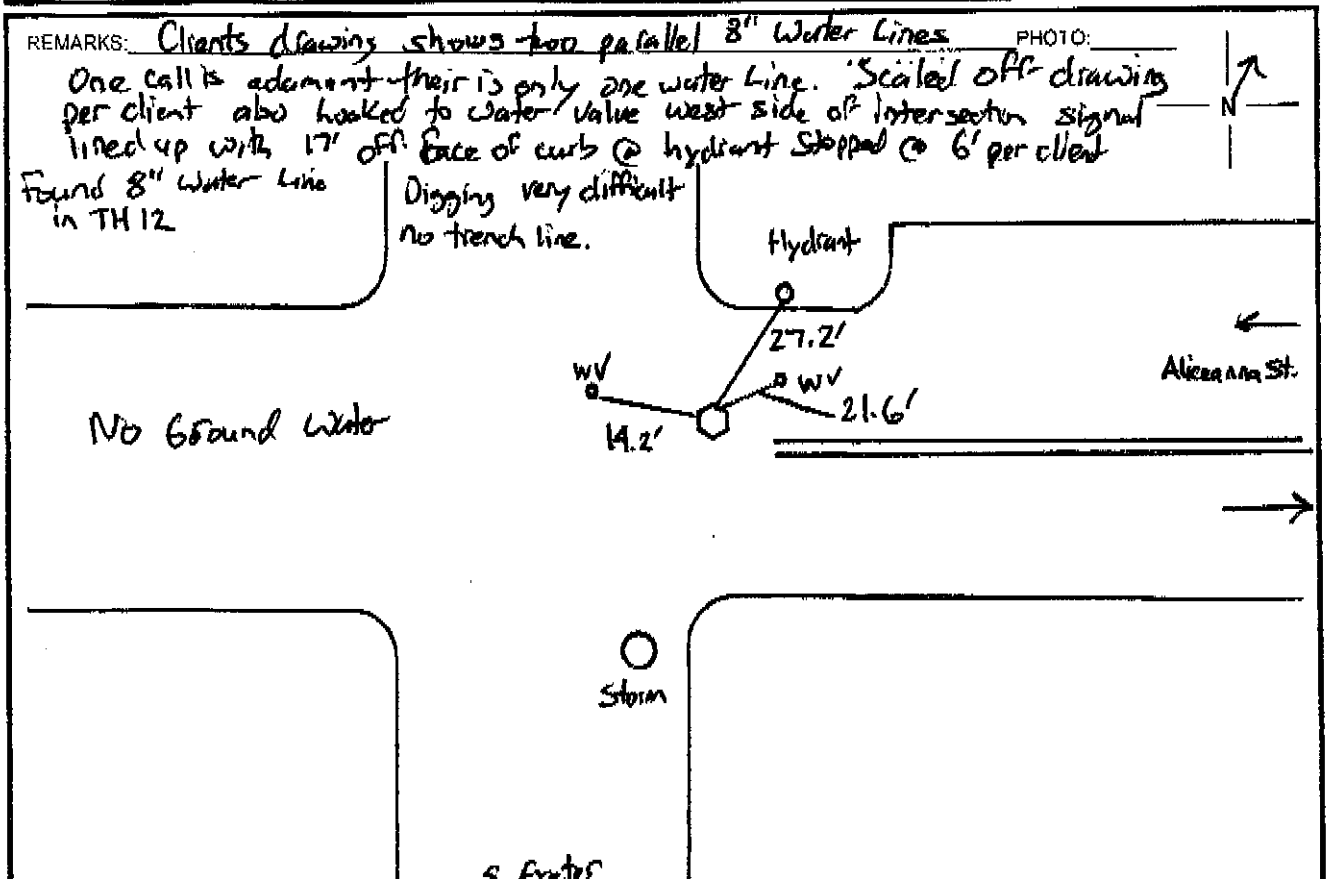
SoftDig® Project #: [illegible] Test Hole #: 11 Client: Veolia Energy Date: 8/27/2011
One-Call Permit #: 114 212 239 SUE Analyst: _____ Truck #: 5110
City / County/State: Baltimore / Baltimore County / MD Road: Aliceanna St
General Location: _____

Actual Size, Color, Material, Type of Utility: No Utility found
Utility Owner: _____ Designation Color: _____
Observed Utility Condition: Good ___ Poor ___ Other: _____
Test Hole marked by: PK Nail ___ Hub ___ Other: _____
Portion of Utility Exposed: Top ___ Half ___ Side ___ Full ___
1. Reference Mark Elevation: _____
2. Utility Top Elevation: _____
3. Utility Bottom Elevation (if applicable): _____
4. Width (if applicable): _____
5. Utility Top Depth from Reference: _____
6. Utility Bottom Depth from Reference (if applicable): _____

Surface Covering Type: Asphalt ✓ Concrete ___ Soil ___ Surface Covering Depth: 12"
Generalized Soil Profile: Select Fill ___ Rock ✓ Sand ___ Clay ___ Other: Asphalt Rubble
1.) Bench Mark Elev.: _____ Description: _____
2.) Bench Mark Elev.: _____ Description: _____
Excavated Location Station: _____ Offset _____

REMARKS: Clients drawing shows two parallel 8" Water Lines PHOTO: _____
One call is adamant their is only one water line. Scaled off drawing per client also looked to water value west side of intersection signal lined up with 17' off face of curb @ hydrant stopped @ 6' per client

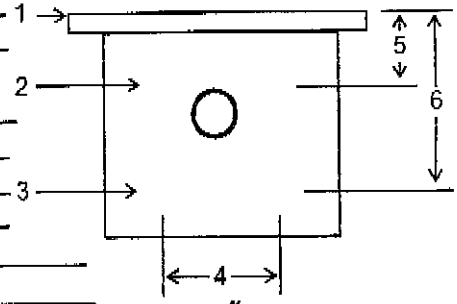
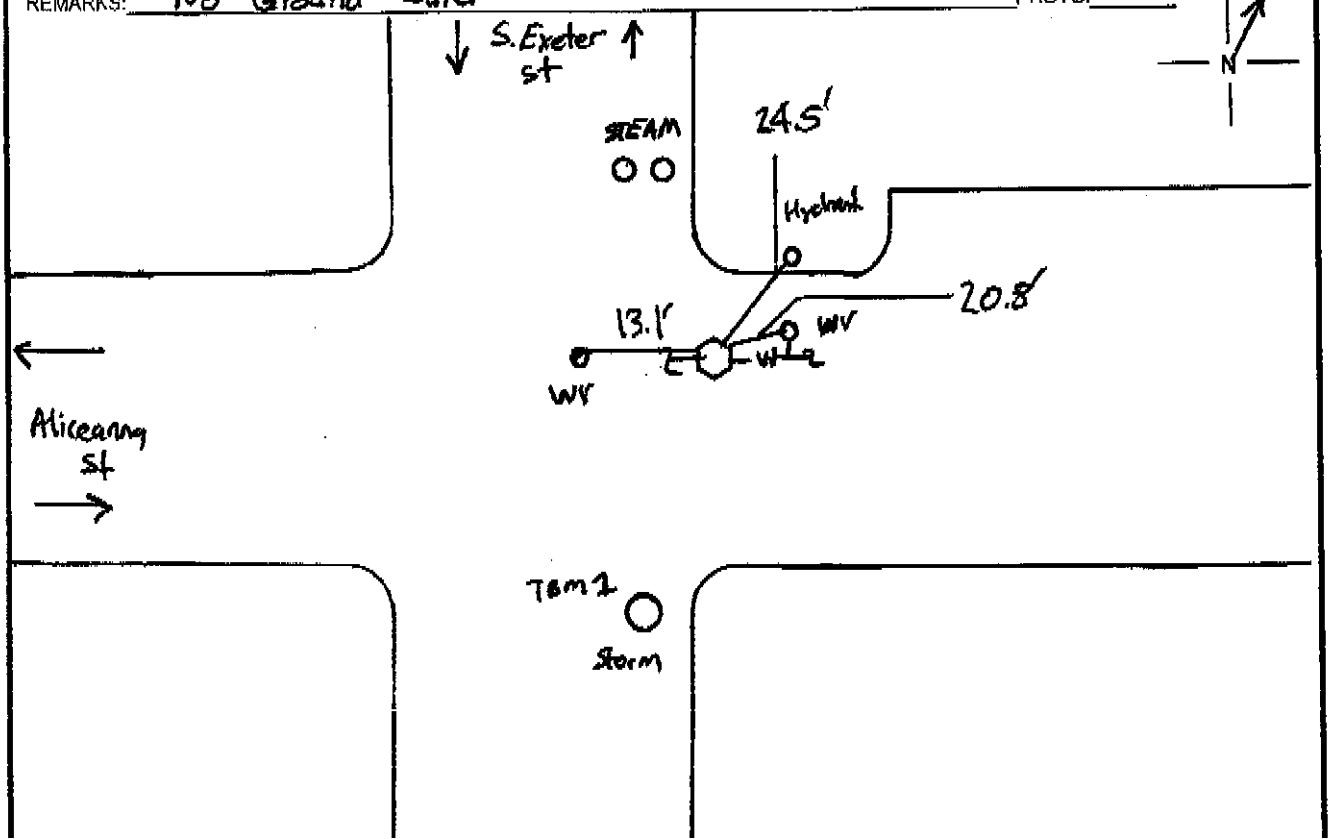
SoftDig® Project #: 115210 Test Hole #: 12 Client: Veolia Energy Date: [illegible]
One-Call Permit #: 114 212 239 SUE Analyst: R. Molnar Truck #: S110
City / County/State: Baltimore / Baltimore County / MD Road: Aliceanna St
General Location: Aliceanna St / S. Exeter St Intersection

Actual Size, Color, Material, Type of Utility: 8" Black Metal Water Pipe
Utility Owner: Unknown Designation Color: Blue
Observed Utility Condition: Good ✓ Poor ___ Other: ___
Test Hole marked by: PK Nail ✓ Hub ___ Other: ___
Portion of Utility Exposed: Top ✓ Half ___ Side ___ Full ___

1. Reference Mark Elevation: 100.15'
2. Utility Top Elevation: 94.62'
3. Utility Bottom Elevation (if applicable): —
4. Width (if applicable): —
5. Utility Top Depth from Reference: 5.53'
6. Utility Bottom Depth from Reference (if applicable): —

Surface Covering Type: Asphalt ✓ Concrete ___ Soil ___ Surface Covering Depth: 12"
Generalized Soil Profile: Select Fill ___ Rock ✓ Sand ___ Clay ___ Other: Steel Rubble
1.) Bench Mark Elev.: 100.00' (Assumed) Description: Storm Manhole North Rim
2.) Bench Mark Elev.: ___ Description: —
Excavated Location Station: — Offset —

REMARKS: No Ground Water PHOTO: ___

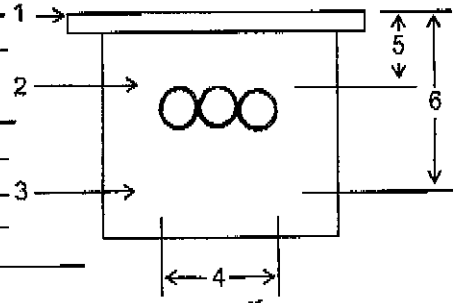
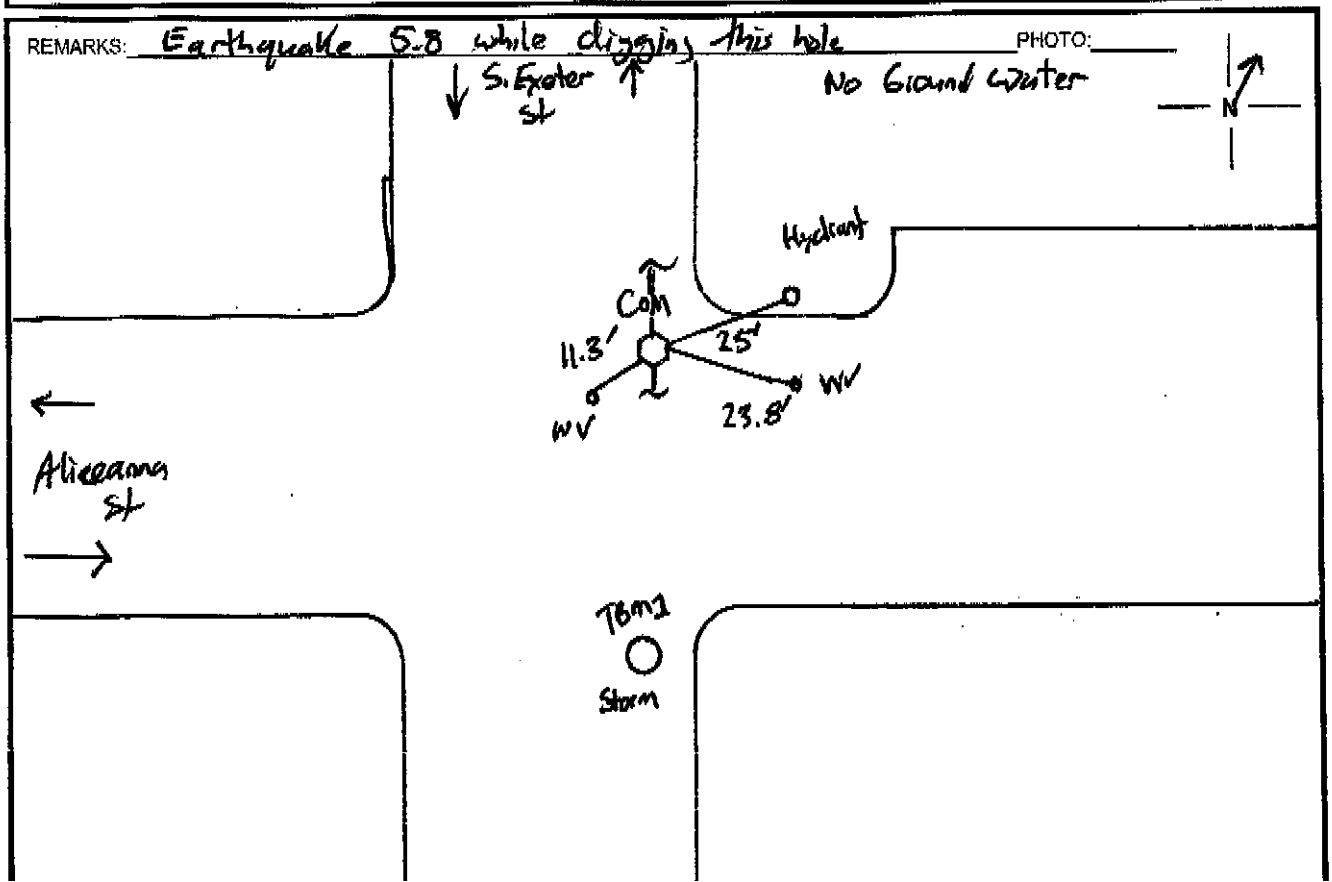
SoftDig® Project #: 113210 Test Hole #: 12A Client: Veolia Energy Date: 01/20/2011
One-Call Permit #: 114 212 239 SUE Analyst: R. molnar Truck #: 5110
City / County/State: Baltimore / Baltimore County / MD Road: Aliceanna St
General Location: Aliceanna St / S. Exeter Intersection

Actual Size, Color, Material, Type of Utility: 3 4" White Plastic Conduits Communications
Utility Owner: Verizon Designation Color: Orange
Observed Utility Condition: Good ✓ Poor ___ Other: ___
Test Hole marked by: PK Nail ✓ Hub ___ Other: ___
Portion of Utility Exposed: Top ✓ Half ___ Side ___ Full ___

1. Reference Mark Elevation: 100.13'
2. Utility Top Elevation: 95.74'
3. Utility Bottom Elevation (if applicable): —
4. Width (if applicable): —
5. Utility Top Depth from Reference: 4.39'
6. Utility Bottom Depth from Reference (if applicable): —

Surface Covering Type: Asphalt ✓ Concrete ___ Soil ___ Surface Covering Depth: 14"
Generalized Soil Profile: Select Fill ___ Rock ✓ Sand ___ Clay ___ Other: Crushed Stone
1.) Bench Mark Elev.: 100.00' (Assumed) Description: Storm Manhole North Rim
2.) Bench Mark Elev.: — Description: —
Excavated Location Station: — Offset —

REMARKS: Earthquake 5.8 while digging this hole PHOTO: ___

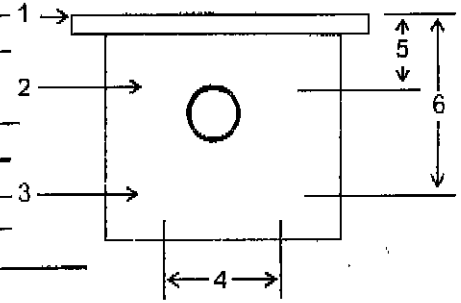
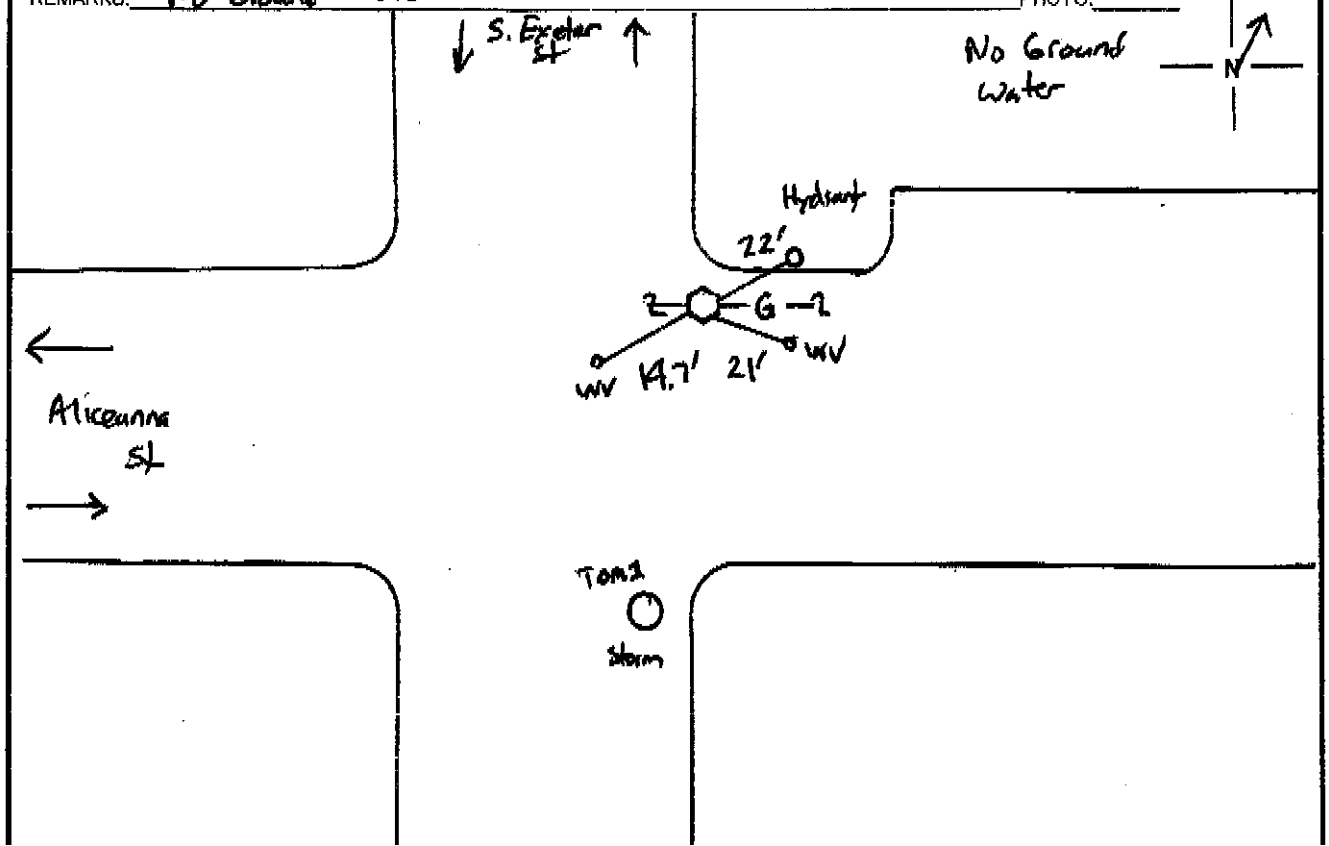
SoftDig® Project #: 115200 Test Hole #: 13 Client: Veolia Energy Date: 8/28/2017
One-Call Permit #: 114 212 239 SUE Analyst: R. Molnar Truck #: S110
City / County/State: Baltimore / Baltimore County / MD Road: Aliceanna St.
General Location: Aliceanna St / S. Exeter Intersection

Actual Size, Color, Material, Type of Utility: 10" Black Metal Steel GAS Pipe
Utility Owner: BGE Designation Color: yellow
Observed Utility Condition: Good ✓ Poor ___ Other: ___
Test Hole marked by: PK Nail ✓ Hub ___ Other: ___
Portion of Utility Exposed: Top ✓ Half ___ Side ___ Full ___
1. Reference Mark Elevation: 99.98
2. Utility Top Elevation: 97.04'
3. Utility Bottom Elevation (if applicable): —
4. Width (if applicable): —
5. Utility Top Depth from Reference: 2.94'
6. Utility Bottom Depth from Reference (if applicable): —

Surface Covering Type: Asphalt ✓ Concrete ___ Soil ___ Surface Covering Depth: 14
Generalized Soil Profile: Select Fill ___ Rock ___ Sand ✓ Clay ___ Other: Sand Around Pipe
1.) Bench Mark Elev.: 100.00' (Assumed) Description: Storm Manhole North Rim
2.) Bench Mark Elev.: — Description: —
Excavated Location Station: — Offset —

REMARKS: No Ground Water PHOTO: ___

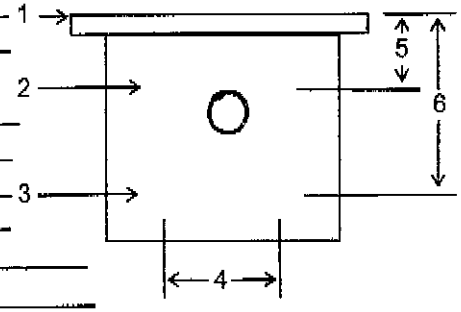
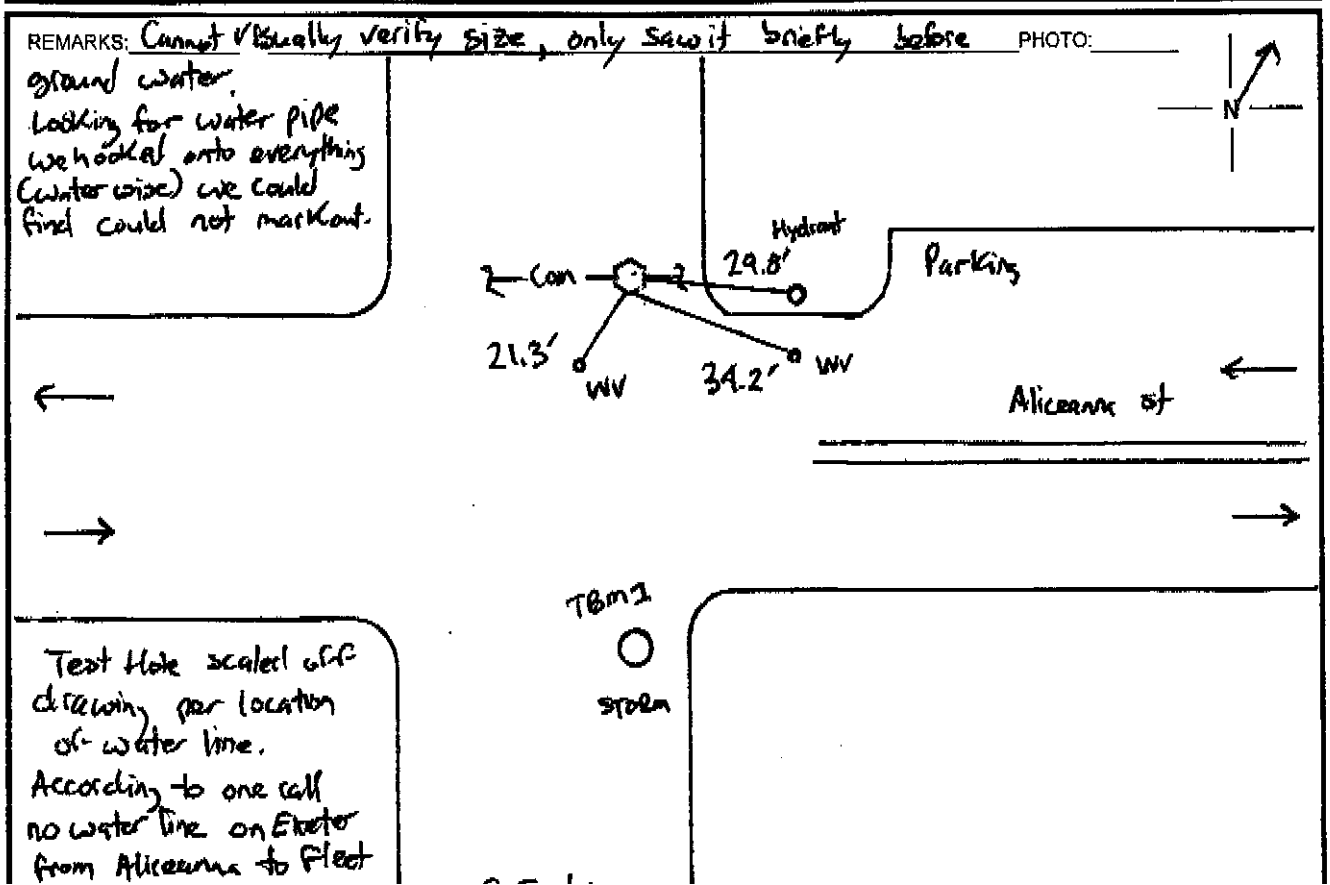
SoftDig® Project #: 113210 Test Hole #: 14 Client: Veolia Energy Date: 01/20/2011
One-Call Permit #: 114 212 39 SUE Analyst: R. Molnar Truck #: 589
City / County/State: Baltimore / Baltimore County / MD Road: S. Exeter St
General Location: Aliceanna St / South Exeter St Intersection

Actual Size, Color, Material, Type of Utility: 4" White Plastic Conduit Communications
Utility Owner: Verizon Designation Color: Orange
Observed Utility Condition: Good ✓ Poor ___ Other: ___
Test Hole marked by: PK Nail ✓ Hub ___ Other: ___
Portion of Utility Exposed: Top ✓ Half ___ Side ___ Full ___

1. Reference Mark Elevation: 99.64'
2. Utility Top Elevation: 92.88'
3. Utility Bottom Elevation (if applicable): —
4. Width (if applicable): —
5. Utility Top Depth from Reference: 6.76'
6. Utility Bottom Depth from Reference (if applicable): —

Surface Covering Type: Asphalt ✓ Concrete ___ Soil ___ Surface Covering Depth: ___
Generalized Soil Profile: Select Fill ___ Rock ✓ Sand ___ Clay ___ Other: Crushed Stone
1.) Bench Mark Elev.: 100.00' (Assumed) Description: Storm Manhole North Rim
2.) Bench Mark Elev.: — Description: —
Excavated Location Station: — Offset —

REMARKS: Cannot visually verify size, only saw it briefly before ground water. Looking for water pipe we hooked onto everything (water wise) we could find could not mark out. PHOTO: ___

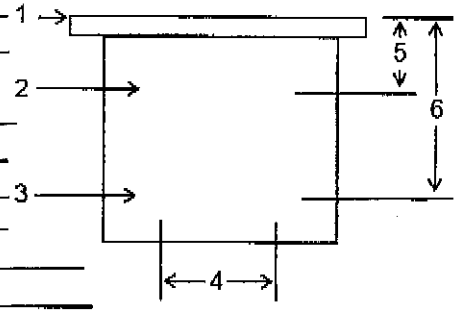
SoftDig® Project #: 115210 Test Hole #: 44 Client: Veolia Energy Date: 8/25/2011
One-Call Permit #: 114212 239 SUE Analyst: Rmalnar Truck #: —
City / County/State: Baltimore / Baltimore County / MD Road: Alicanna St
General Location: Alicanna St / S. Exeter St Intersection

Actual Size, Color, Material, Type of Utility: No Test Hole Dug
Utility Owner: _____ Designation Color: _____
Observed Utility Condition: Good ___ Poor ___ Other: _____
Test Hole marked by: PK Nail ___ Hub ___ Other: _____
Portion of Utility Exposed: Top ___ Half ___ Side ___ Full ___
1. Reference Mark Elevation: _____
2. Utility Top Elevation: _____
3. Utility Bottom Elevation (if applicable): _____
4. Width (if applicable): _____
5. Utility Top Depth from Reference: _____
6. Utility Bottom Depth from Reference (if applicable): _____

REMARKS: One hall had no electric markout where drawing shows TH 44 in the direction of the line shown on drawing. We opened two small BPW manholes and did not get line shown going through TH 44. PHOTO: _____

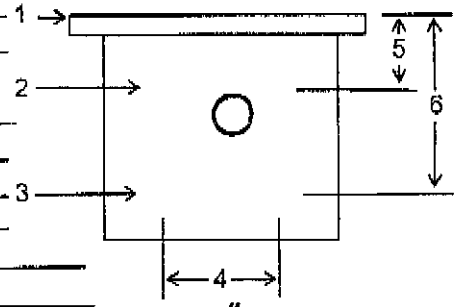
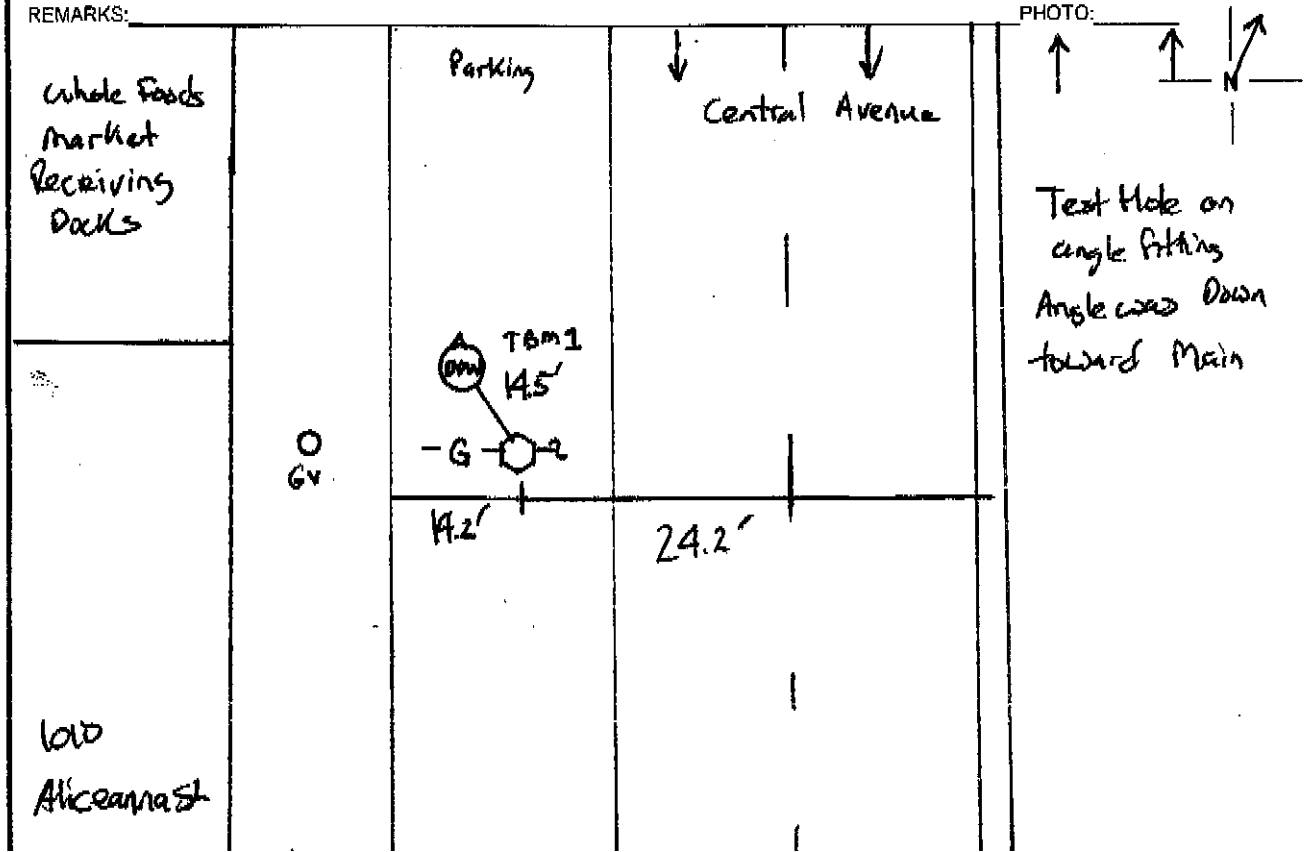
SoftDig® Project #: 113210 Test Hole #: 15 Client: Veolia Energy Date: 8/18/2014
One-Call Permit #: 114 21194 SUE Analyst: R. Molnar Truck #: 589
City / County/State: Baltimore / Baltimore County / MD Road: Central Avenue
General Location: Near Intersection Aliceanna St / Central Avenue

Actual Size, Color, Material, Type of Utility: 10" Plastic Wrapped Black Metal GAS pipe
Utility Owner: BGE Designation Color: Yellow
Observed Utility Condition: Good ✓ Poor ___ Other: ___
Test Hole marked by: PK Nail ✓ Hub ___ Other: ___
Portion of Utility Exposed: Top ✓ Half ___ Side ___ Full ___

1. Reference Mark Elevation: 99.93'
2. Utility Top Elevation: 97.47'
3. Utility Bottom Elevation (if applicable): —
4. Width (if applicable): —
5. Utility Top Depth from Reference: 2.46'
6. Utility Bottom Depth from Reference (if applicable): —

Surface Covering Type: Asphalt ✓ Concrete ___ Soil ___ Surface Covering Depth: 16"
Generalized Soil Profile: Select Fill ___ Rock ___ Sand ✓ Clay ___ Other: Pipe in Sand, Crushed Stone under Asphalt
1.) Bench Mark Elev.: 100.00' (Assumed) Description: DPW Conduit Manhole Rim
2.) Bench Mark Elev.: — Description: —
Excavated Location Station: — Offset —
