INNER HARBOR EAST – HIGH TEMPERATURE
HOT WATER MAIN RELOCATION – TEST PIT PLAN
SCALE: 1" = 10'-0"

PROJECT TITLE: INNER HARBOR EAST HIGH TEMP HOT WATER RELOCATION

MESSAGE: Test Hole Reports and Invert Sheets

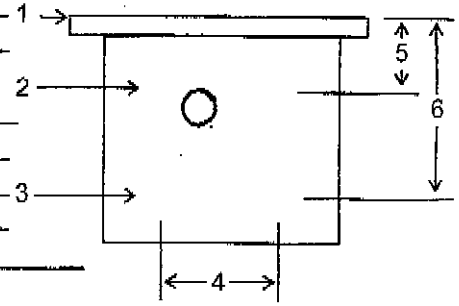
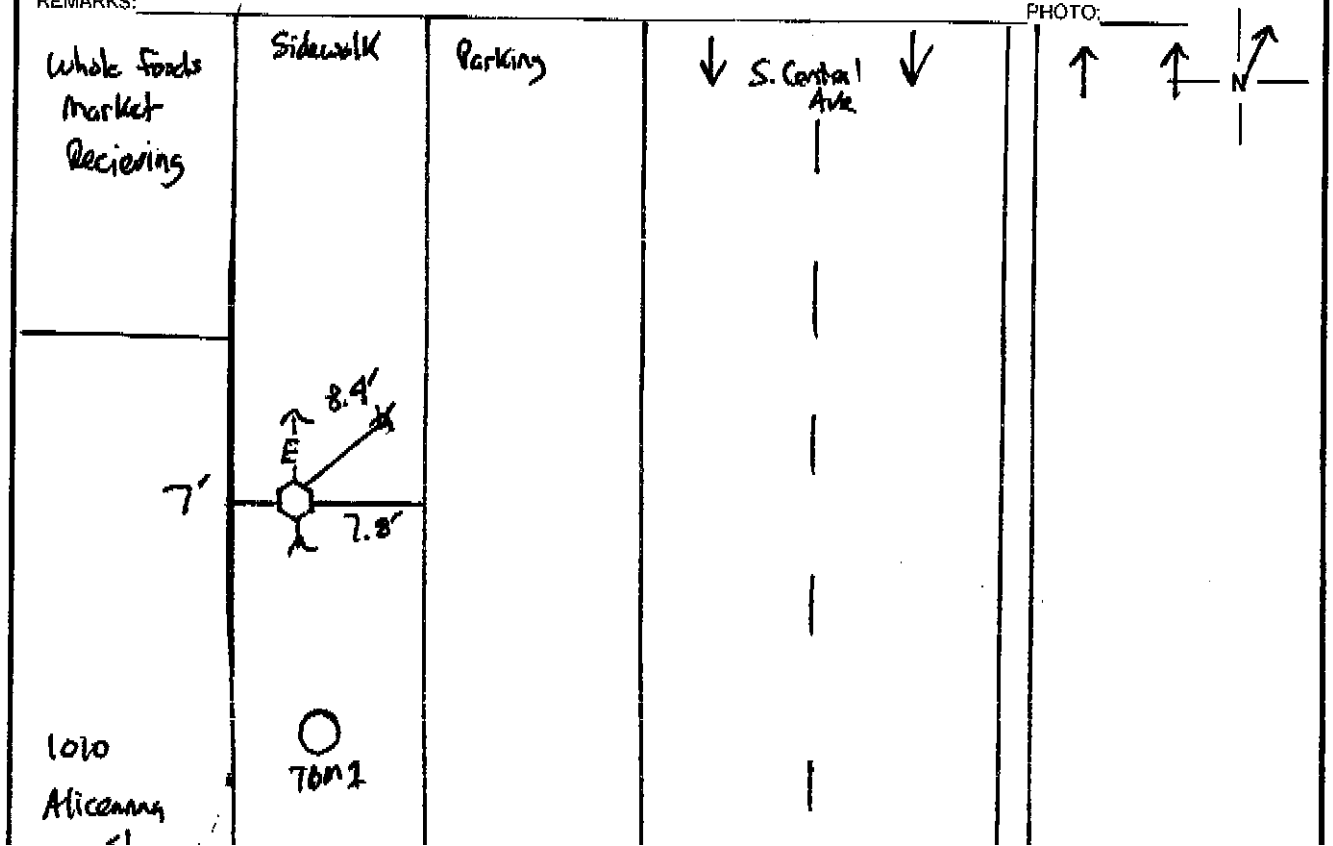
SoftDig® Project #: 115210 Test Hole #: 16 Client: Veolia Energy Date: 8/22/2011
One-Call Permit #: 114 211 94 SUE Analyst: R. Molnar Truck #: S110
City / County/State: Baltimore / Baltimore County / MD Road: S. Central Ave
General Location: near Intersection Aliceanna St / S. Central Ave

Actual Size, Color, Material, Type of Utility: 3" Gray Plastic Conduit Electric
Utility Owner: Baltimore DPW Designation Color: Red
Observed Utility Condition: Good ✓ Poor ___ Other: ___
Test Hole marked by: PK Nail ___ Hub ___ Other: Chiseled "X"
Portion of Utility Exposed: Top ✓ Half ___ Side ___ Full ___

1. Reference Mark Elevation: 100.0V
2. Utility Top Elevation: 98.20'
3. Utility Bottom Elevation (if applicable): —
4. Width (if applicable): —
5. Utility Top Depth from Reference: 1.8V
6. Utility Bottom Depth from Reference (if applicable): —

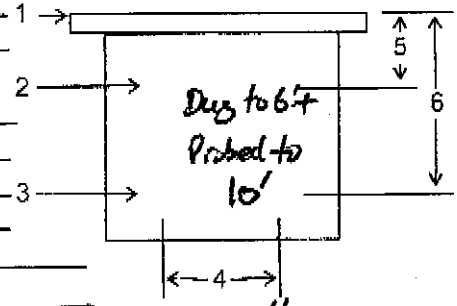
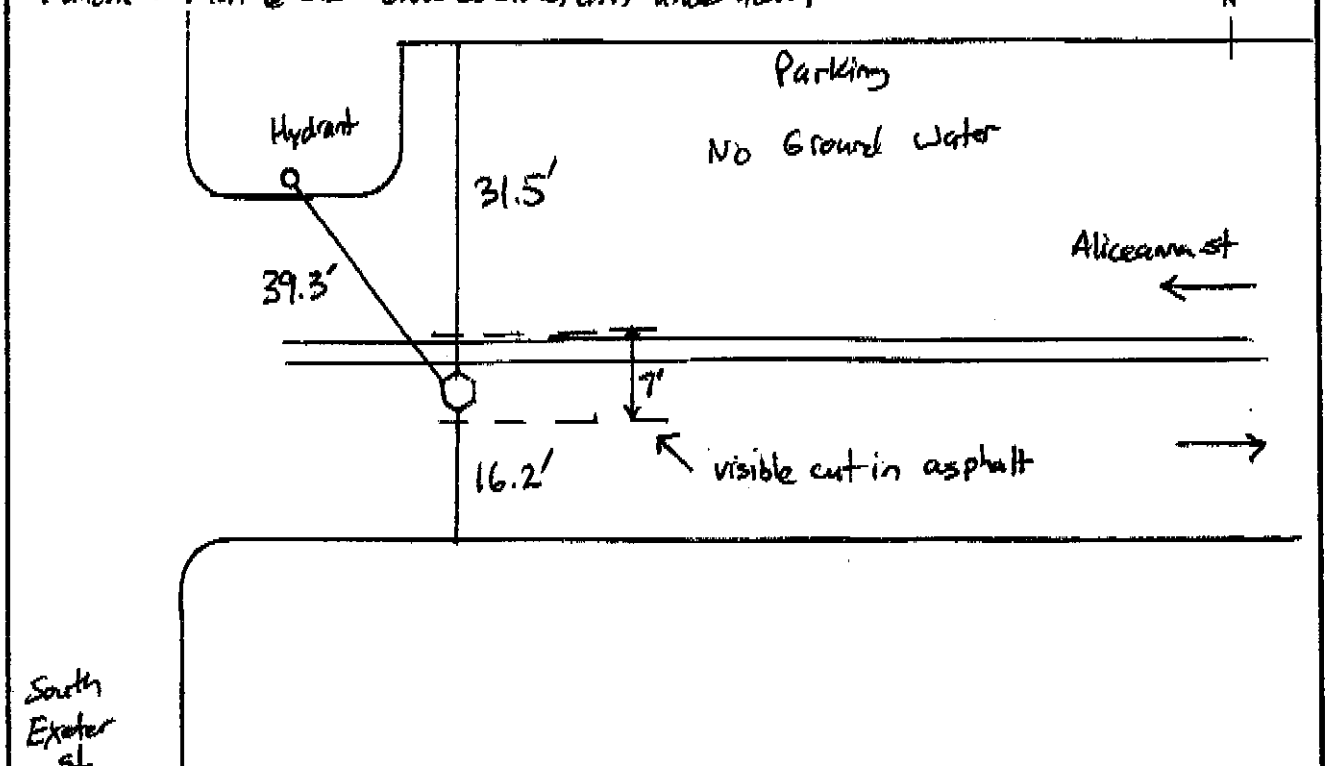
SoftDig® Project #: 113 210 Test Hole #: 17 Client: Veolia Energy Date: 8/29/2011
One-Call Permit #: 114 212 239 SUE Analyst: R. Molnar Truck #: S110
City / County/State: Baltimore / Baltimore County / MD Road: Aliceanna St
General Location: Aliceanna st near Intersection with South Exeter St

Actual Size, Color, Material, Type of Utility: No Utility Found
Utility Owner: — Designation Color: —
Observed Utility Condition: Good___ Poor___ Other: —
Test Hole marked by: PK Nail___ Hub___ Other: —
Portion of Utility Exposed: Top ___ Half ___ Side ___ Full ___
1. Reference Mark Elevation: —
2. Utility Top Elevation: —
3. Utility Bottom Elevation (if applicable): —
4. Width (if applicable): —
5. Utility Top Depth from Reference: —
6. Utility Bottom Depth from Reference (if applicable): —

Surface Covering Type: Asphalt ✓ Concrete ✓ Soil___ Surface Covering Depth: 12"
Generalized Soil Profile: Select Fill___ Rock ✓ Sand___ Clay___ Other: —
1.) Bench Mark Elev.: — Description: —
2.) Bench Mark Elev.: — Description: —
Excavated Location Station: — Offset —

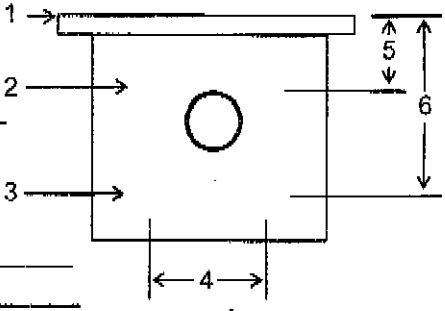
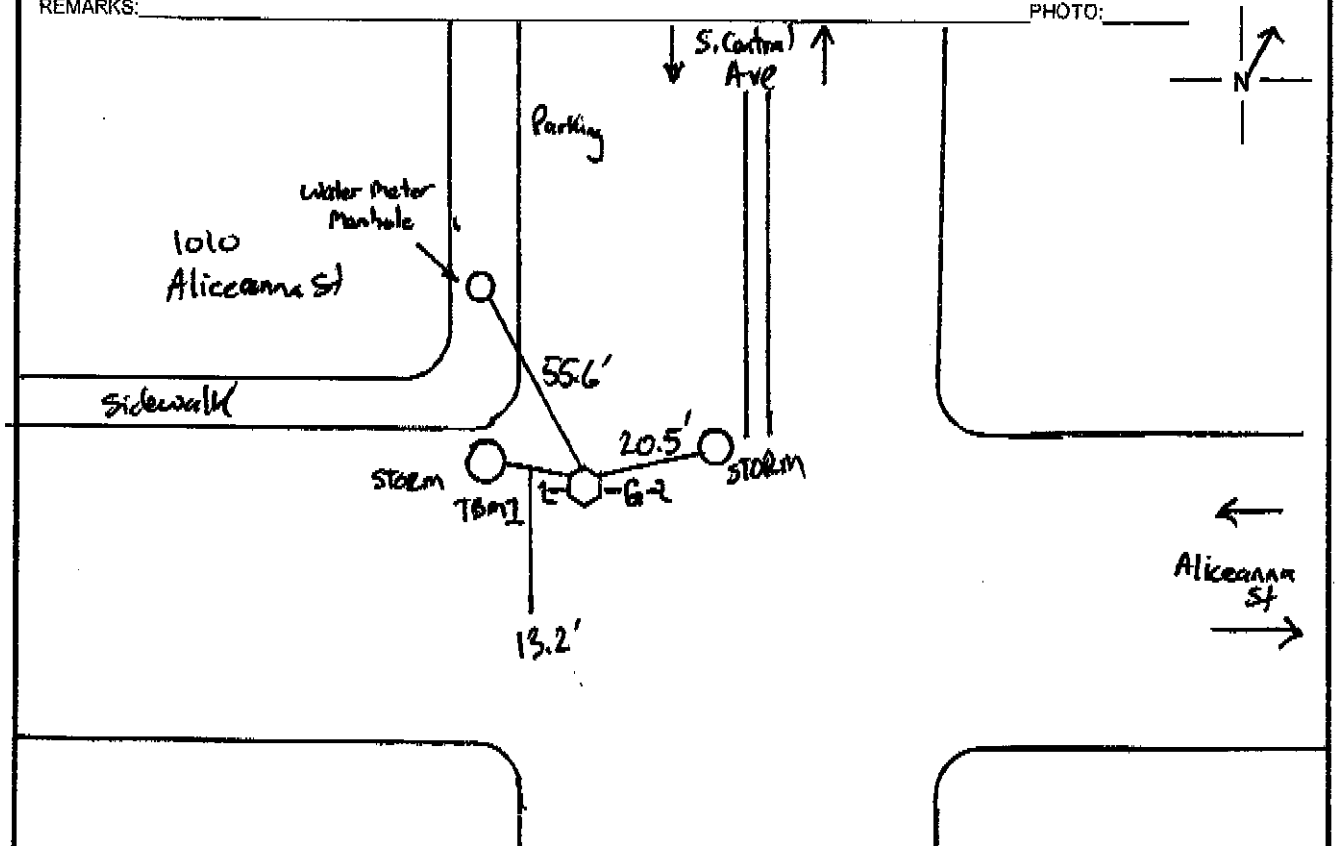
SoftDig® Project #: 113210 Test Hole #: 18 Client: Veolia Energy Date: 8/29/2011
One-Call Permit #: 114 211 94 SUE Analyst: R. Molnar Truck #: 589
City / County/State: Baltimore / Baltimore County / MD Road: Alicegann St.
General Location: Alicegann St / S. Central Ave Intersection

Actual Size, Color, Material, Type of Utility: 10" Black Metal Gas Pipe
Utility Owner: BGE Designation Color: Yellow
Observed Utility Condition: Good ✓ Poor ___ Other: ___
Test Hole marked by: PK Nail ✓ Hub ___ Other: ___
Portion of Utility Exposed: Top ✓ Half ___ Side ___ Full ___

Surface Covering Type: Asphalt ✓ Concrete ___ Soil ___ Surface Covering Depth: 12"
Generalized Soil Profile: Select Fill ___ Rock ___ Sand ✓ Clay ___ Other: ___
1.) Bench Mark Elev.: 100.00' (Assumed) Description: Storm Manhole North Rim
2.) Bench Mark Elev.: — Description: —
Excavated Location Station: — Offset —

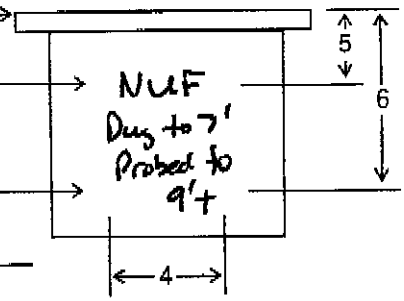
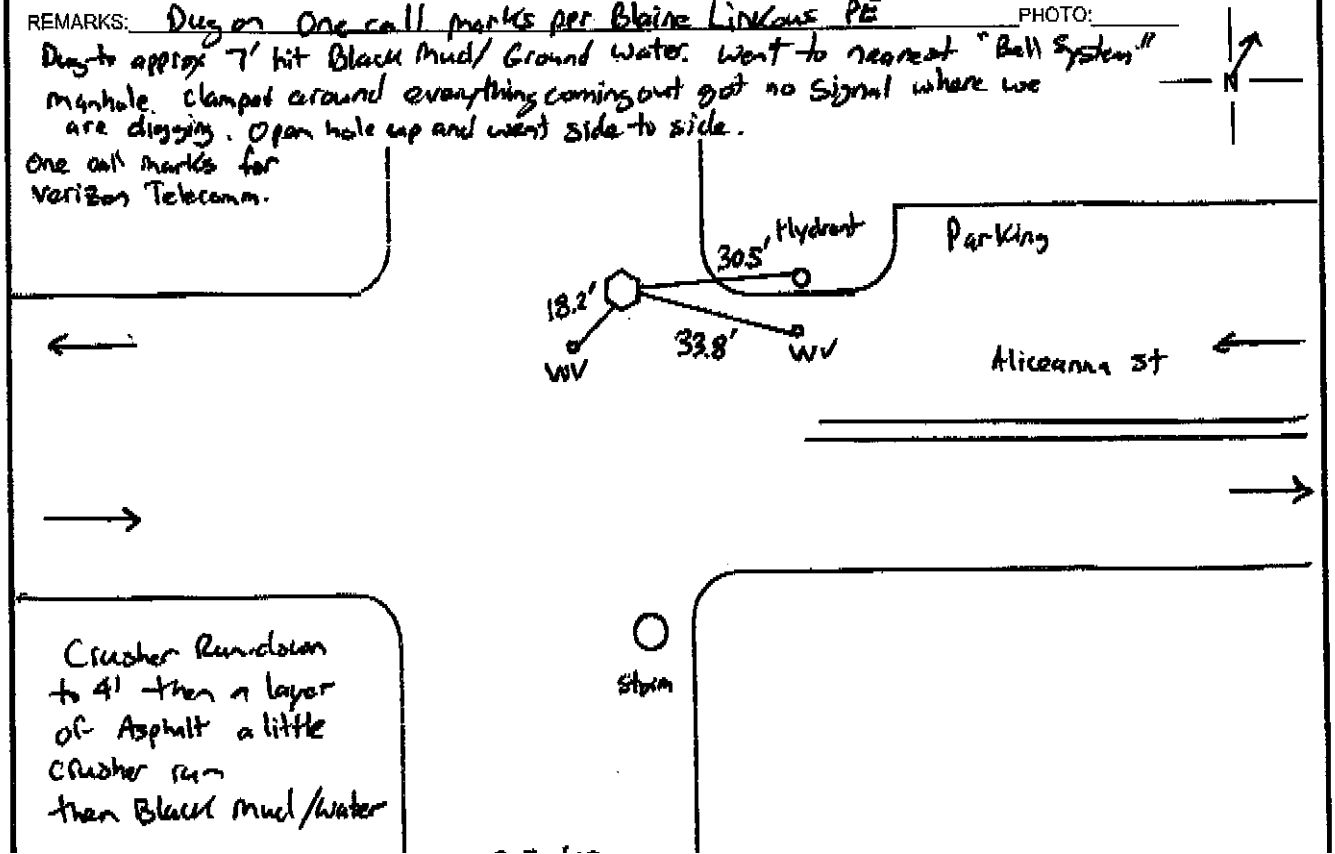
SoftDig® Project #: 113210 Test Hole #: 19 Client: Veolia Energy Date: 8/29/09
One-Call Permit #: 114 212 39 SUE Analyst: R. Molnar Truck #: 589
City / County/State: Baltimore / Baltimore County / MD Road: S. Exeter St
General Location: Aliceanna St / South Exeter St Intersection

Actual Size, Color, Material, Type of Utility: No Utility Found
Utility Owner: — Designation Color: —
Observed Utility Condition: Good ___ Poor ___ Other: —
Test Hole marked by: PK Nail ___ Hub ___ Other: —
Portion of Utility Exposed: Top ___ Half ___ Side ___ Full ___
1. Reference Mark Elevation: —
2. Utility Top Elevation: —
3. Utility Bottom Elevation (if applicable): —
4. Width (if applicable): —
5. Utility Top Depth from Reference: —
6. Utility Bottom Depth from Reference (if applicable): —

Surface Covering Type: Asphalt ✓ Concrete ___ Soil ___ Surface Covering Depth: 12"
Generalized Soil Profile: Select Fill ___ Rock ___ Sand ✓ Clay ___ Other: Crusher Run
1.) Bench Mark Elev.: — Description: —
2.) Bench Mark Elev.: — Description: —
Excavated Location Station: ___ Offset ___
