CHAPTER 4: ANALYSIS OF THE EXISTING TRANSPORTATION NETWORK

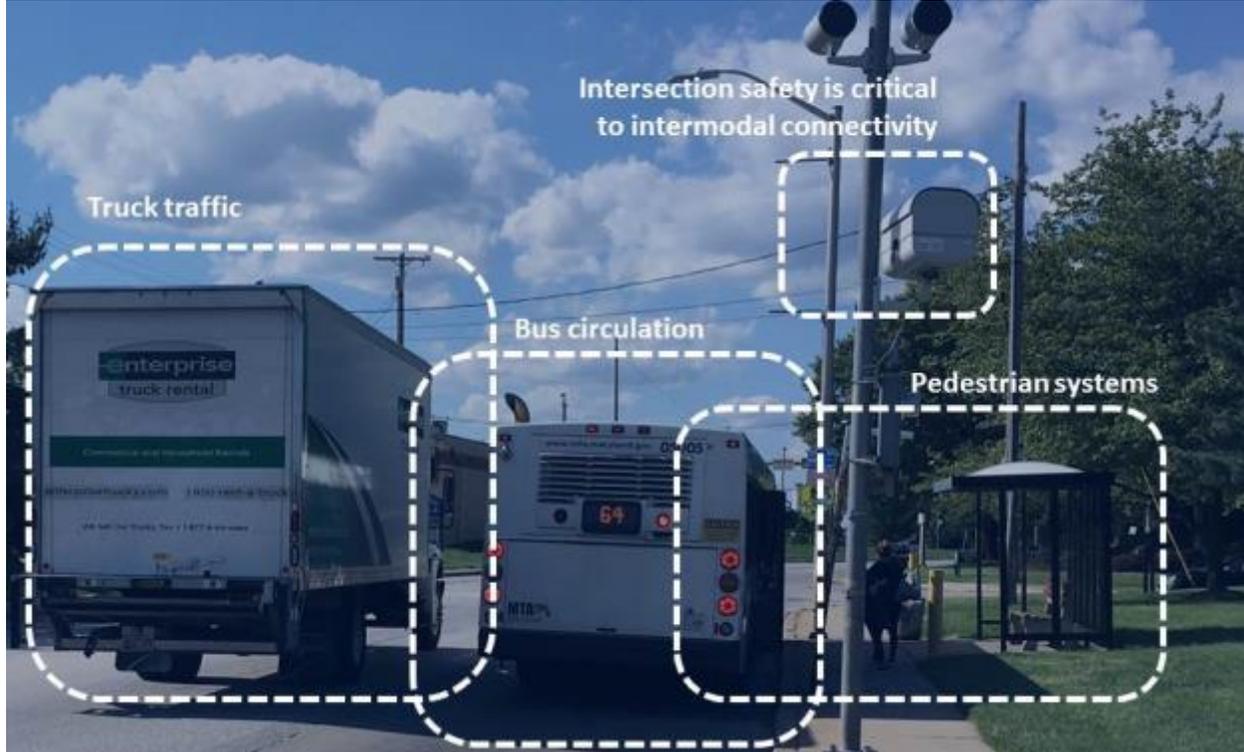
FIGURE 4-1: CONVERGENCE OF MULTIPLE TRANSPORTATION MODES

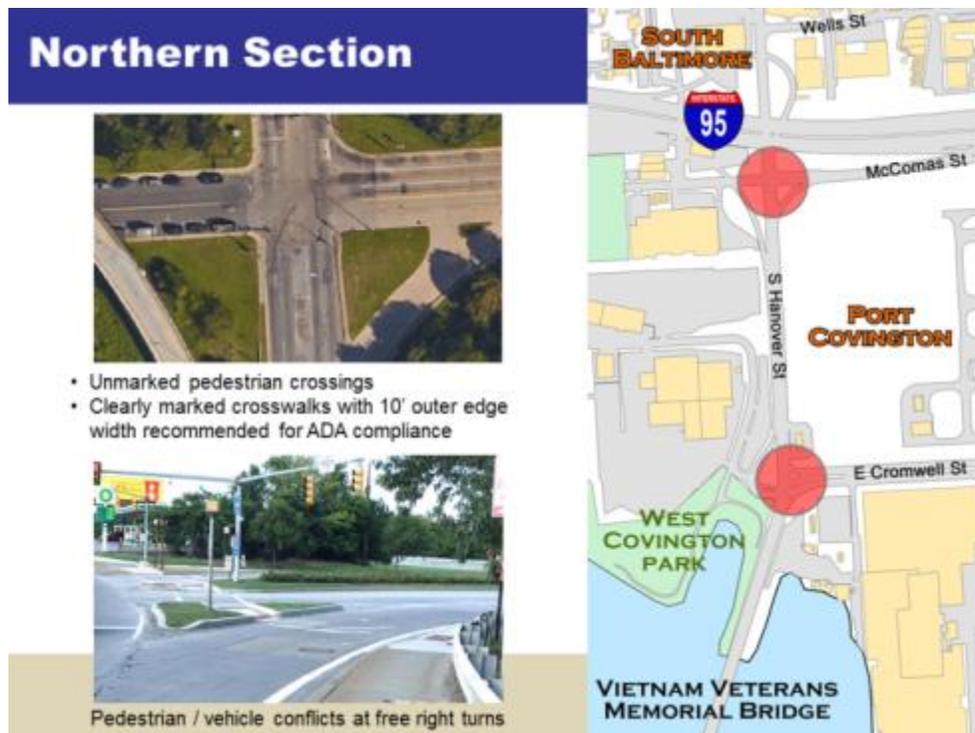
FIGURE 4-8: MULTIMODAL BARRIERS NORTH OF THE DRAWBRIDGE SPAN (1)

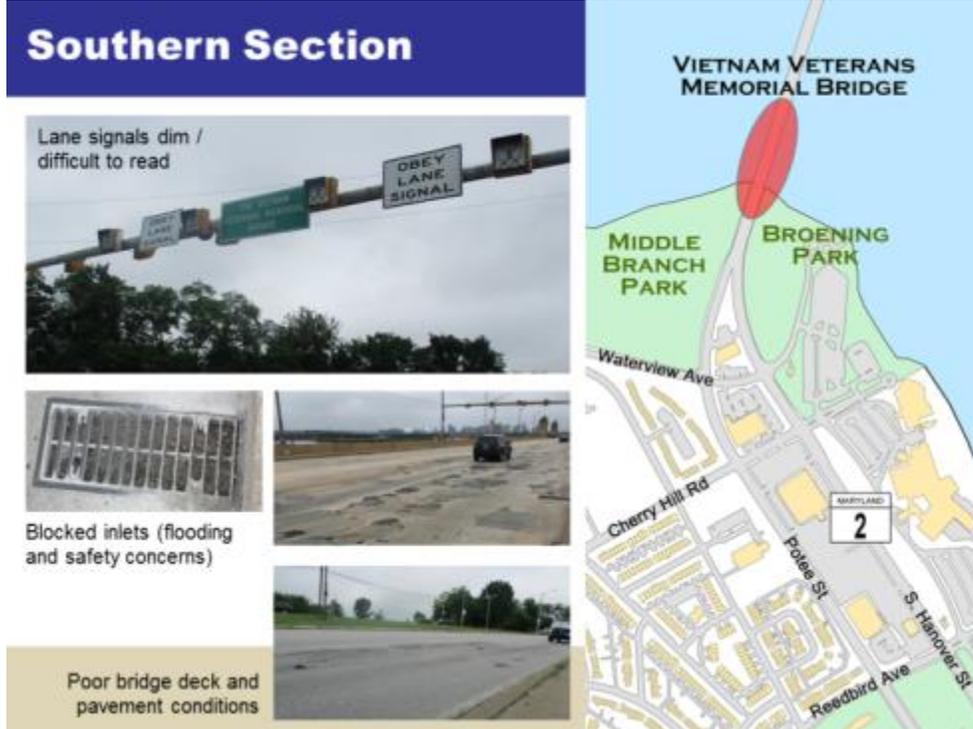
FIGURE 4-11: MULTIMODAL BARRIERS SOUTH OF THE DRAWBRIDGE SPAN (1)

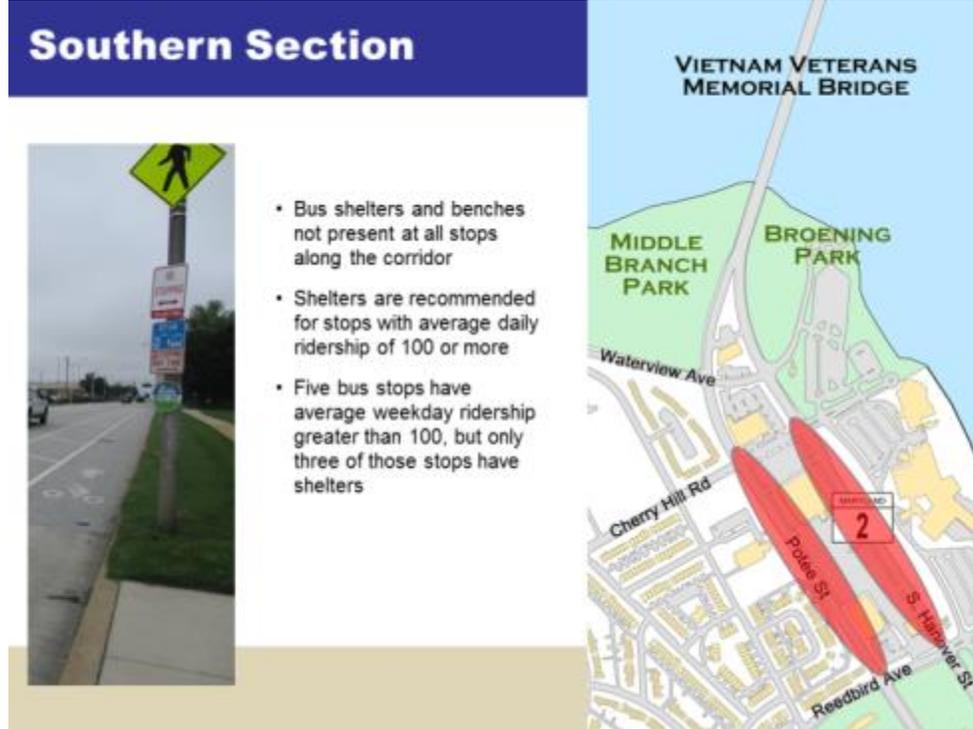
FIGURE 4-15: MULTIMODAL BARRIERS SOUTH OF THE DRAWBRIDGE SPAN (5)

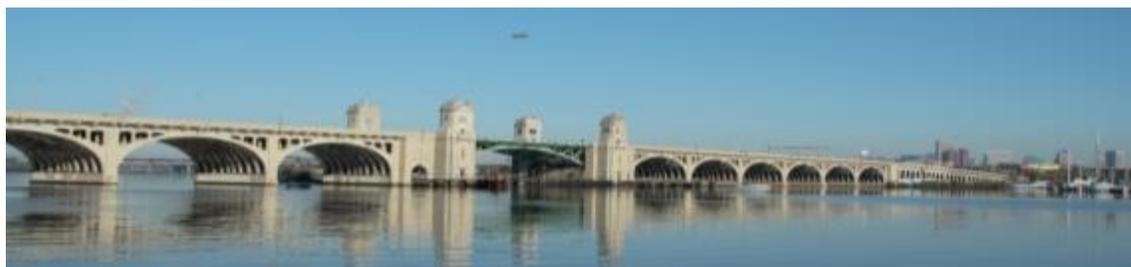
PHOTO 4-1: VIETNAM VETERANS MEMORIAL BRIDGE VIEW FROM WATER

The Vietnam Veterans Memorial Bridge (Bridge BC 5210, shown in **Photo 4-1**) which carries Hanover Street over Middle Branch is a major component of this corridor and is perhaps the most iconic structure in the inventory of the Baltimore City Department of Transportation – and given its age and unique structural configurations, can be considered a significant structure on a national scale as well.

The bridge is considered to be in poor condition – based upon the *Structure Inventory and Appraisal* provided in the *Bridge Inspection Report*, dated 2015. This “poor condition rating” is based upon standard guidelines for the assessment of structures based upon their repair needs, and not necessarily the load carrying capacity of the structure. For this structure, the “poor” rating is indicated because major rehabilitation work is required for both the deck and supporting superstructure. The Load Rating Summary indicates no major deficiencies regarding the load carrying capacities prescribed by current AASHTO design codes.

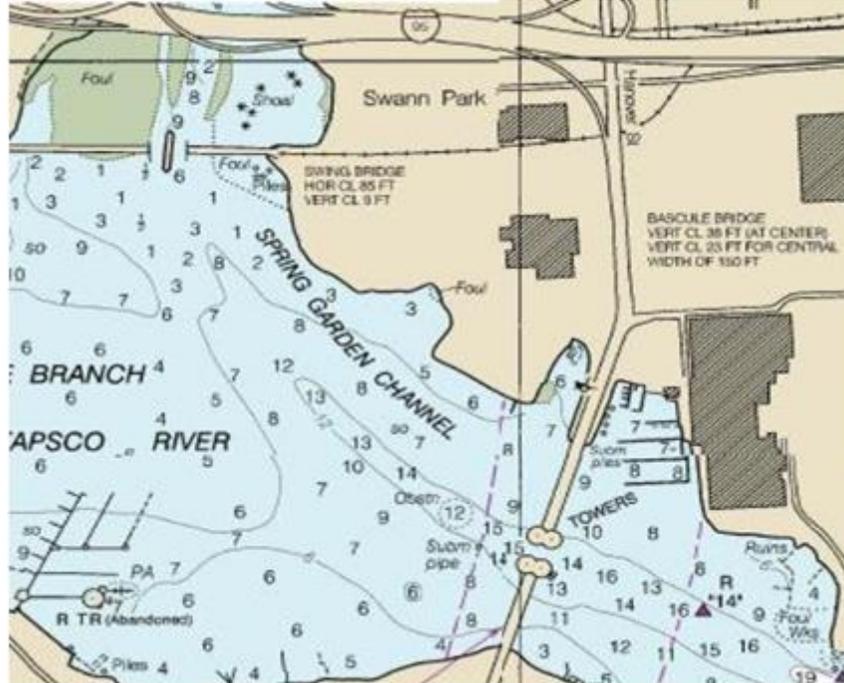
Existing water depths and clearances are shown in **Figure 4-18**. The current vertical clearance of the bridge in the closed position is 38 feet at the center and 23 feet for the entire 150-foot channel width. The existing clearance is adequate for barge and small tug access if necessary for future dredging and marine construction, including maintenance access for I-95, I-395, and Light Rail piers.

FIGURE 4-18: MIDDLE BRANCH WATER DEPTHS AND VERTICAL CLEARANCE

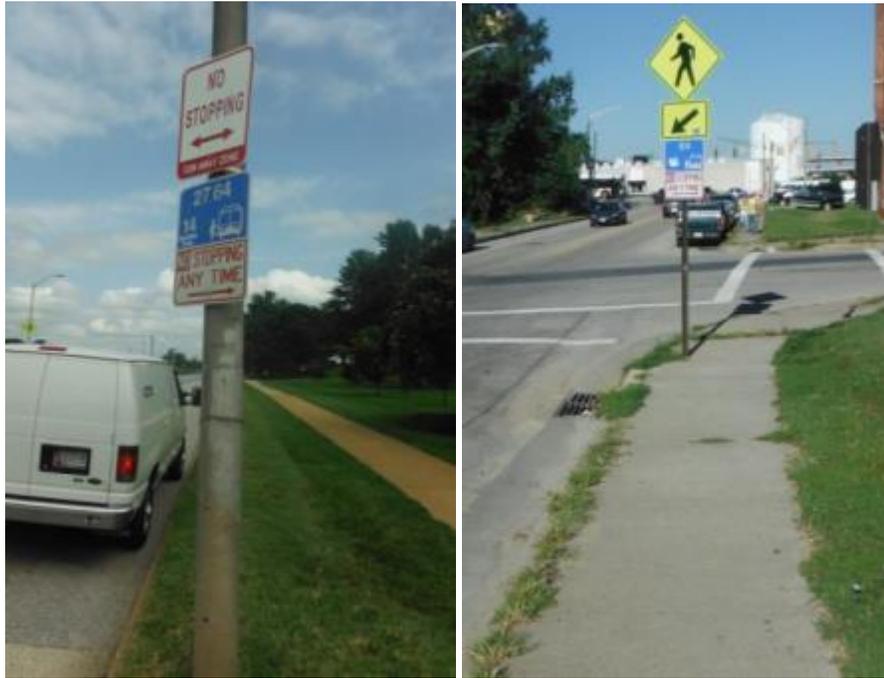
PHOTO 4-8: TYPICAL STUDY AREA BUS STOPS

Although most of the bus stops evaluated were connected with sidewalks, not all sidewalks were in good condition or had adequate width for pedestrians to travel to the bus stops safely and comfortably. In several places, the sidewalks were obstructed by light poles or were discontinued. Two stops in the study area were on grass without any sidewalk access.

Some level of street lighting was present at the majority of the bus stops. In most cases, lighting was poor or barely adequate for riders to feel safe in absence of daylight. There were four stops without any lighting and one stop with pedestrian level lighting available.

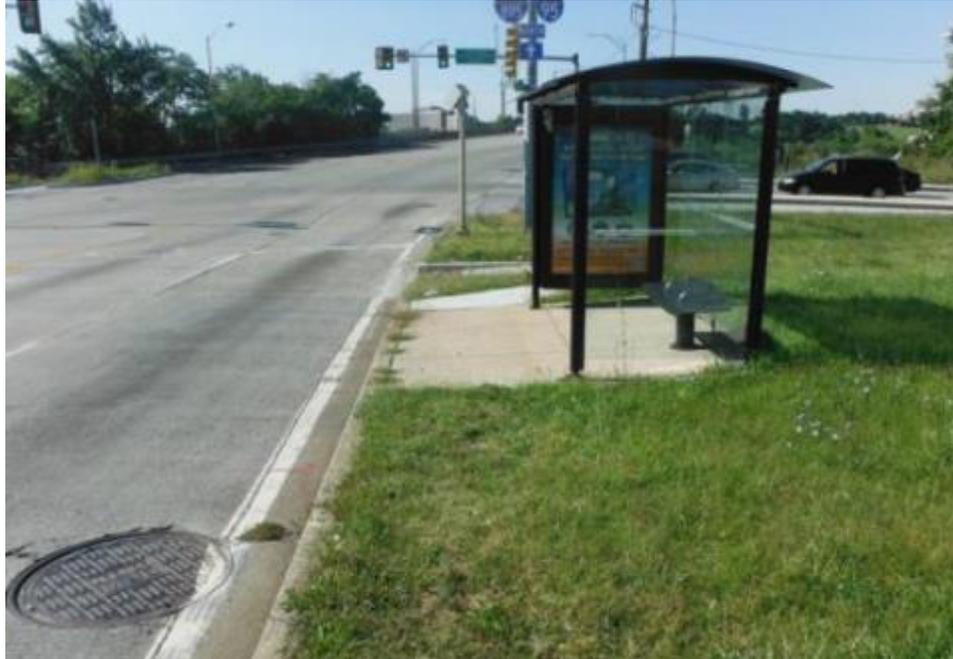
PHOTO 4-9: HANOVER STREET/CROMWELL STREET BUS SHELTER (LOWEST RIDERSHIP)

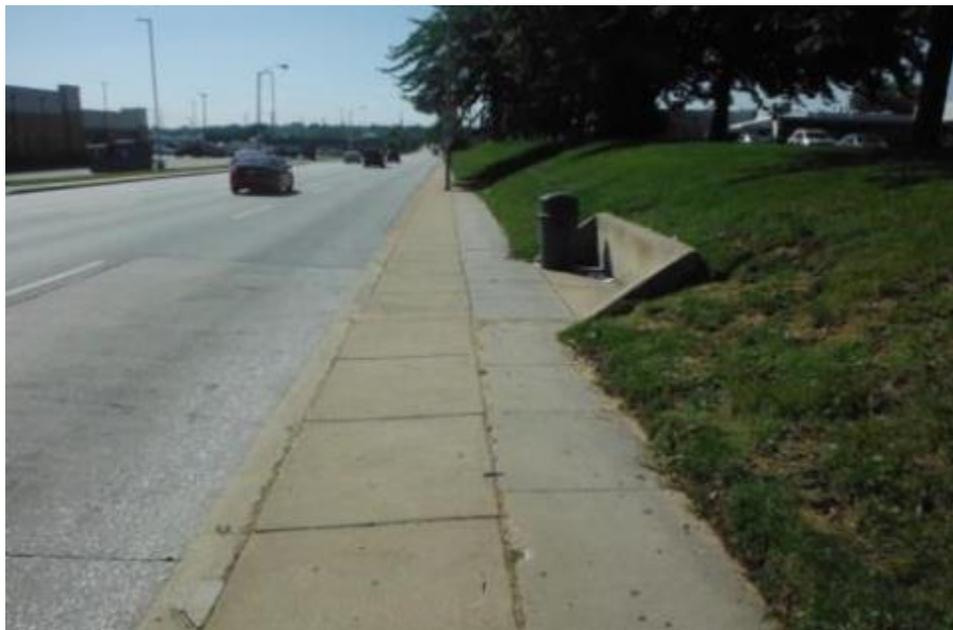
PHOTO 4-10: POTEE STREET/CHERRY HILL ROAD (HIGHEST RIDERSHIP)

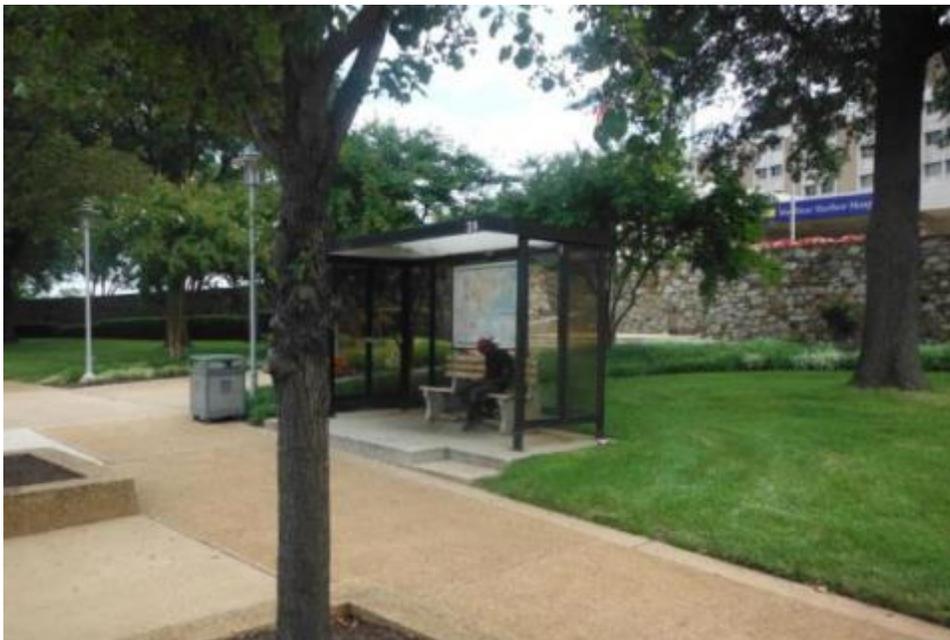
The bus stop located on Hanover Street at MedStar Harbor Hospital was the most complete bus stop in the study area with many pedestrian amenities, including a shelter, wide sidewalks, trash receptacles, pedestrian scale lighting, trees, and green areas.

PHOTO 4-12: HANOVER STREET AT MEDSTAR HARBOR HOSPITAL

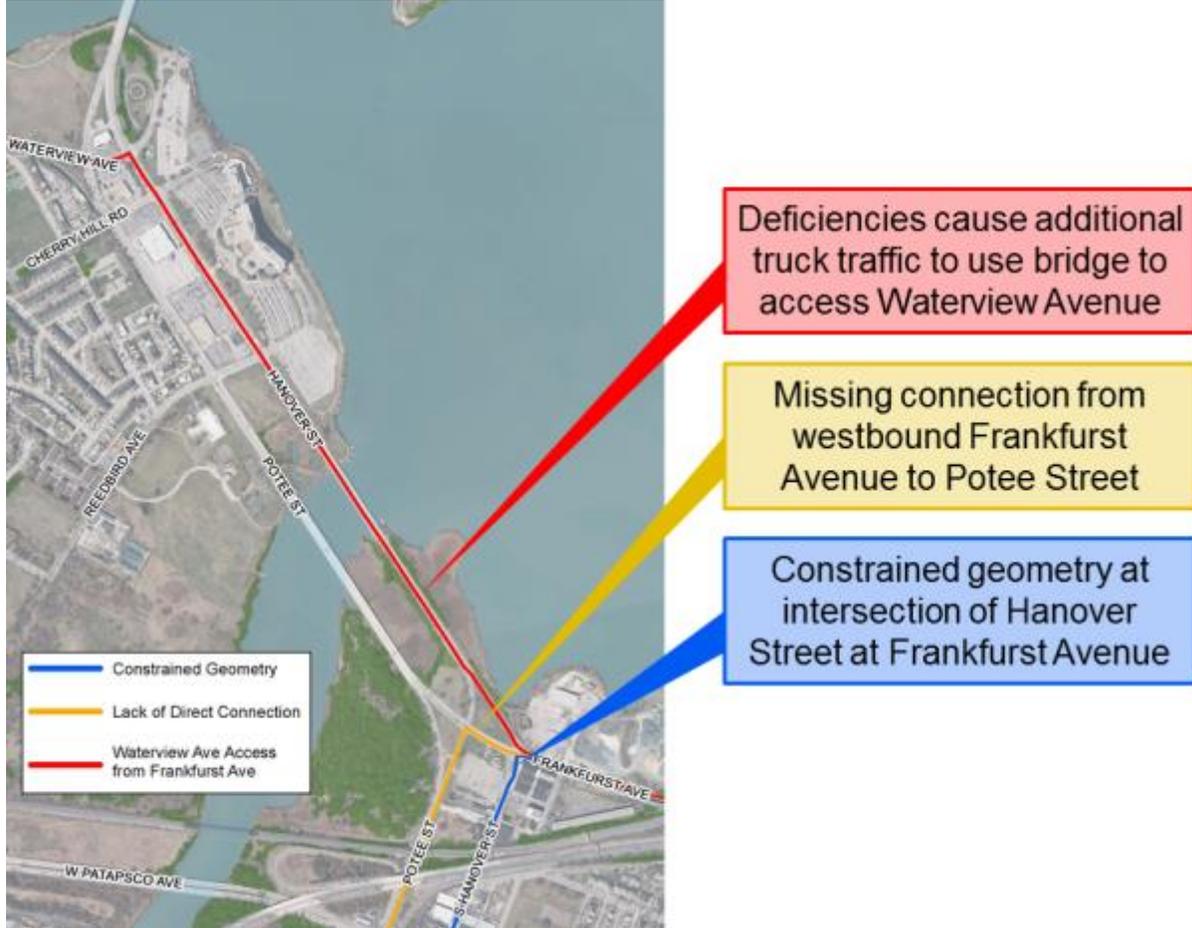
Just south of the study area, the combination of constrained geometry at the intersection of Hanover Street at Frankfurst Avenue and lack of a direct connection from Frankfurst Avenue to Potee Street has been well documented. Based on discussions with local business associations and industry groups, trucks traveling west on Frankfurst Avenue cannot turn left onto Potee Street to travel towards Anne Arundel County, so they instead travel north on Hanover Street to Waterview Avenue to access I-295 or I-95. The June 2014 *Hanover Street Safety and Multimodal Access Study* documented that truck drivers have difficulty turning to/from Frankfurst Street to Hanover Street and included concepts that were developed to connect westbound Frankfurst Avenue to Potee Street. Members of the Interagency Advisory Group (IAG) have also indicated that these deficiencies cause additional truck traffic to use Hanover Street and Potee Street north of Frankfurst Avenue to access Waterview Avenue. Allowing truck traffic that currently uses Waterview Avenue, a relatively low speed, minor roadway that divides the Cherry Hill neighborhood from Middle Branch Park, to more safely and efficiently access a higher classification roadway (i.e. Potee Street) would improve truck safety and circulation. **Figure 4-27** shows a map of these truck movements.

FIGURE 4-27: TRUCK CONSTRAINTS SOUTH OF THE STUDY AREA
