City of Baltimore Department of Transportation

Rehabilitation of Bridge No. BC3456 on Remington Avenue over Stony Run – TR14309

80% Design Display

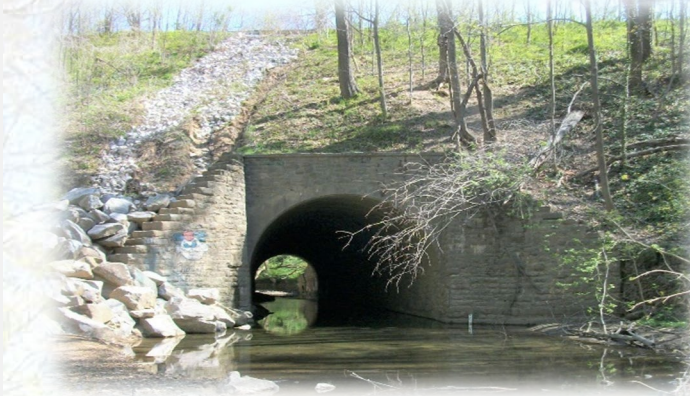
Existing Concrete and Stone Arch Bridge

The Existing Bridge is in need of rehabilitation, Existing Conditions Include:

- Cracks and Deterioration
- Settlement and Displacement
- Limited Hydraulic Capacity.

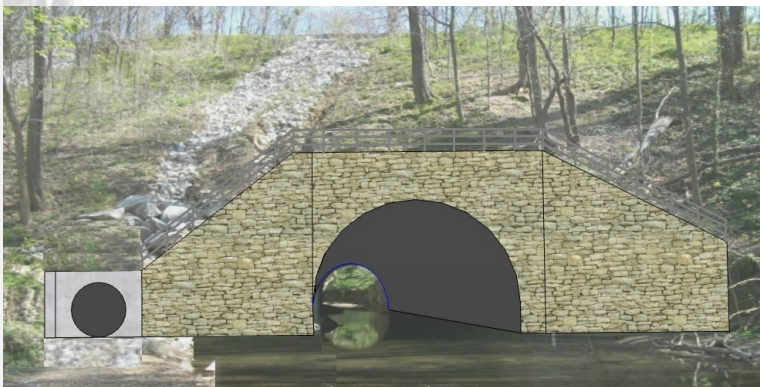
The proposed arch liner will be a little smaller than the existing, with an adjacent overflow tunnel providing the larger flow area needed to improve hydraulics.

Proposed Overflow Tunnel and Lined Arch Bridge

- Install new overflow tunnel adjacent to existing arch
- Installation of Structural Liner
 - Reinforced Concrete Arch Liner and Wing Walls
 - Match stone style with new stone look finish
 - Provide riparian plantings on embankment and access road
- No impacts to vehicular traffic or pedestrians
